R-003A

COVE RD
New Bedford

Inspection Status: Remote Inspection
Inspection Level: Level 2

Project: | New Bedford 3D Regulator Inspections
Owner: New Bedford, MA
Customer: CDM Smith

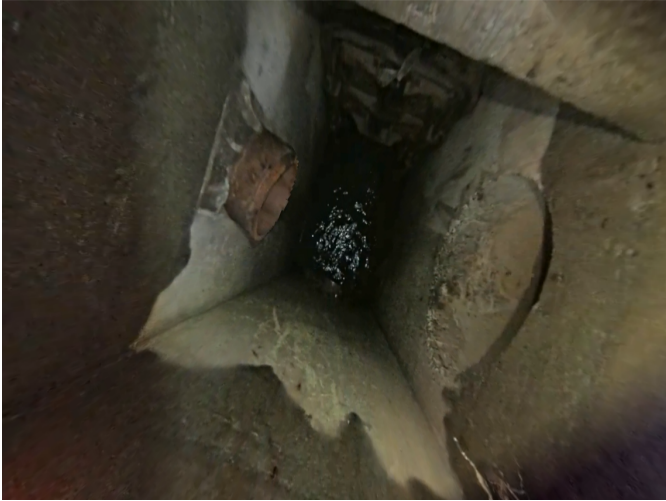
Code: **MGO**
Description: **Miscellaneous General Observation**

Distance: **0ft**
Structural Grade: **0**
O&M Grade: **0**
Clock Start/From:
Clock To:
1st Value:
2nd Value:
Value Percent:
Continuous Index:
Within Eight" of Joint: **False**
Remarks: **Start inspection**

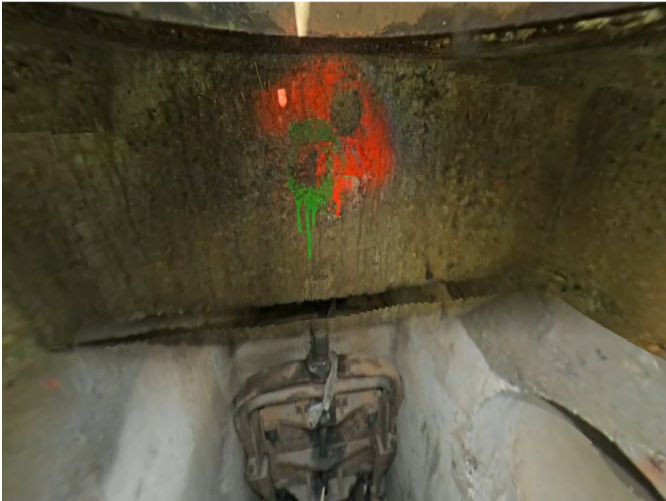
Code: **IS**
Description: **Infiltration Stain**

Distance: **0ft**
Structural Grade: **0**
O&M Grade: **1**
Clock Start/From: **12**
Clock To: **12**
1st Value:
2nd Value:
Value Percent:
Continuous Index: **S01**
Within Eight" of Joint: **False**
Remarks:

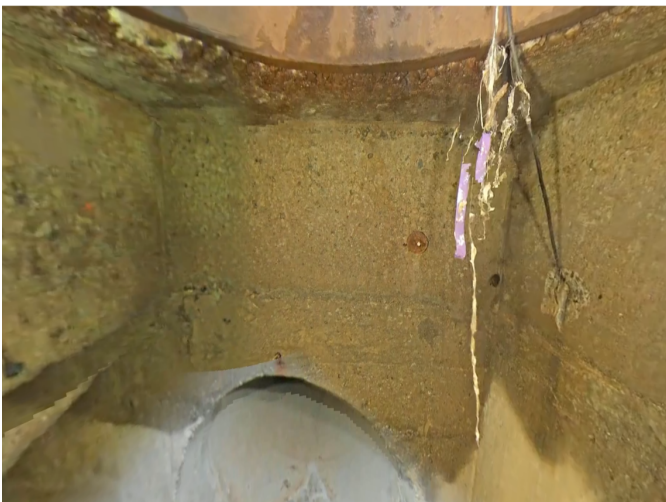
Code: **SAV**
Description: **Surface Damage Aggregate Visible**

Distance: **0ft**
Structural Grade: **2**
O&M Grade: **0**
Clock Start/From: **12**
Clock To: **12**
1st Value:
2nd Value:
Value Percent:
Continuous Index: **S02**
Within Eight" of Joint: **False**
Remarks:

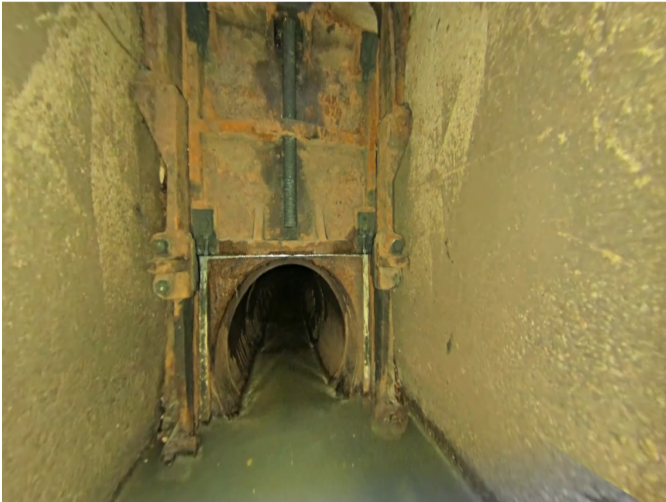
Code: **OBS**
Description: **Obstruction Built Into Structure**

Distance: **6ft**
Structural Grade: **0**
O&M Grade: **0**
Clock Start/From: **6**
Clock To:
1st Value:
2nd Value:
Value Percent: **10**
Continuous Index:
Within Eight" of Joint: **False**
Remarks: **Gate structure**

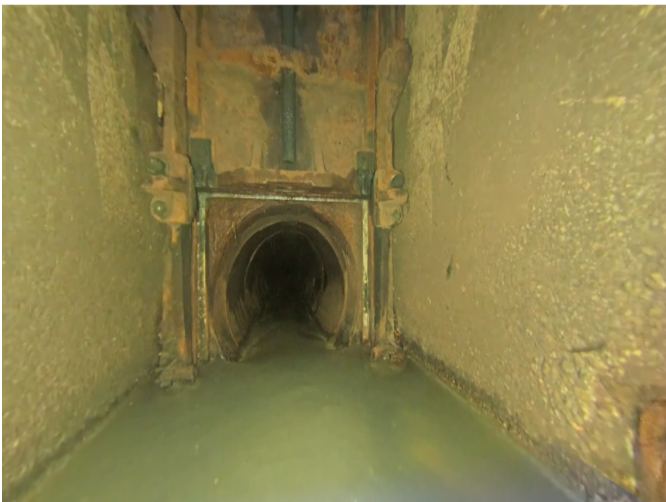
Code: **IS**
Description: **Infiltration Stain**

Distance: **7ft**
Structural Grade: **0**
O&M Grade: **1**
Clock Start/From: **12**
Clock To: **12**
1st Value:
2nd Value:
Value Percent:
Continuous Index: **F01**
Within Eight" of Joint: **False**
Remarks:

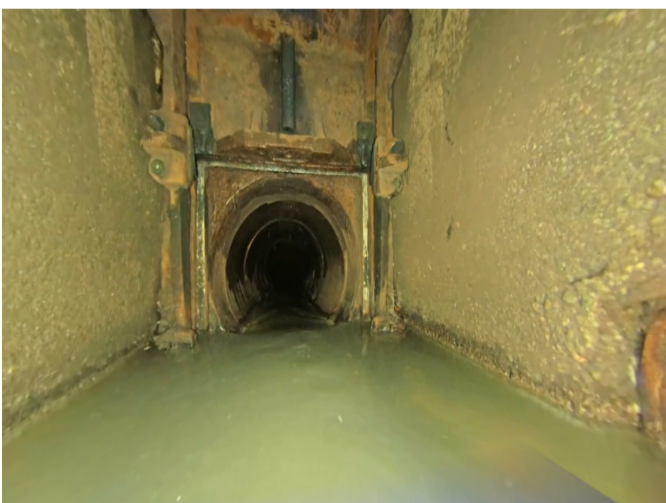
Code: **MGO**
Description: **Miscellaneous General Observation**

Distance: **7ft**
Structural Grade: **0**
O&M Grade: **0**
Clock Start/From:
Clock To:
1st Value:
2nd Value:
Value Percent:
Continuous Index:
Within Eight" of Joint: **False**
Remarks: **End inspection**

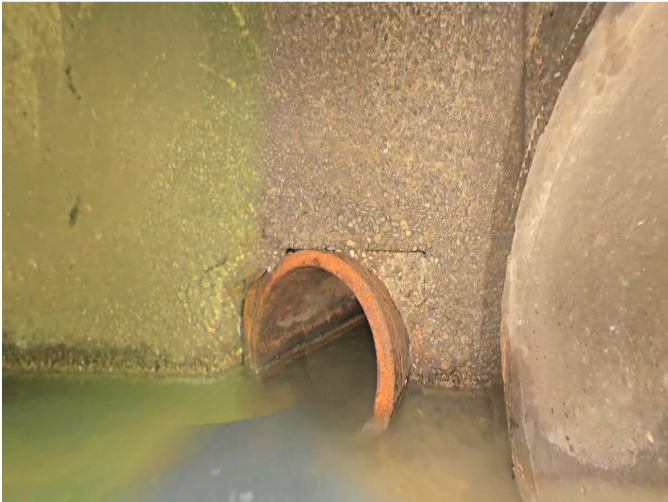
Code: **SAV**
Description: **Surface Damage
Aggregate Visible**

Distance: **7ft**
Structural Grade: **2**
O&M Grade: **0**
Clock Start/From: **12**
Clock To: **12**
1st Value:
2nd Value:
Value Percent:
Continuous Index: **F02**
Within Eight" of Joint: **False**
Remarks:
