# R-003B

NORWELL ST  
New Bedford

Inspection Status: Remote Inspection  
Inspection Level: Level 2

**Project:** | New Bedford 3D Regulator Inspections

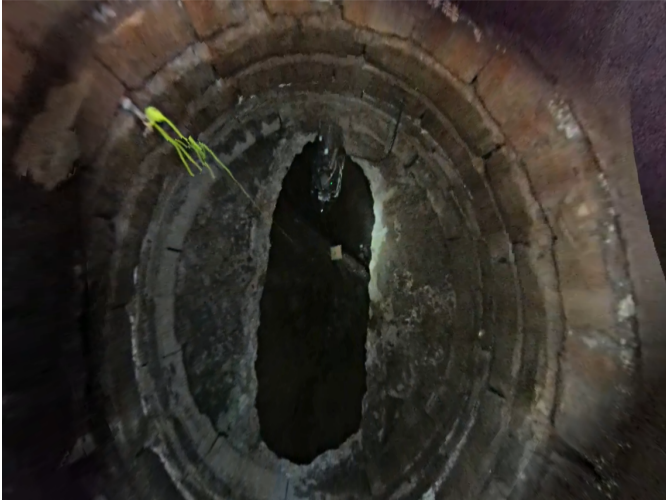
Code: **MGO**  
Description: **Miscellaneous General Observation**

Distance: **0ft**  
Structural Grade: **0**  
O&M Grade: **0**  
Clock Start/From:  
Clock To:  
1st Value:  
2nd Value:  
Value Percent:  
Continuous Index:  
Within Eight" of Joint: **False**  
Remarks: **Start inspection**

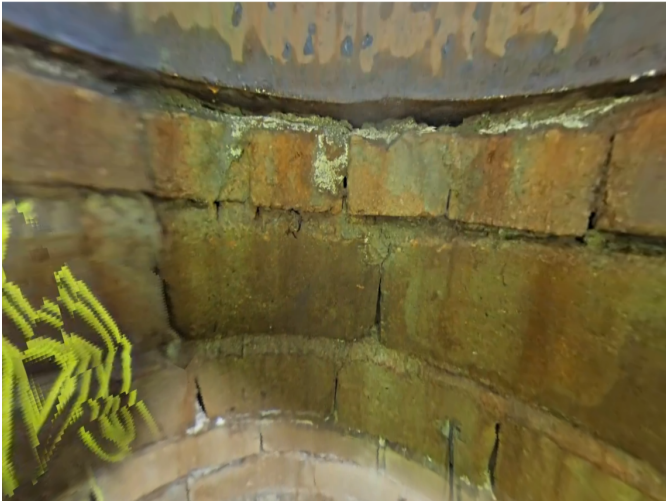
Code: **MMS**  
Description: **Missing Mortar Small**

Distance: **1ft**  
Structural Grade: **2**  
O&M Grade: **0**  
Clock Start/From: **12**  
Clock To: **12**  
1st Value:  
2nd Value:  
Value Percent:  
Continuous Index:  
Within Eight" of Joint: **False**  
Remarks:

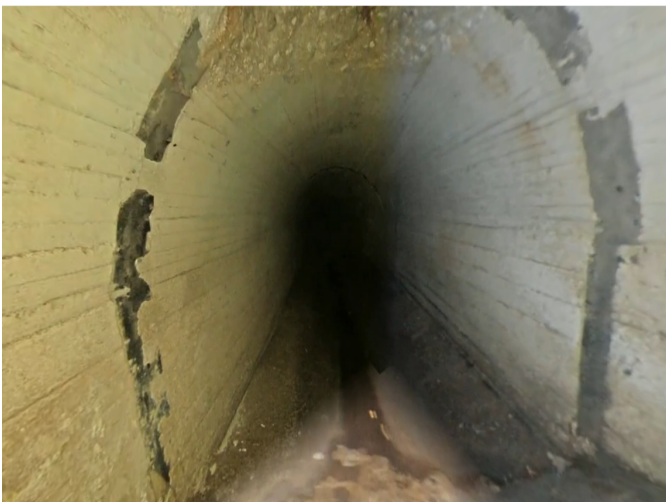
Code: **MGO**  
Description: **Miscellaneous General Observation**

Distance: **5ft**  
Structural Grade: **0**  
O&M Grade: **0**  
Clock Start/From:  
Clock To:  
1st Value:  
2nd Value:  
Value Percent:  
Continuous Index:  
Within Eight" of Joint: **False**  
Remarks: **End inspection**
