# R-004A

COVE RD  
New Bedford

Inspection Status: Remote Inspection  
Inspection Level: Level 2

**Project:** | New Bedford 3D Regulator Inspections  
**Owner:** New Bedford, MA  
**Customer:** CDM Smith

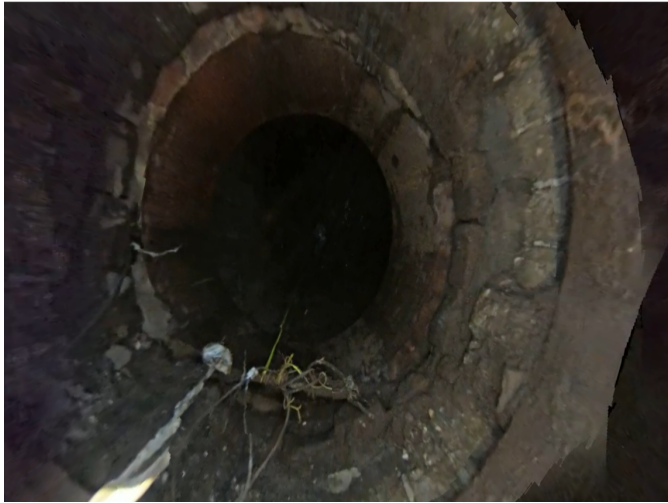
Code: **MGO**  
Description: **Miscellaneous General Observation**

Distance: **0ft**  
Structural Grade: **0**  
O&M Grade: **0**  
Clock Start/From:  
Clock To:  
1st Value:  
2nd Value:  
Value Percent:  
Continuous Index:  
Within Eight" of Joint: **False**  
Remarks: **Start inspection**

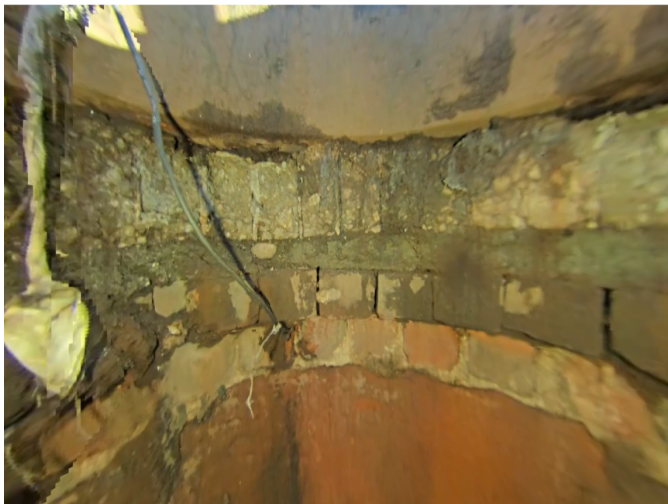
| Graph | Position | Code | Observation | Video (sec) | Grade |
|---|---|---|---|---|---|
| | 1.1ft | MMS | Missing Mortar Small | 7.4 | S 2 |

Code: **MMS**  
Description: **Missing Mortar Small**

Distance: **1ft**  
Structural Grade: **2**  
O&M Grade: **0**  
Clock Start/From: **12**  
Clock To: **12**  
1st Value:  
2nd Value:  
Value Percent:  
Continuous Index:  
Within Eight" of Joint: **False**  
Remarks:

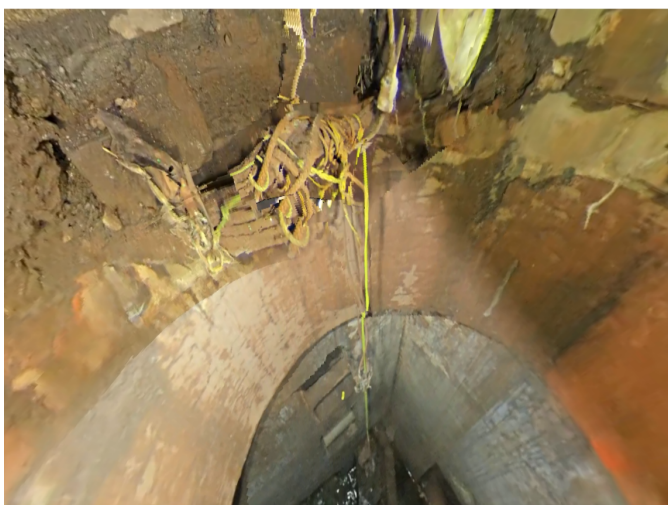
| Graph | Position | Code | Observation | Video (sec) | Grade |
|---|---|---|---|---|---|
| | 1.1ft | DAZ | Deposits Attached Other | 7.4 | S 0 |

Code: **DAZ**  
Description: **Deposits Attached Other**

Distance: **1ft**  
Structural Grade: **0**  
O&M Grade: **0**  
Clock Start/From: **6**  
Clock To:  
1st Value:  
2nd Value:  
Value Percent: **5**  
Continuous Index: **S01**  
Within Eight" of Joint: **False**  
Remarks: **Rope**

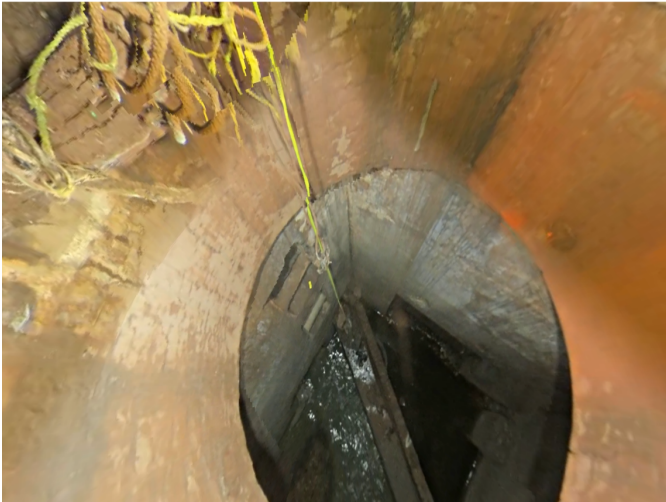
| Graph | Position | Code | Observation | Video (sec) | Grade |
|---|---|---|---|---|---|
| | 1.1ft | IS | Infiltration Stain | 7.4 | M 1 |

Code: **IS**  
Description: **Infiltration Stain**

Distance: **1ft**  
Structural Grade: **0**  
O&M Grade: **1**  
Clock Start/From: **12**  
Clock To: **12**  
1st Value:  
2nd Value:  
Value Percent:  
Continuous Index: **S02**  
Within Eight" of Joint: **False**  
Remarks:

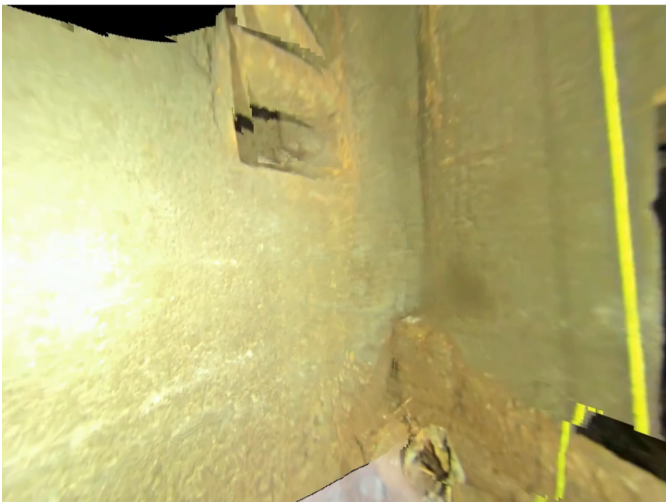
| Graph | Position | Code | Observation | Video (sec) | Grade |
|---|---|---|---|---|---|
| | 6ft | DAZ | Deposits Attached Other | 17.2 | S 0 |

Code: **DAZ**  
Description: **Deposits Attached Other**

Distance: **6ft**  
Structural Grade: **0**  
O&M Grade: **0**  
Clock Start/From: **6**  
Clock To:  
1st Value:  
2nd Value:  
Value Percent: **5**  
Continuous Index: **F01**  
Within Eight" of Joint: **False**  
Remarks: **Rope**

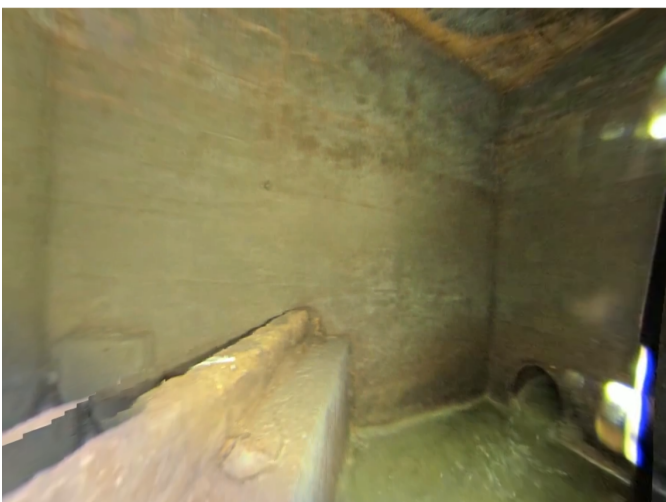
| Graph | Position | Code | Observation | Video (sec) | Grade |
|---|---|---|---|---|---|
| | 6ft | IS | Infiltration Stain | 17.2 | M 1 |

Code: **IS**  
Description: **Infiltration Stain**

Distance: **6ft**  
Structural Grade: **0**  
O&M Grade: **1**  
Clock Start/From: **12**  
Clock To: **12**  
1st Value:  
2nd Value:  
Value Percent:  
Continuous Index: **F02**  
Within Eight" of Joint: **False**  
Remarks:

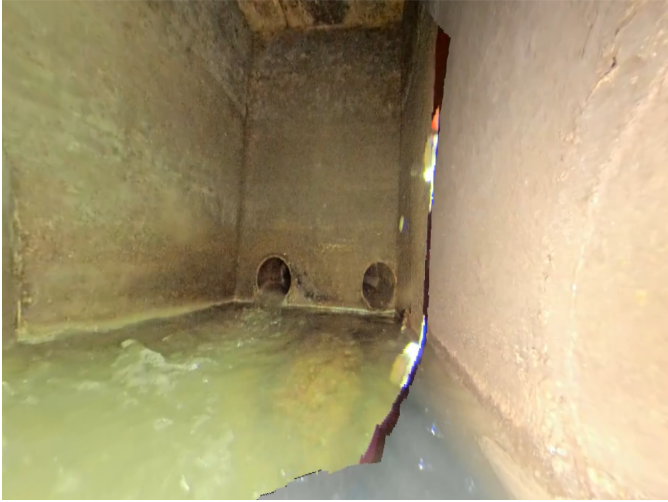
Code: **MGO**  
Description: **Miscellaneous General Observation**

Distance: **7ft**  
Structural Grade: **0**  
O&M Grade: **0**  
Clock Start/From:  
Clock To:  
1st Value:  
2nd Value:  
Value Percent:  
Continuous Index:  
Within Eight" of Joint: **False**  
Remarks: **End inspection**
