R-004A_FLOAT

COVE RD
New Bedford

Inspection Status: Remote Inspection
Inspection Level: Level 2

Project: | New Bedford 3D Regulator Inspections

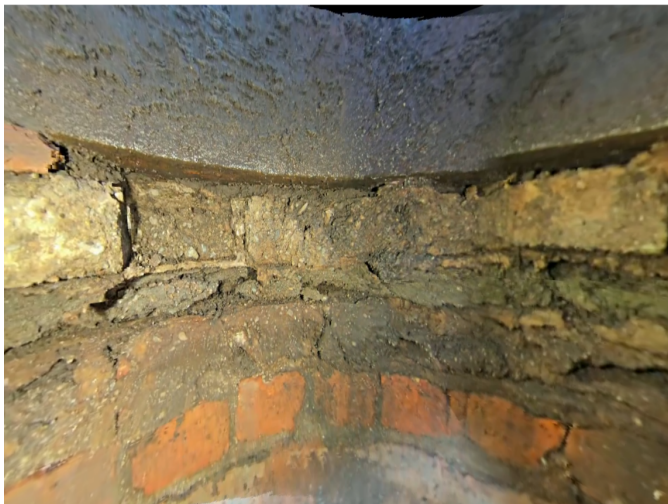
Code: **MMS**
Description: **Missing Mortar Small**

Distance: **0ft**
Structural Grade: **2**
O&M Grade: **0**
Clock Start/From: **12**
Clock To: **12**
1st Value:
2nd Value:
Value Percent:
Continuous Index:
Within Eight" of Joint: **False**
Remarks:

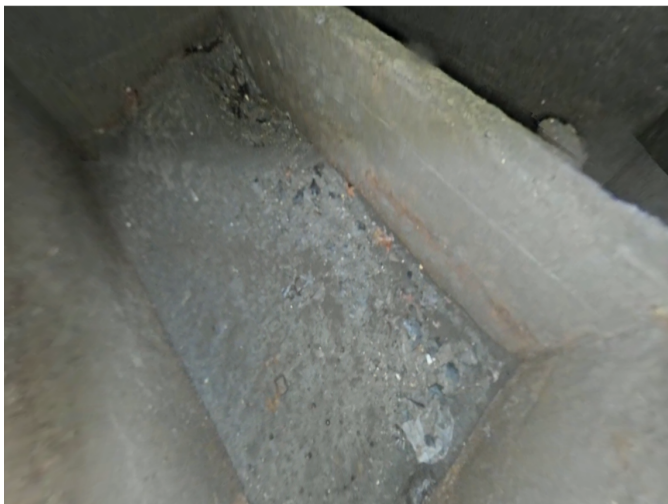
Code: **DSC**
Description: **Deposits Settled Compacted**

Distance: **4ft**
Structural Grade: **0**
O&M Grade: **2**
Clock Start/From: **12**
Clock To: **12**
1st Value:
2nd Value:
Value Percent: **50**
Continuous Index:
Within Eight" of Joint: **False**
Remarks:

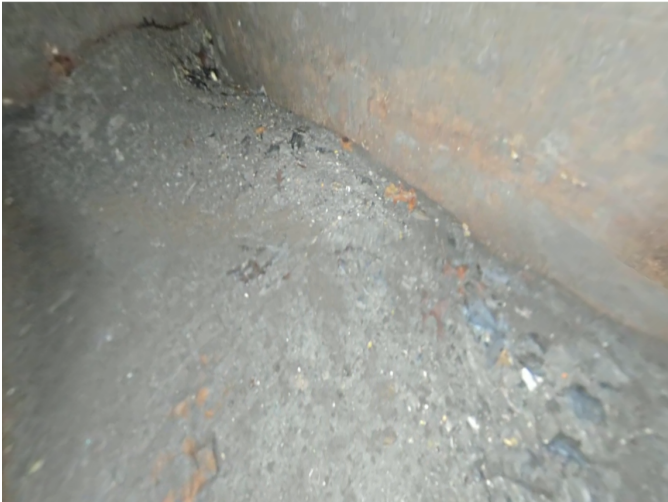
Code: **DSC**
Description: **Deposits Settled
Compacted**

Distance: **5ft**
Structural Grade: **0**
O&M Grade: **2**
Clock Start/From: **12**
Clock To: **12**
1st Value:
2nd Value:
Value Percent: **60**
Continuous Index:
Within Eight" of Joint: **False**
Remarks:

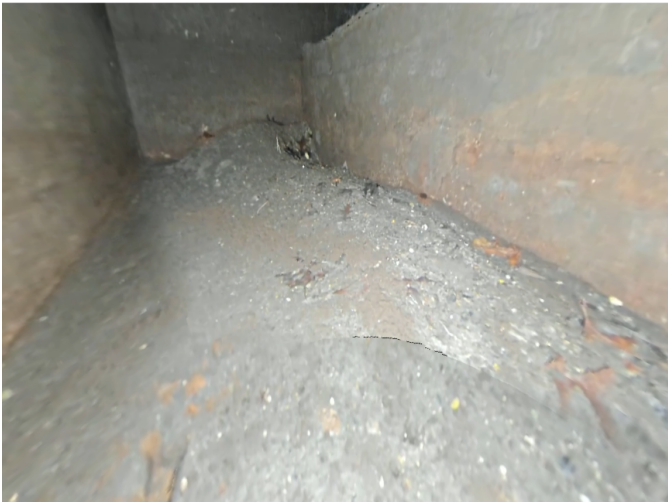
Code: **MSA**
Description: **Miscellaneous Survey
Abandoned**

Distance: **6ft**
Structural Grade: **0**
O&M Grade: **0**
Clock Start/From:
Clock To:
1st Value:
2nd Value:
Value Percent:
Continuous Index:
Within Eight" of Joint: **False**
Remarks: **Pipe connections not
visible**
