R-004A_TIDE

COVE RD
New Bedford

Project: | New Bedford 3D Regulator Inspections
Owner: New Bedford, MA
Customer: CDM Smith

Condition Report

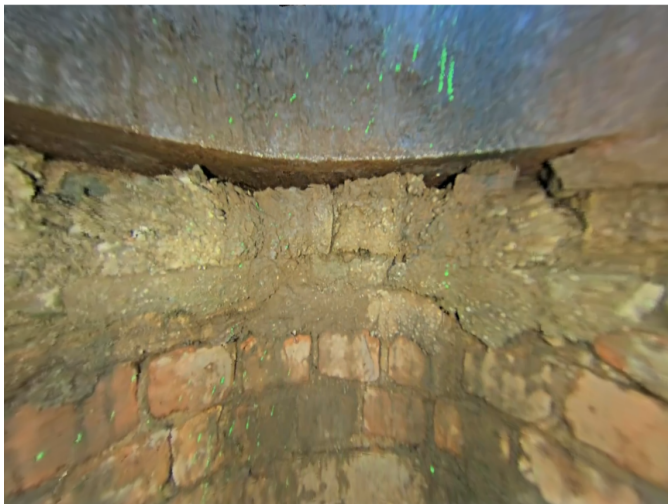
Code: **MMS**
Description: **Missing Mortar Small**

Distance: **0ft**
Structural Grade: **2**
O&M Grade: **0**
Clock Start/From: **12**
Clock To: **12**
1st Value:
2nd Value:
Value Percent:
Continuous Index:
Within Eight" of Joint: **False**
Remarks:

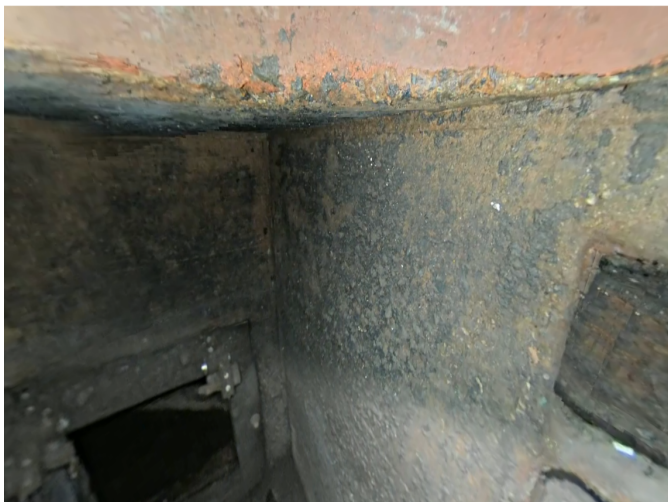
Code: **SRI**
Description: **Surface Damage Roughness Increased**

Distance: **3ft**
Structural Grade: **1**
O&M Grade: **0**
Clock Start/From: **12**
Clock To: **12**
1st Value:
2nd Value:
Value Percent:
Continuous Index: **S01**
Within Eight" of Joint: **False**
Remarks:

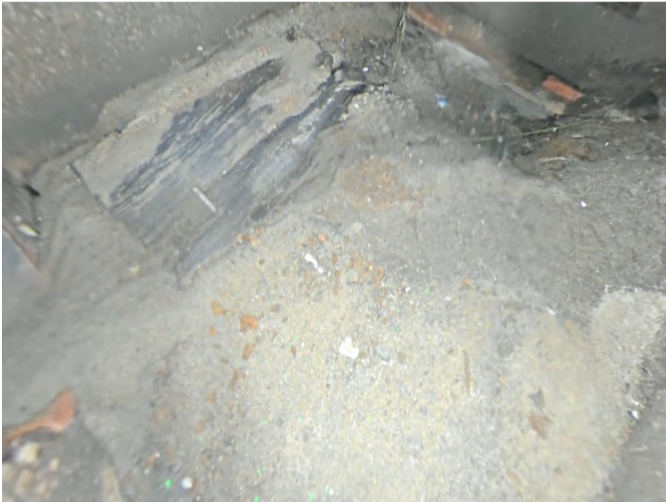
Code: **DSF**
Description: **Deposits Settled Fine**

Distance: **6ft**
Structural Grade: **0**
O&M Grade: **1**
Clock Start/From: **12**
Clock To: **12**
1st Value:
2nd Value:
Value Percent: **25**
Continuous Index:
Within Eight" of Joint: **False**
Remarks:

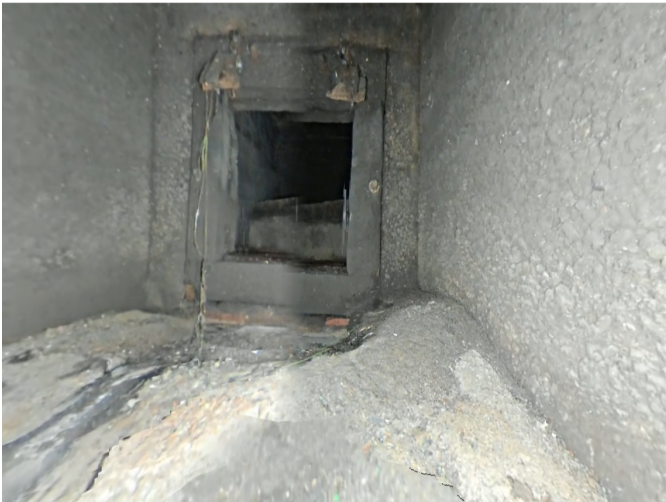
Code: **SRI**
Description: **Surface Damage
Roughness Increased**

Distance: **7ft**
Structural Grade: **1**
O&M Grade: **0**
Clock Start/From: **12**
Clock To: **12**
1st Value:
2nd Value:
Value Percent:
Continuous Index: **F01**
Within Eight" of Joint: **False**
Remarks:
