R-004B

COVE RD
New Bedford

Inspection Status: Remote Inspection
Inspection Level: Level 2

Project: | New Bedford 3D Regulator Inspections

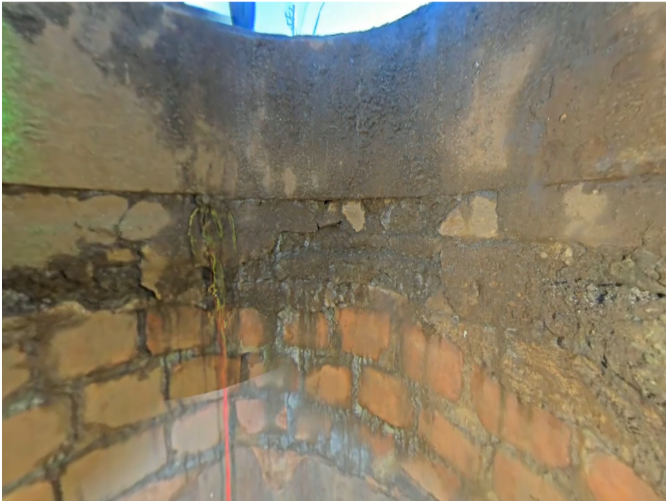
Code: **CC**
Description: **Crack Circumferential**

Distance: **0ft**
Structural Grade: **2**
O&M Grade: **0**
Clock Start/From: **12**
Clock To: **12**
1st Value:
2nd Value:
Value Percent:
Continuous Index:
Within Eight" of Joint: **True**
Remarks:

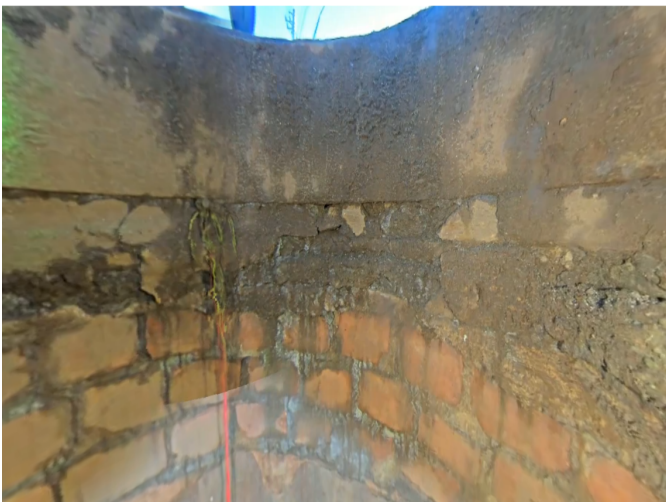
Code: **IS**
Description: **Infiltration Stain**

Distance: **0ft**
Structural Grade: **0**
O&M Grade: **1**
Clock Start/From: **12**
Clock To: **12**
1st Value:
2nd Value:
Value Percent:
Continuous Index: **S01**
Within Eight" of Joint: **False**
Remarks:

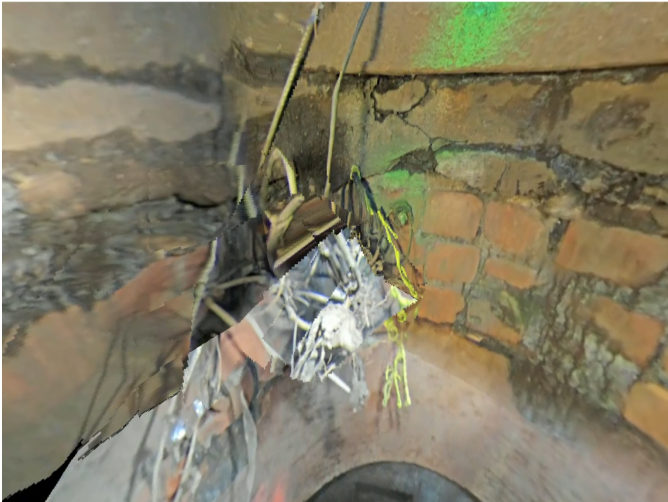
Code: **DAZ**
Description: **Deposits Attached Other**

Distance: **0ft**
Structural Grade: **0**
O&M Grade: **0**
Clock Start/From: **5**
Clock To:
1st Value:
2nd Value:
Value Percent: **20**
Continuous Index:
Within Eight" of Joint: **False**
Remarks: **Rope or wire**

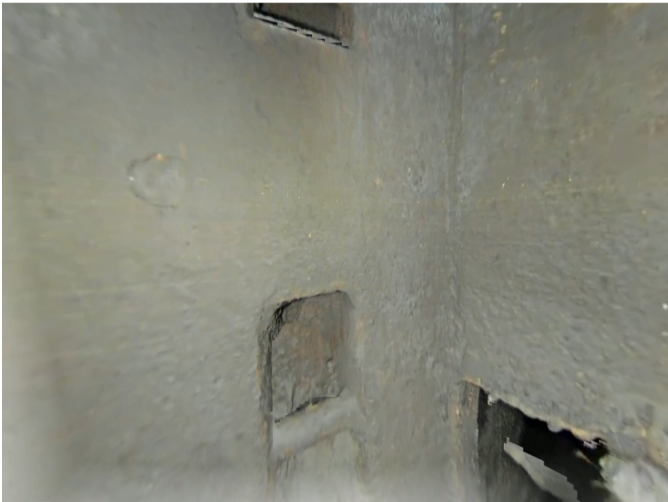
Code: **IS**
Description: **Infiltration Stain**

Distance: **4ft**
Structural Grade: **0**
O&M Grade: **1**
Clock Start/From: **12**
Clock To: **12**
1st Value:
2nd Value:
Value Percent:
Continuous Index: **F01**
Within Eight" of Joint: **False**
Remarks:
