R-004B_FLOAT

COVE RD
New Bedford

Inspection Status: Remote Inspection
Inspection Level: Level 2

Project: | New Bedford 3D Regulator Inspections

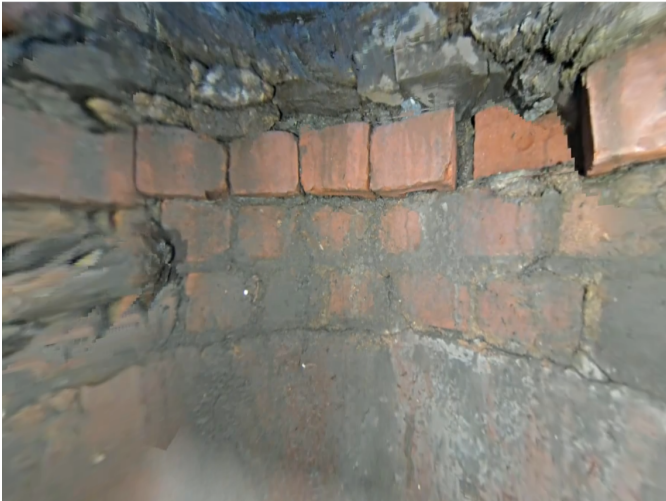
Code: **MMS**
Description: **Missing Mortar Small**

Distance: **1ft**
Structural Grade: **2**
O&M Grade: **0**
Clock Start/From: **12**
Clock To: **12**
1st Value:
2nd Value:
Value Percent:
Continuous Index:
Within Eight" of Joint: **False**
Remarks:

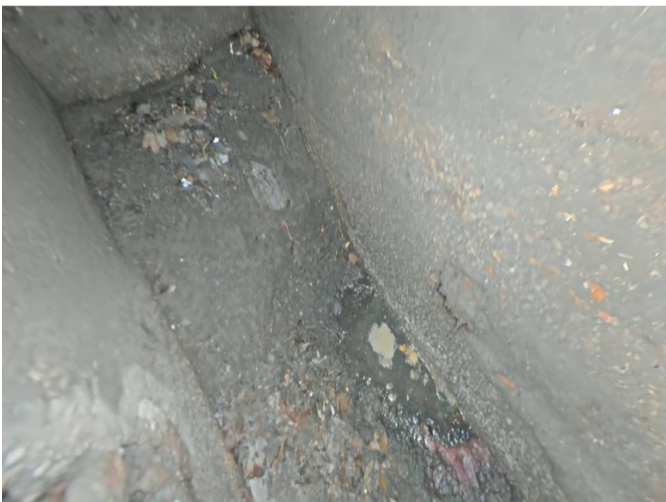
Code: **DSC**
Description: **Deposits Settled Compacted**

Distance: **7ft**
Structural Grade: **0**
O&M Grade: **2**
Clock Start/From: **12**
Clock To: **12**
1st Value:
2nd Value:
Value Percent: **75**
Continuous Index:
Within Eight" of Joint: **False**
Remarks:

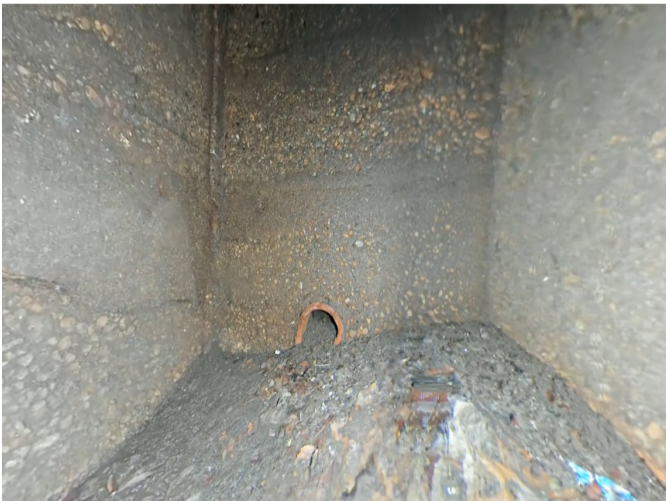
Code: **SAV**
Description: **Surface Damage Aggregate Visible**

Distance: **9ft**
Structural Grade: **2**
O&M Grade: **0**
Clock Start/From: **12**
Clock To: **12**
1st Value:
2nd Value:
Value Percent:
Continuous Index:
Within Eight" of Joint: **False**
Remarks:
