R-004B_TIDE

COVE RD
New Bedford

Inspection Status: Remote Inspection
Inspection Level: Level 2

Project: | New Bedford 3D Regulator Inspections
Owner: | New Bedford, MA
Customer: CCDM Smith

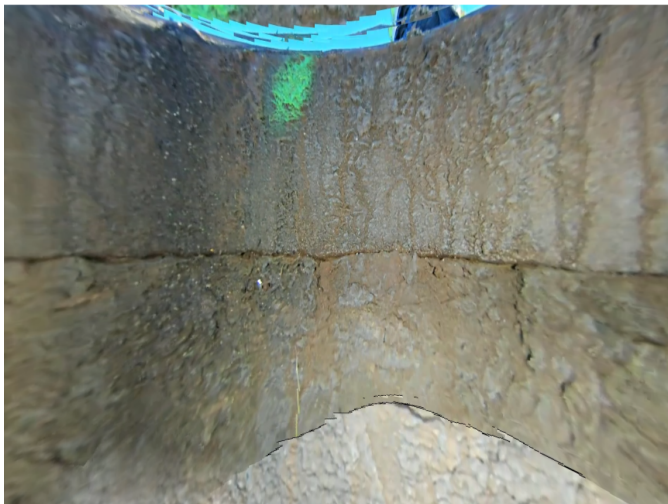
Code: **IS**
Description: **Infiltration Stain**

Distance: **0ft**
Structural Grade: **0**
O&M Grade: **1**
Clock Start/From: **12**
Clock To: **12**
1st Value:
2nd Value:
Value Percent:
Continuous Index: **S01**
Within Eight" of Joint: **False**
Remarks:

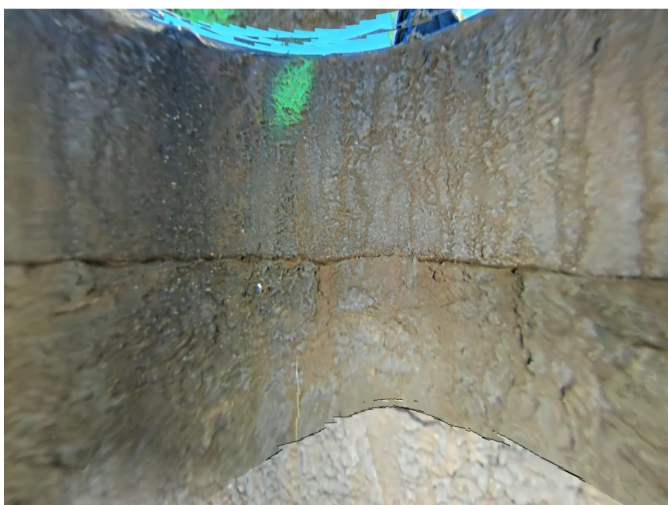
Code: **SRI**
Description: **Surface Damage Roughness Increased**

Distance: **0ft**
Structural Grade: **1**
O&M Grade: **0**
Clock Start/From: **12**
Clock To: **12**
1st Value:
2nd Value:
Value Percent:
Continuous Index: **S02**
Within Eight" of Joint: **False**
Remarks:

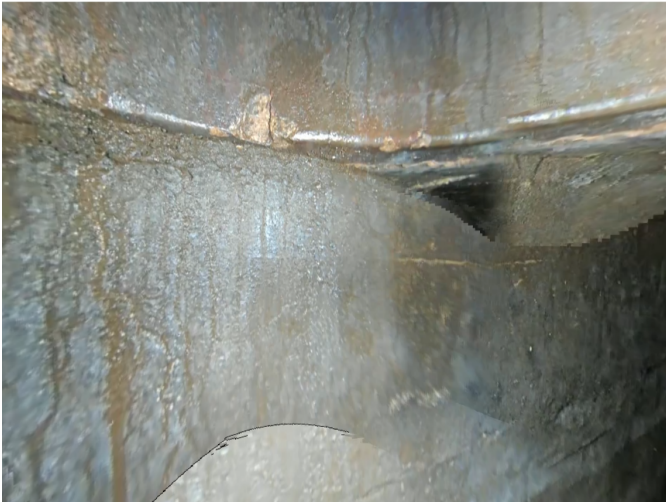
Code: **SRI**
Description: **Surface Damage
Roughness Increased**

Distance: **2ft**
Structural Grade: **1**
O&M Grade: **0**
Clock Start/From: **12**
Clock To: **12**
1st Value:
2nd Value:
Value Percent:
Continuous Index: **F02**
Within Eight" of Joint: **False**
Remarks:

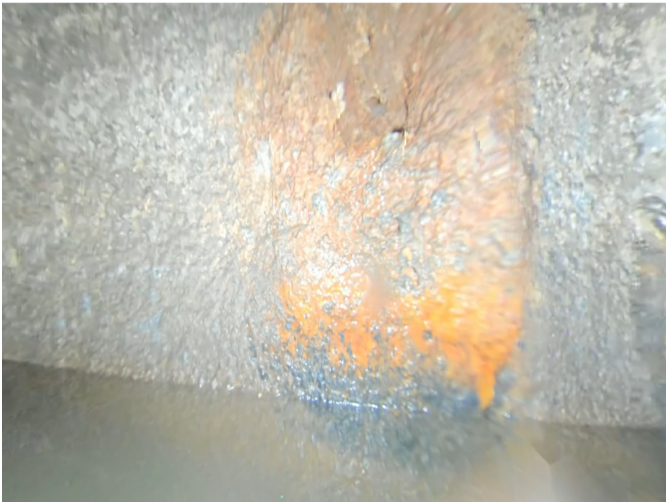
Code: **IS**
Description: **Infiltration Stain**

Distance: **8ft**
Structural Grade: **0**
O&M Grade: **1**
Clock Start/From: **12**
Clock To: **12**
1st Value:
2nd Value:
Value Percent:
Continuous Index: **F01**
Within Eight" of Joint: **False**
Remarks:
