R-004E

RIVE ST
New Bedford

Inspection Status: Remote Inspection
Inspection Level: Level 2

Project: | New Bedford 3D Regulator Inspections
Owner: New Bedford, MA
Customer: CDM Smith

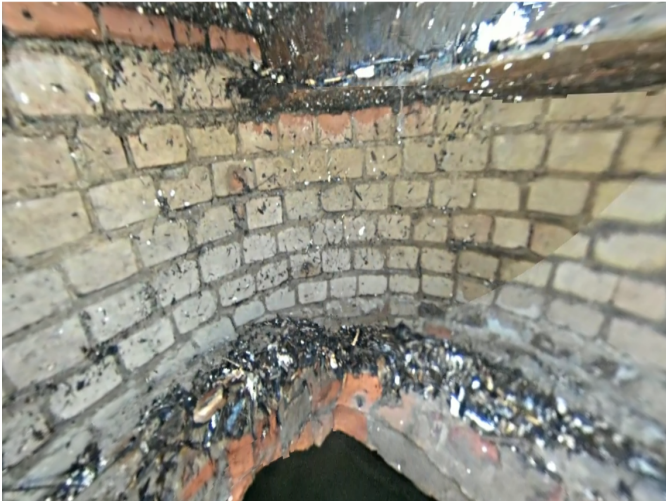
Code: **DAZ**
Description: **Deposits Attached Other**

Distance: **1ft**
Structural Grade: **0**
O&M Grade: **0**
Clock Start/From: **12**
Clock To: **12**
1st Value:
2nd Value:
Value Percent: **5**
Continuous Index:
Within Eight" of Joint: **False**
Remarks: **Soil attached to chimney**
