# R-004F

RIVET ST  
New Bedford

**Project:** | New Bedford 3D Regulator Inspections  
**Owner:** New Bedford, MA  
**Customer:** CDM Smith

# Condition Report

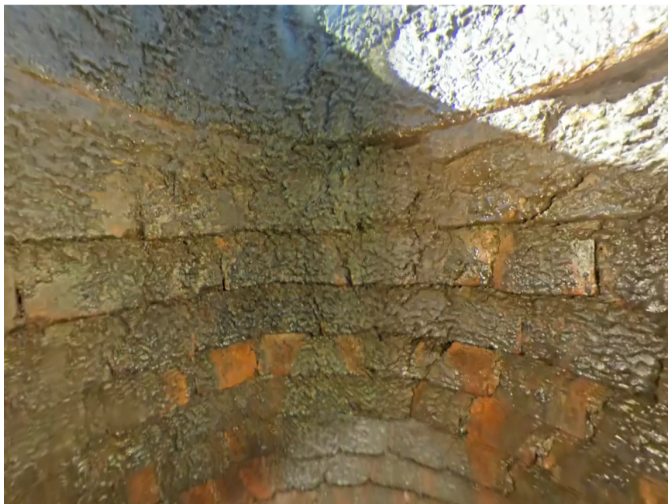
Code: **SRI**  
Description: **Surface Damage Roughness Increased**

Distance: **1ft**  
Structural Grade: **1**  
O&M Grade: **0**  
Clock Start/From: **12**  
Clock To: **12**  
1st Value:  
2nd Value:  
Value Percent:  
Continuous Index:  
Within Eight" of Joint: **False**  
Remarks:

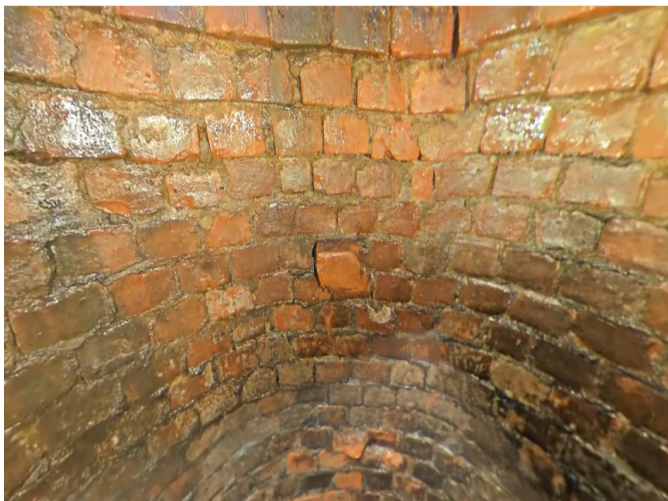
Code: **DB**  
Description: **Displaced Brick**

Distance: **2ft**  
Structural Grade: **3**  
O&M Grade: **0**  
Clock Start/From: **3**  
Clock To: **9**  
1st Value:  
2nd Value:  
Value Percent:  
Continuous Index:  
Within Eight" of Joint: **False**  
Remarks:

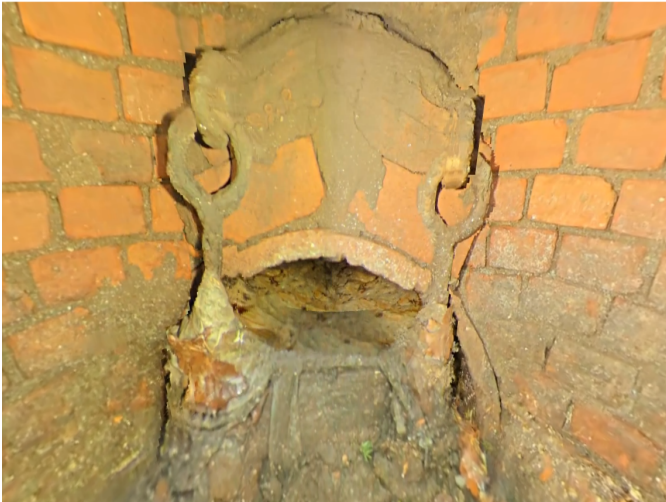
Code: **OBS**  
Description: **Obstruction Built Into Structure**

Distance: **5ft**  
Structural Grade: **0**  
O&M Grade: **0**  
Clock Start/From: **12**  
Clock To:  
1st Value:  
2nd Value:  
Value Percent: **60**  
Continuous Index:  
Within Eight" of Joint: **False**  
Remarks: **gate blocking pipe connection**

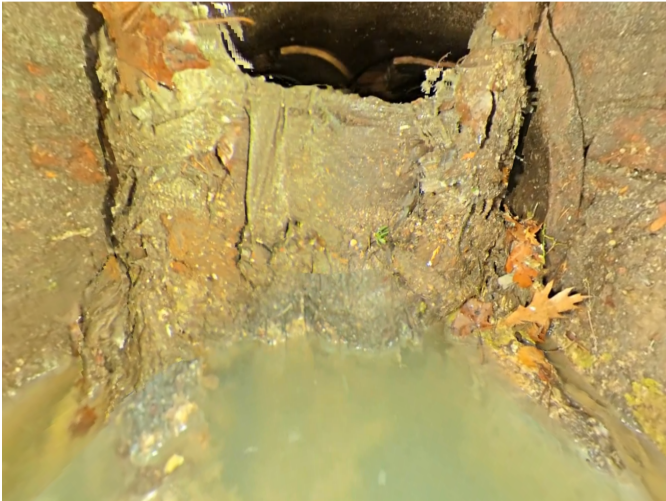
Code: **DSZ**  
Description: **Deposits Settled Other**

Distance: **6ft**  
Structural Grade: **0**  
O&M Grade: **0**  
Clock Start/From: **11**  
Clock To: **1**  
1st Value:  
2nd Value:  
Value Percent: **25**  
Continuous Index:  
Within Eight" of Joint: **False**  
Remarks: **debris surrounding gate**
