# R-004G

CRAPO ST  
New Bedford

Inspection Status: Surface Inspection  
Inspection Level: Level 2

**Project:** | New Bedford 3D Regulator Inspections

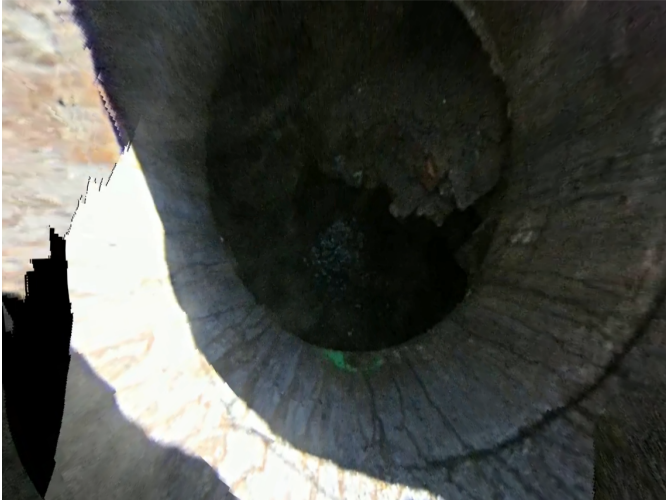
Code: **MGO**  
Description: **Miscellaneous General Observation**

Distance: **0ft**  
Structural Grade: **0**  
O&M Grade: **0**  
Clock Start/From:  
Clock To:  
1st Value:  
2nd Value:  
Value Percent:  
Continuous Index:  
Within Eight" of Joint: **False**  
Remarks: **Start inspection**

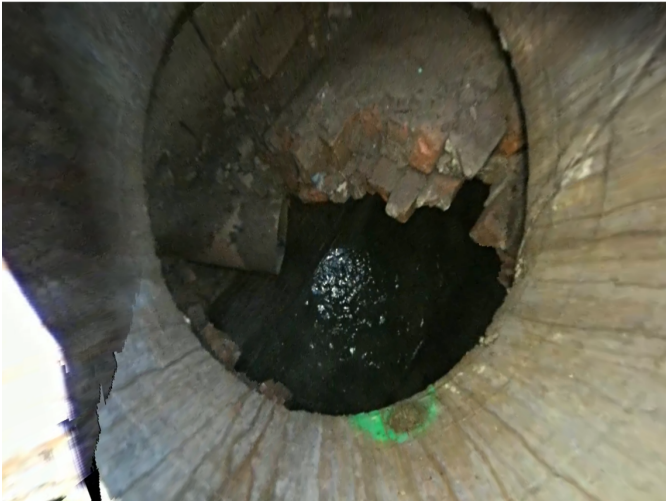
Code: **IS**  
Description: **Infiltration Stain**

Distance: **0ft**  
Structural Grade: **0**  
O&M Grade: **1**  
Clock Start/From: **12**  
Clock To: **12**  
1st Value:  
2nd Value:  
Value Percent:  
Continuous Index: **S01**  
Within Eight" of Joint: **False**  
Remarks:

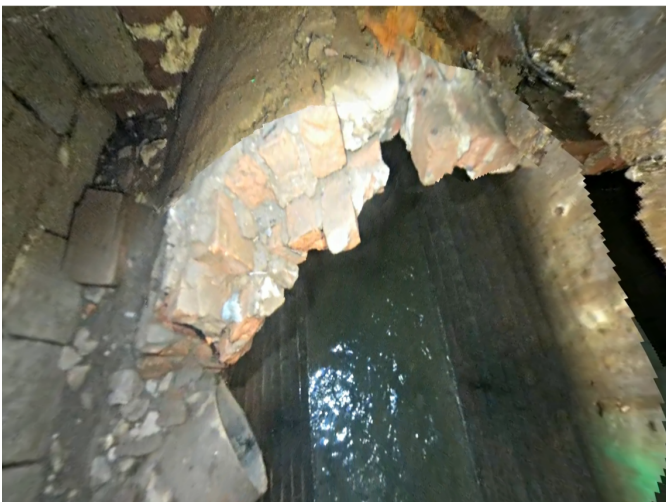
Code: **OBB**  
Description: **Obstruction Brick or Masonry**

Distance: **1ft**  
Structural Grade: **0**  
O&M Grade: **0**  
Clock Start/From: **12**  
Clock To: **12**  
1st Value:  
2nd Value:  
Value Percent: **75**  
Continuous Index:  
Within Eight" of Joint: **False**  
Remarks: **Pipe wall in manhole**

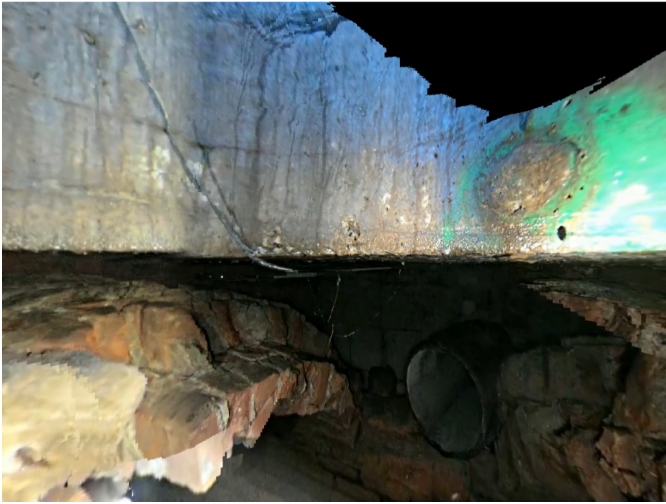
Code: **IS**  
Description: **Infiltration Stain**

Distance: **1ft**  
Structural Grade: **0**  
O&M Grade: **1**  
Clock Start/From: **12**  
Clock To: **12**  
1st Value:  
2nd Value:  
Value Percent:  
Continuous Index: **F01**  
Within Eight" of Joint: **False**  
Remarks:

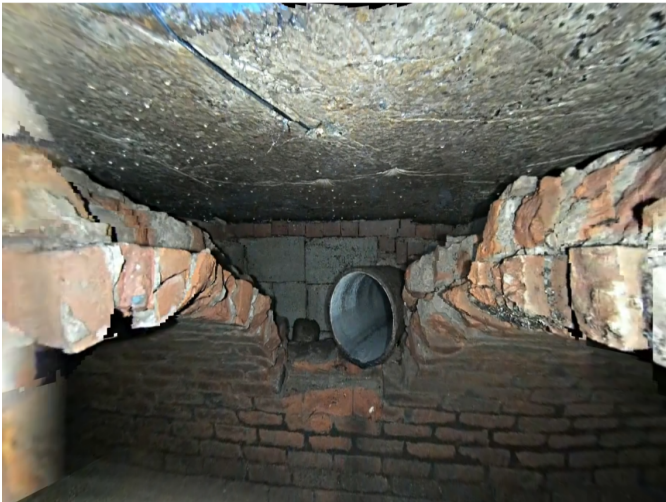
Code: **CM**  
Description: **Crack Multiple**

Distance: **2ft**  
Structural Grade: **3**  
O&M Grade: **0**  
Clock Start/From: **12**  
Clock To: **12**  
1st Value:  
2nd Value:  
Value Percent:  
Continuous Index:  
Within Eight" of Joint: **False**  
Remarks: **Top of chamber**

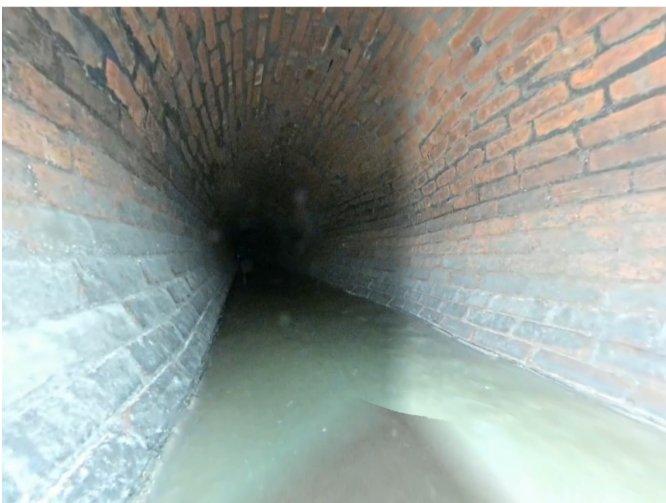
Code: **MGO**  
Description: **Miscellaneous General Observation**

Distance: **5ft**  
Structural Grade: **0**  
O&M Grade: **0**  
Clock Start/From:  
Clock To:  
1st Value:  
2nd Value:  
Value Percent:  
Continuous Index:  
Within Eight" of Joint: **False**  
Remarks: **End inspection**
