R-004H

COVE RD
New Bedford

Inspection Status: Remote Inspection
Inspection Level: Level 2

Project: | New Bedford 3D Regulator Inspections
Owner: New Bedford, MA
Customer: CDM Smith

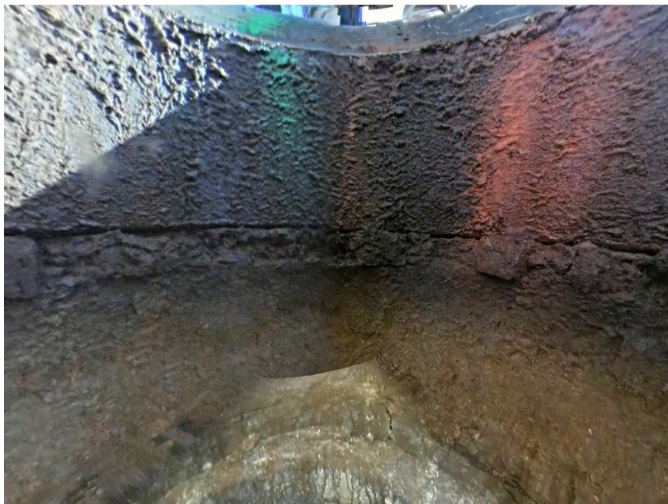
Code: **SRI**
Description: **Surface Damage Roughness Increased**

Distance: **0ft**
Structural Grade: **1**
O&M Grade: **0**
Clock Start/From: **12**
Clock To: **12**
1st Value:
2nd Value:
Value Percent:
Continuous Index: **S01**
Within Eight" of Joint: **False**
Remarks:

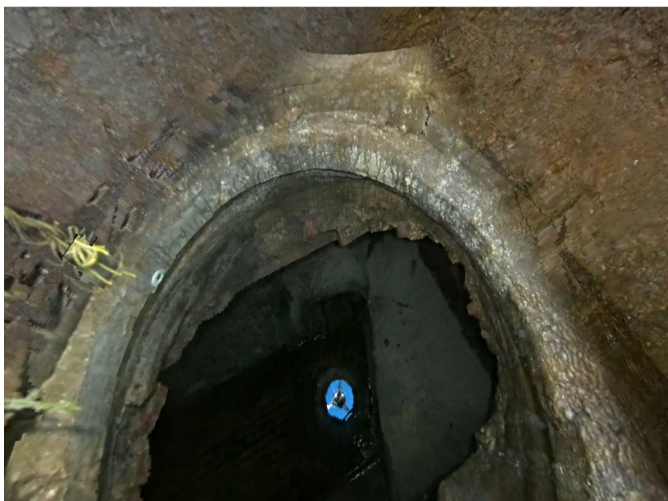
Code: **IS**
Description: **Infiltration Stain**

Distance: **0ft**
Structural Grade: **0**
O&M Grade: **1**
Clock Start/From: **12**
Clock To: **12**
1st Value:
2nd Value:
Value Percent:
Continuous Index: **S02**
Within Eight" of Joint: **False**
Remarks:

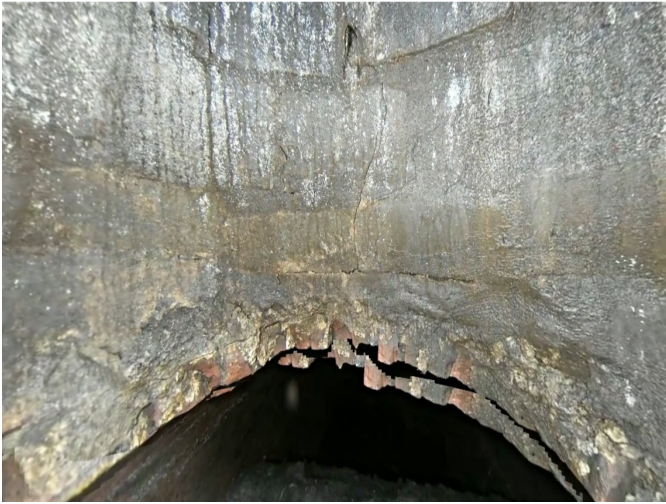
Code: **CM**
Description: **Crack Multiple**

Distance: **3ft**
Structural Grade: **3**
O&M Grade: **0**
Clock Start/From: **12**
Clock To: **12**
1st Value:
2nd Value:
Value Percent:
Continuous Index:
Within Eight" of Joint: **False**
Remarks:

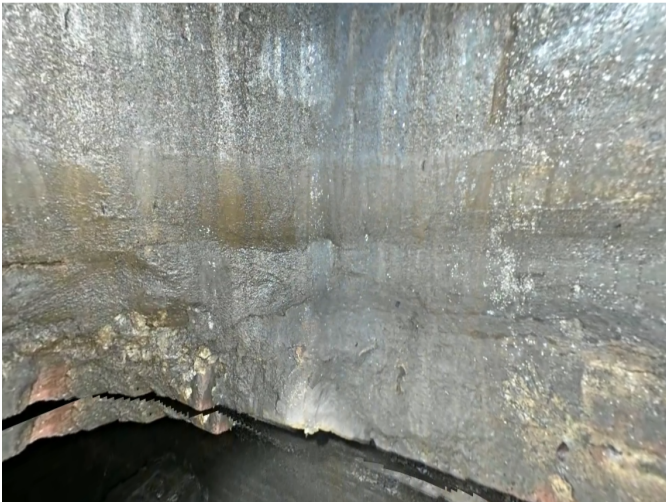
Code: **SRI**
Description: **Surface Damage
Roughness Increased**

Distance: **3ft**
Structural Grade: **1**
O&M Grade: **0**
Clock Start/From: **12**
Clock To: **12**
1st Value:
2nd Value:
Value Percent:
Continuous Index: **F01**
Within Eight" of Joint: **False**
Remarks:

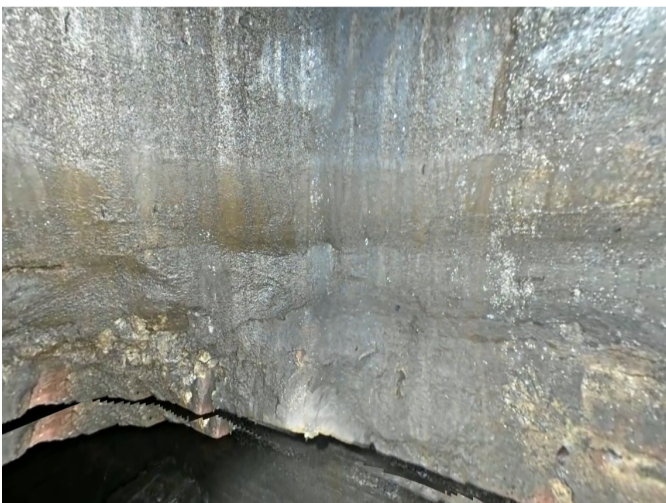
Code: **IS**
Description: **Infiltration Stain**

Distance: **3ft**
Structural Grade: **0**
O&M Grade: **1**
Clock Start/From: **12**
Clock To: **12**
1st Value:
2nd Value:
Value Percent:
Continuous Index: **F02**
Within Eight" of Joint: **False**
Remarks:
