R-004I

DAVID ST
New Bedford

Inspection Status: Remote Inspection
Inspection Level: Level 2

Project: | New Bedford 3D Regulator Inspections

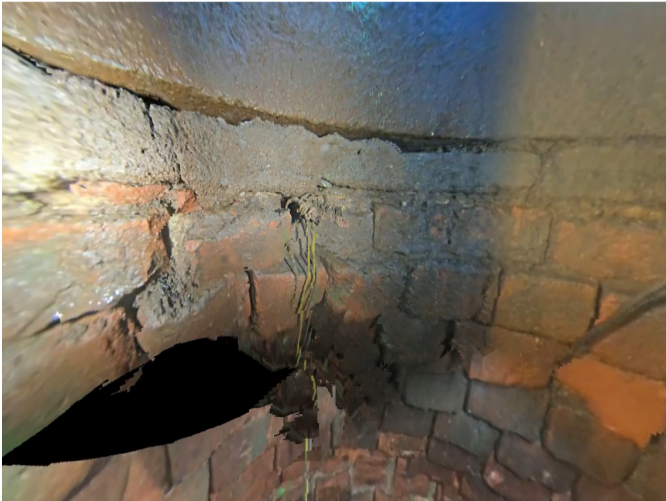
Code: **MMS**
Description: **Missing Mortar Small**

Distance: **0ft**
Structural Grade: **2**
O&M Grade: **0**
Clock Start/From: **12**
Clock To: **12**
1st Value:
2nd Value:
Value Percent:
Continuous Index:
Within Eight" of Joint: **False**
Remarks:
