R-004I_2

RODNEY F BLVD
New Bedford

Inspection Status: Remote Inspection
Inspection Level: Level 2

Project: | New Bedford 3D Regulator Inspections

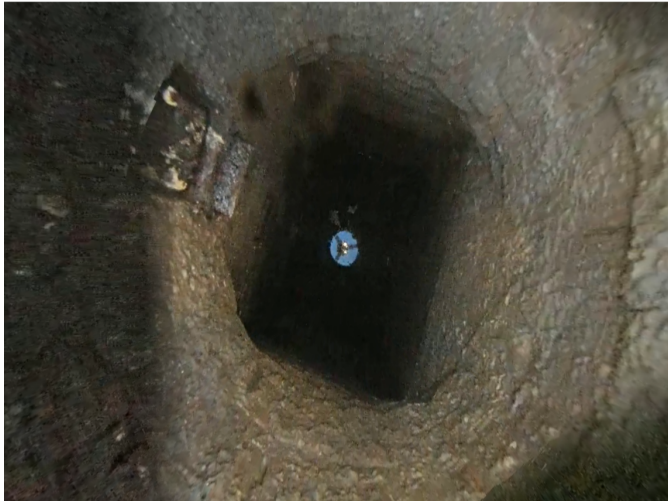
Code: **MGO**
Description: **Miscellaneous General Observation**

Distance: **0ft**
Structural Grade: **0**
O&M Grade: **0**
Clock Start/From:
Clock To:
1st Value:
2nd Value:
Value Percent:
Continuous Index:
Within Eight" of Joint: **False**
Remarks: **Start inspection**

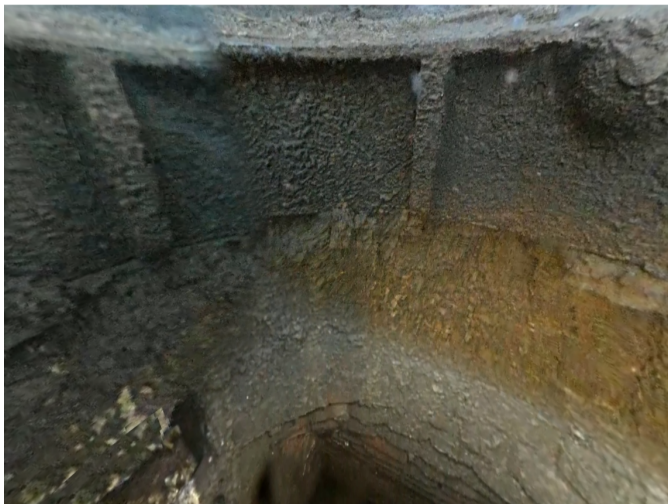
Code: **SRI**
Description: **Surface Damage Roughness Increased**

Distance: **0ft**
Structural Grade: **1**
O&M Grade: **0**
Clock Start/From: **12**
Clock To: **12**
1st Value:
2nd Value:
Value Percent:
Continuous Index: **S01**
Within Eight" of Joint: **False**
Remarks:

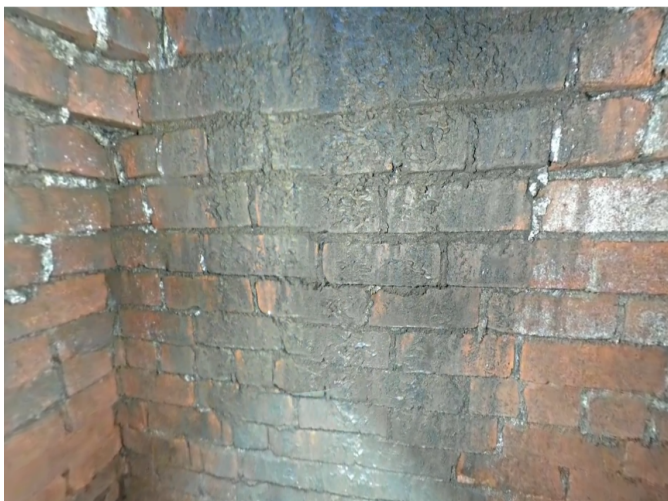
Code: **SRI**
Description: **Surface Damage Roughness Increased**

Distance: **3ft**
Structural Grade: **1**
O&M Grade: **0**
Clock Start/From: **12**
Clock To: **12**
1st Value:
2nd Value:
Value Percent:
Continuous Index: **F01**
Within Eight" of Joint: **False**
Remarks:

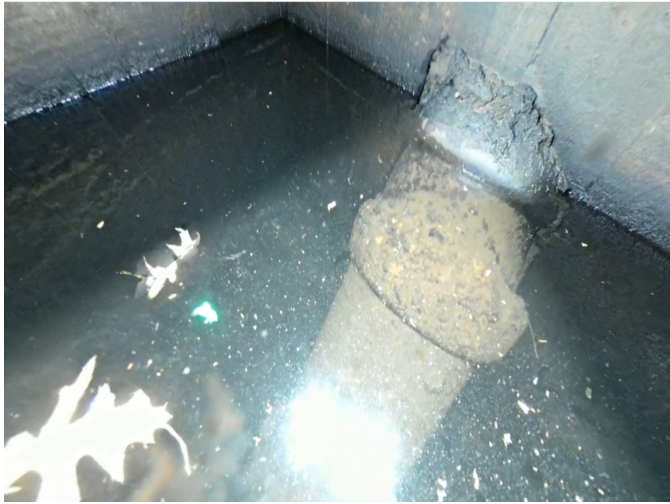
Code: **MSA**
Description: **Miscellaneous Survey
Abandoned**

Distance: **6ft**
Structural Grade: **0**
O&M Grade: **0**
Clock Start/From:
Clock To:
1st Value:
2nd Value:
Value Percent:
Continuous Index:
Within Eight" of Joint: **False**
Remarks: **Manhole surcharged**
