# R-006A

LUCAS ST  
New Bedford

**Project:** | New Bedford 3D Regulator Inspections

# Condition Report

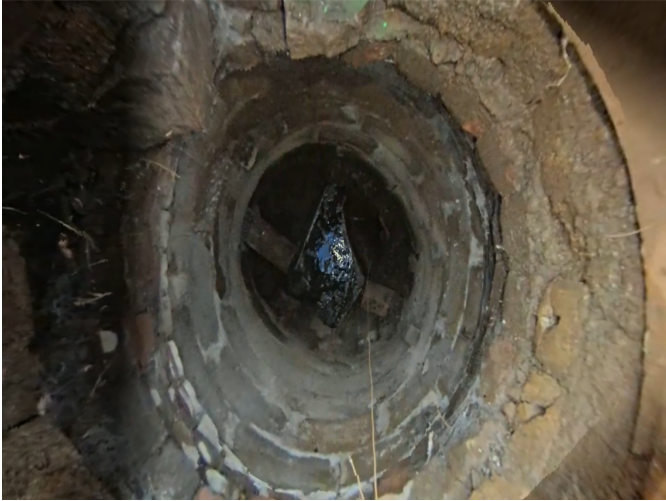
Code: **MGO**  
Description: **Miscellaneous General Observation**

Distance: **0ft**  
Structural Grade: **0**  
O&M Grade: **0**  
Clock Start/From:  
Clock To:  
1st Value:  
2nd Value:  
Value Percent:  
Continuous Index:  
Within Eight" of Joint: **False**  
Remarks: **Start inspection**

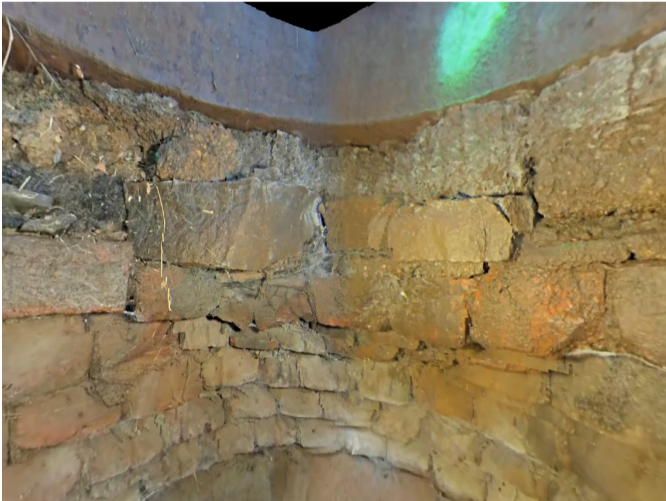
Code: **DB**  
Description: **Displaced Brick**

Distance: **1ft**  
Structural Grade: **3**  
O&M Grade: **0**  
Clock Start/From: **6**  
Clock To:  
1st Value:  
2nd Value:  
Value Percent:  
Continuous Index:  
Within Eight" of Joint: **False**  
Remarks:

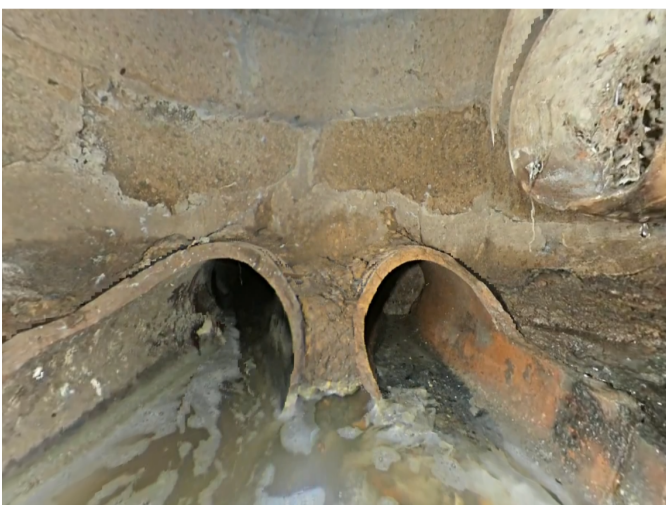
Code: **MGO**  
Description: **Miscellaneous General Observation**

Distance: **5ft**  
Structural Grade: **0**  
O&M Grade: **0**  
Clock Start/From:  
Clock To:  
1st Value:  
2nd Value:  
Value Percent:  
Continuous Index:  
Within Eight" of Joint: **False**  
Remarks: **End inspection**
