# R-006B

OAKLAWN ST  
New Bedford

Inspection Status: Remote Inspection  
Inspection Level: Level 2

**Project:** | New Bedford 3D Regulator Inspections

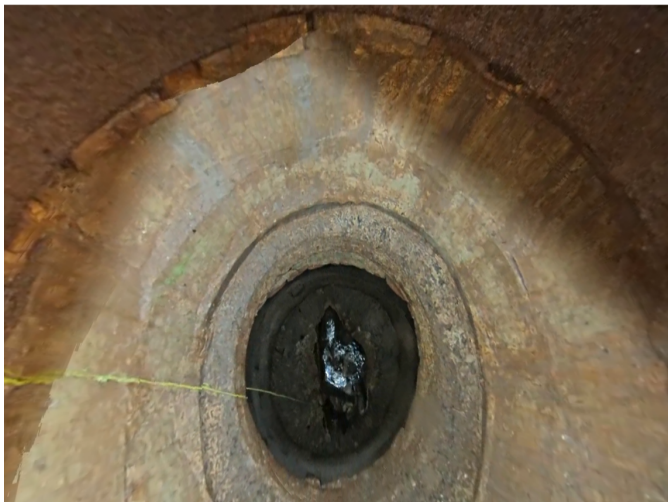
Code: **IS**  
Description: **Infiltration Stain**

Distance: **0ft**  
Structural Grade: **0**  
O&M Grade: **1**  
Clock Start/From: **12**  
Clock To: **12**  
1st Value:  
2nd Value:  
Value Percent:  
Continuous Index: **S01**  
Within Eight" of Joint: **False**  
Remarks:

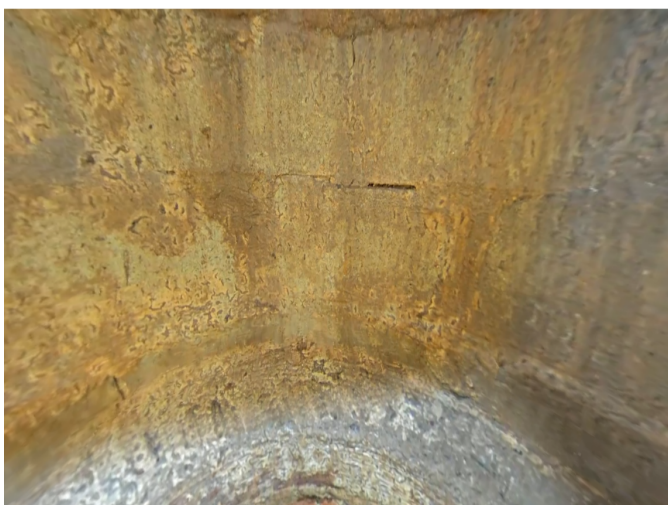
Code: **CC**  
Description: **Crack Circumferential**

Distance: **1ft**  
Structural Grade: **2**  
O&M Grade: **0**  
Clock Start/From: **10**  
Clock To: **5**  
1st Value:  
2nd Value:  
Value Percent:  
Continuous Index:  
Within Eight" of Joint: **False**  
Remarks:

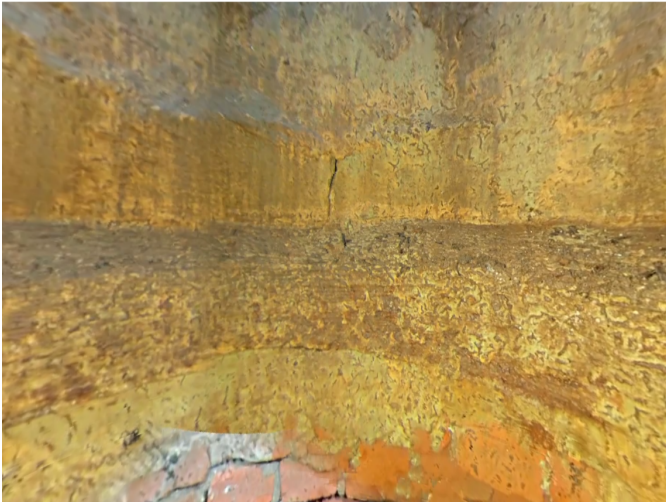
Code: **CL**  
Description: **Crack Longitudinal**

Distance: **2ft**  
Structural Grade: **2**  
O&M Grade: **0**  
Clock Start/From: **5**  
Clock To:  
1st Value:  
2nd Value:  
Value Percent:  
Continuous Index:  
Within Eight" of Joint: **False**  
Remarks:

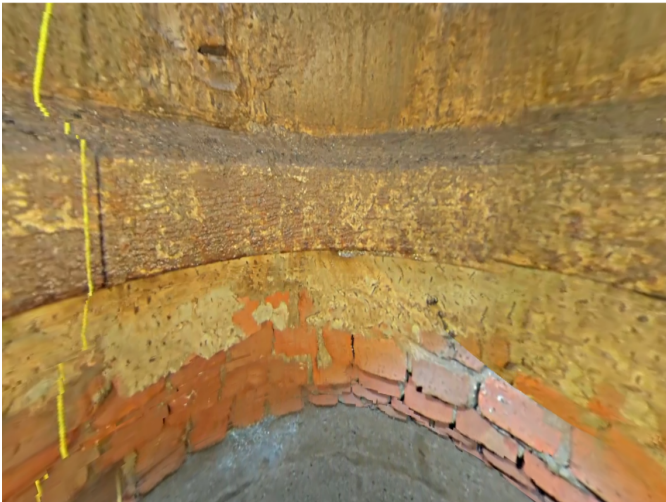
Code: **IS**  
Description: **Infiltration Stain**

Distance: **2ft**  
Structural Grade: **0**  
O&M Grade: **1**  
Clock Start/From: **12**  
Clock To: **12**  
1st Value:  
2nd Value:  
Value Percent:  
Continuous Index: **F01**  
Within Eight" of Joint: **False**  
Remarks:

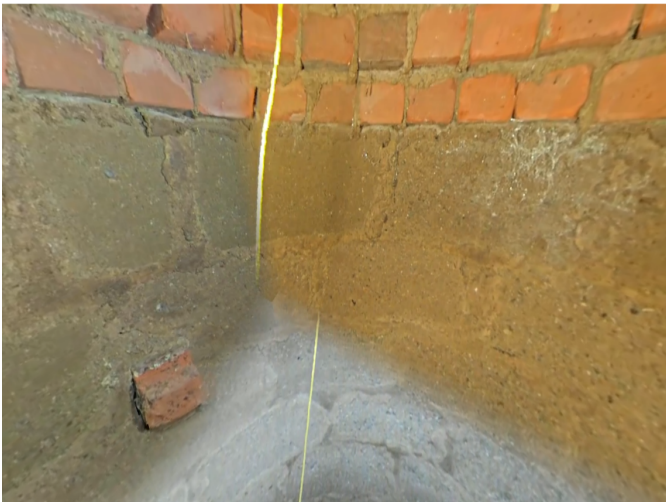
Code: **SRI**  
Description: **Surface Damage  
Roughness Increased**

Distance: **4ft**  
Structural Grade: **1**  
O&M Grade: **0**  
Clock Start/From: **12**  
Clock To: **12**  
1st Value:  
2nd Value:  
Value Percent:  
Continuous Index: **S02**  
Within Eight" of Joint: **False**  
Remarks:

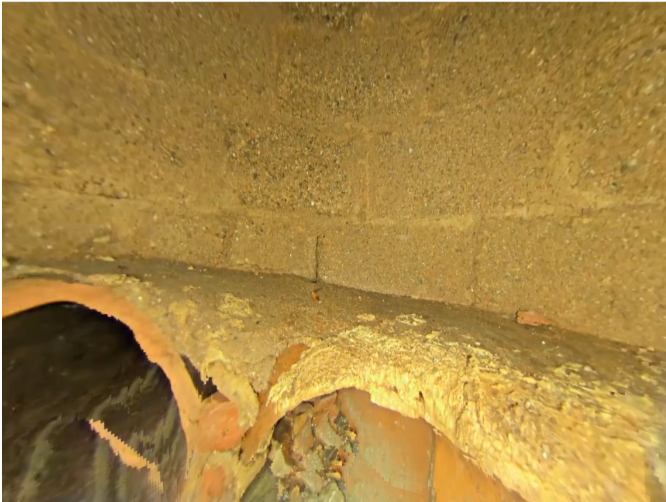
Code: **SRI**  
Description: **Surface Damage  
Roughness Increased**

Distance: **7ft**  
Structural Grade: **1**  
O&M Grade: **0**  
Clock Start/From: **12**  
Clock To: **12**  
1st Value:  
2nd Value:  
Value Percent:  
Continuous Index: **F02**  
Within Eight" of Joint: **False**  
Remarks:

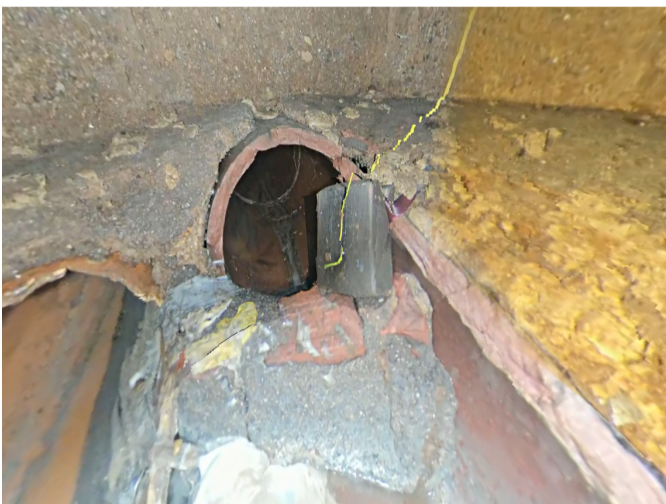
Code: **DSZ**  
Description: **Deposits Settled Other**

Distance: **7ft**  
Structural Grade: **0**  
O&M Grade: **4**  
Clock Start/From: **12**  
Clock To:  
1st Value:  
2nd Value:  
Value Percent: **40**  
Continuous Index:  
Within Eight" of Joint: **False**  
Remarks: **Bricks and gravel**
