R-006C

CAPITOL ST
New Bedford

Inspection Status: Remote Inspection
Inspection Level: Level 2

Project: | New Bedford 3D Regulator Inspections

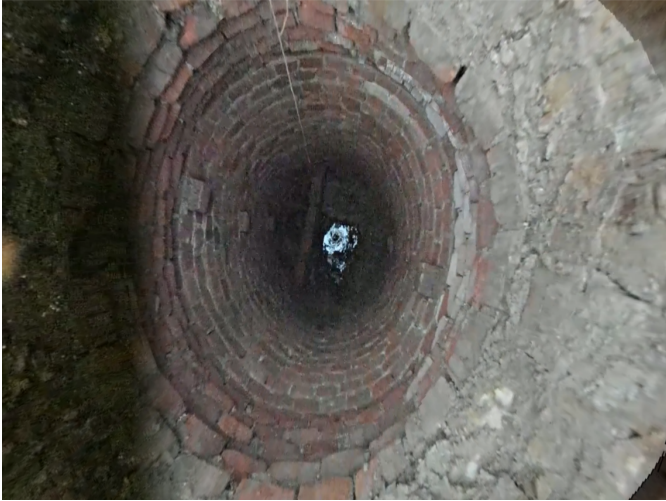
Code: **MGO**
Description: **Miscellaneous General Observation**

Distance: **0ft**
Structural Grade: **0**
O&M Grade: **0**
Clock Start/From:
Clock To:
1st Value:
2nd Value:
Value Percent:
Continuous Index:
Within Eight" of Joint: **False**
Remarks: **Start inspection**

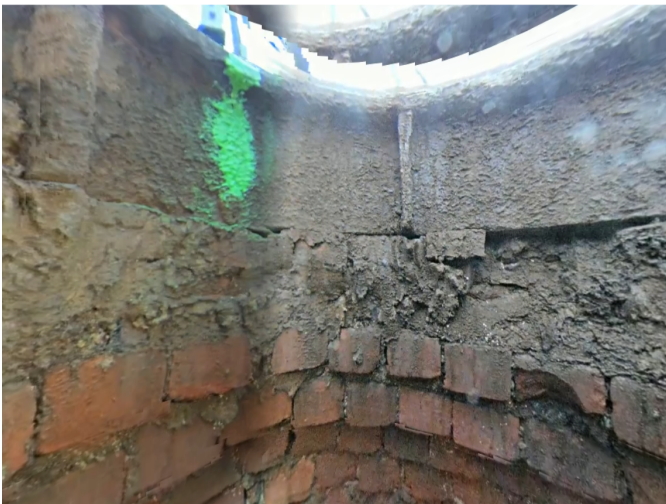
Code: **SRI**
Description: **Surface Damage Roughness Increased**

Distance: **0ft**
Structural Grade: **1**
O&M Grade: **0**
Clock Start/From: **12**
Clock To: **12**
1st Value:
2nd Value:
Value Percent:
Continuous Index:
Within Eight" of Joint: **False**
Remarks:

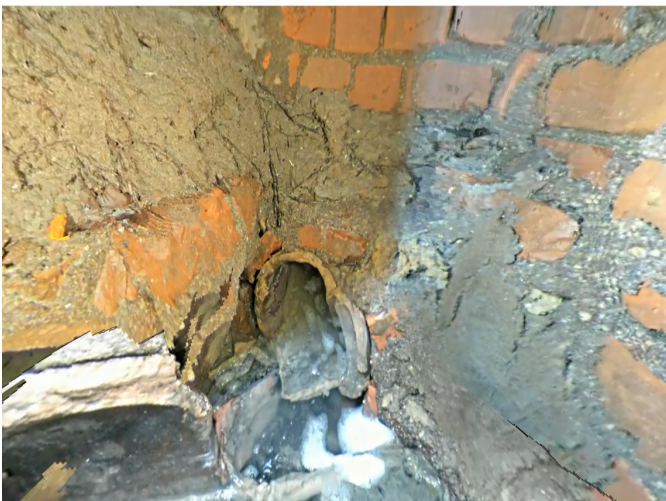
Code: **MGO**
Description: **Miscellaneous General Observation**

Distance: **7ft**
Structural Grade: **0**
O&M Grade: **0**
Clock Start/From:
Clock To:
1st Value:
2nd Value:
Value Percent:
Continuous Index:
Within Eight" of Joint: **False**
Remarks: **End inspection**
