R-006D

LUCAS ST
New Bedford

Inspection Status: Remote Inspection
Inspection Level: Level 2

Project: | New Bedford 3D Regulator Inspections

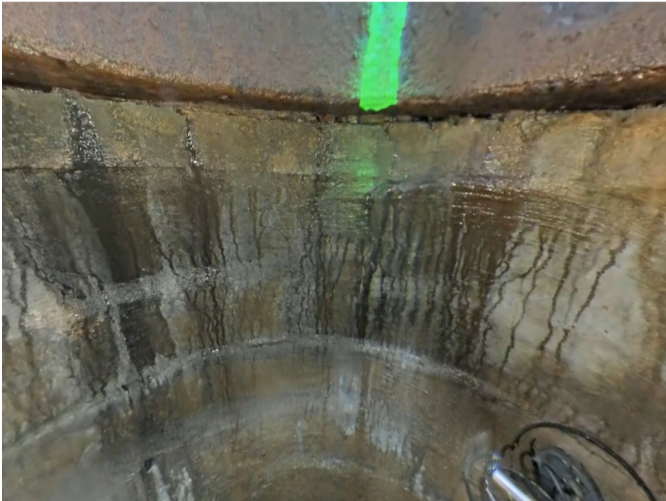
Code: **IW**
Description: **Infiltration Weeper**

Distance: **0ft**
Structural Grade: **0**
O&M Grade: **2**
Clock Start/From: **12**
Clock To: **12**
1st Value:
2nd Value:
Value Percent:
Continuous Index: **S01**
Within Eight" of Joint: **False**
Remarks:

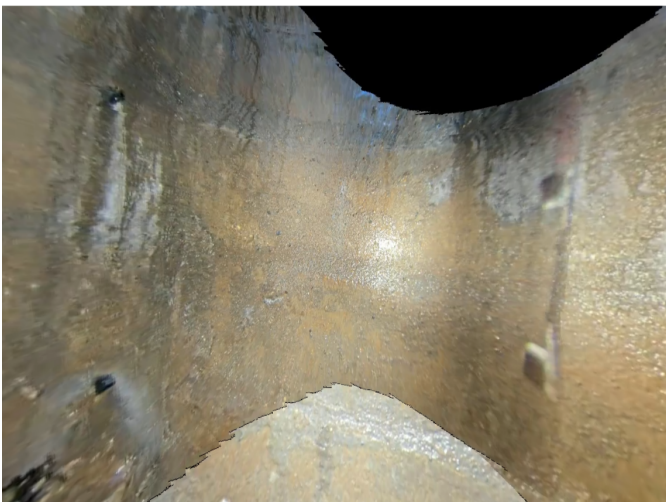
Code: **IW**
Description: **Infiltration Weeper**

Distance: **2ft**
Structural Grade: **0**
O&M Grade: **2**
Clock Start/From: **12**
Clock To: **12**
1st Value:
2nd Value:
Value Percent:
Continuous Index: **F01**
Within Eight" of Joint: **False**
Remarks:
