# R-007A

CAPITOL ST  
New Bedford

**Project:** | New Bedford 3D Regulator Inspections

# Condition Report

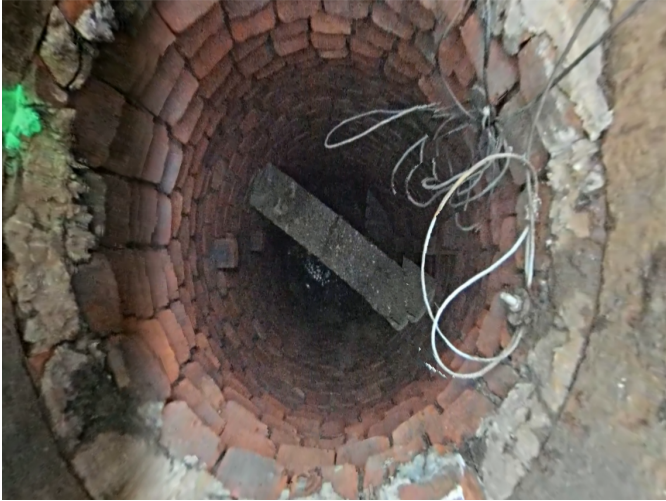
Code: **MGO**  
Description: **Miscellaneous General Observation**

Distance: **0ft**  
Structural Grade: **0**  
O&M Grade: **0**  
Clock Start/From:  
Clock To:  
1st Value:  
2nd Value:  
Value Percent:  
Continuous Index:  
Within Eight" of Joint: **False**  
Remarks: **Start inspection**

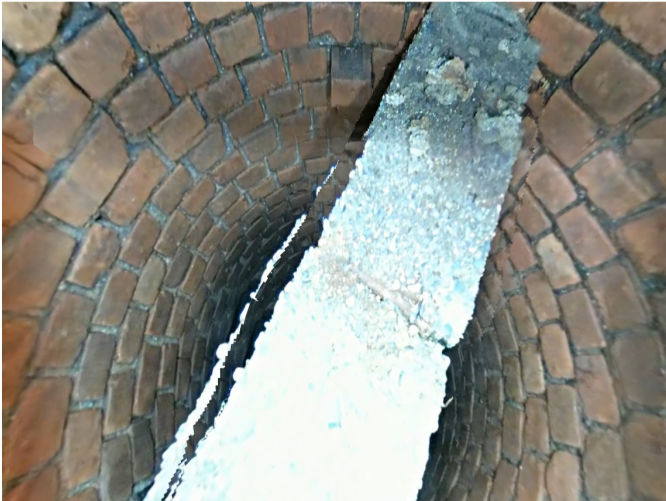
Code: **MSA**  
Description: **Miscellaneous Survey Abandoned**

Distance: **2ft**  
Structural Grade: **0**  
O&M Grade: **0**  
Clock Start/From:  
Clock To:  
1st Value:  
2nd Value:  
Value Percent:  
Continuous Index:  
Within Eight" of Joint: **False**  
Remarks: **Wall in way of bottom**
