# R-008A

CALUMET ST  
New Bedford

**Project:** | New Bedford 3D Regulator Inspections

# Condition Report

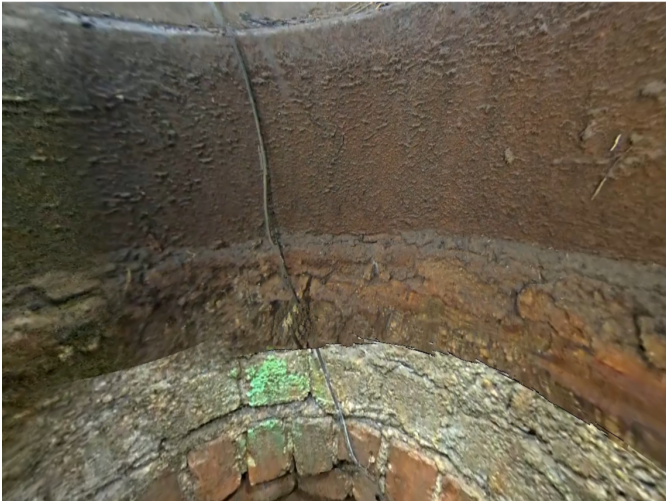
Code: **SRI**  
Description: **Surface Damage Roughness Increased**

Distance: **0ft**  
Structural Grade: **1**  
O&M Grade: **0**  
Clock Start/From: **12**  
Clock To: **12**  
1st Value:  
2nd Value:  
Value Percent:  
Continuous Index:  
Within Eight" of Joint: **False**  
Remarks:

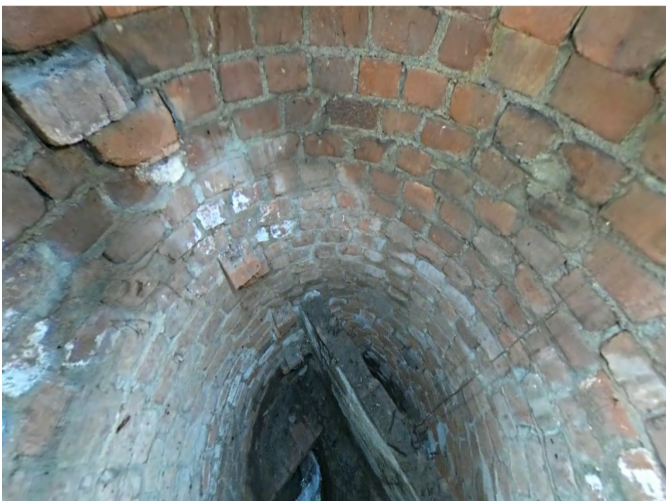
Code: **DB**  
Description: **Displaced Brick**

Distance: **2ft**  
Structural Grade: **3**  
O&M Grade: **0**  
Clock Start/From: **12**  
Clock To: **12**  
1st Value:  
2nd Value:  
Value Percent:  
Continuous Index: **S01**  
Within Eight" of Joint: **False**  
Remarks:

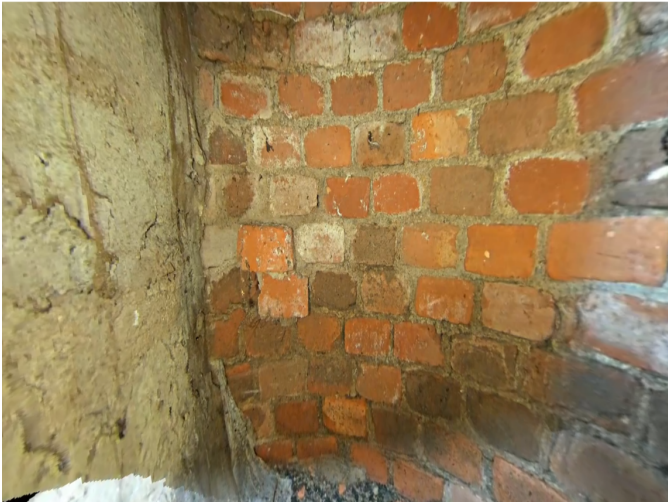
Code: **DB**  
Description: **Displaced Brick**

Distance: **7ft**  
Structural Grade: **3**  
O&M Grade: **0**  
Clock Start/From: **12**  
Clock To: **12**  
1st Value:  
2nd Value:  
Value Percent:  
Continuous Index: **F01**  
Within Eight" of Joint: **False**  
Remarks:
