R-009A

AQUIDNECK ST
New Bedford

Inspection Status: Remote Inspection
Inspection Level: Level 2

Project: | New Bedford 3D Regulator Inspections

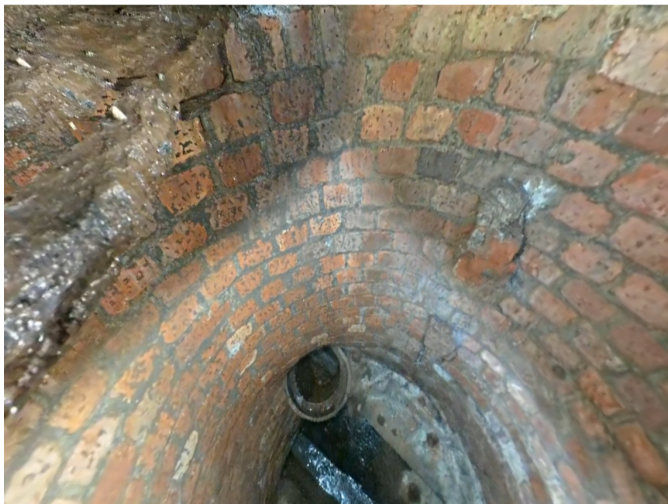
Code: **IS**
Description: **Infiltration Stain**

Distance: **0ft**
Structural Grade: **0**
O&M Grade: **1**
Clock Start/From: **12**
Clock To: **12**
1st Value:
2nd Value:
Value Percent:
Continuous Index: **S01**
Within Eight" of Joint: **False**
Remarks:

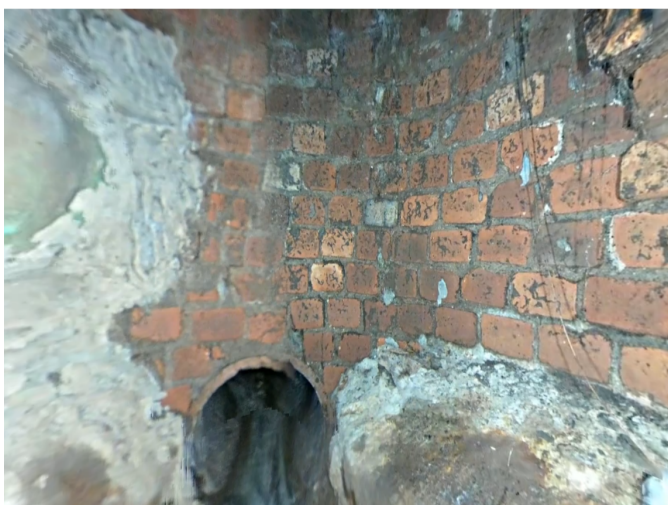
Code: **IS**
Description: **Infiltration Stain**

Distance: **6ft**
Structural Grade: **0**
O&M Grade: **1**
Clock Start/From: **12**
Clock To: **12**
1st Value:
2nd Value:
Value Percent:
Continuous Index: **F01**
Within Eight" of Joint: **False**
Remarks:
