R-009B

AQUIDNECK ST
New Bedford

Inspection Status: Remote Inspection
Inspection Level: Level 2

Project: | New Bedford 3D Regulator Inspections
Owner: New Bedford, MA
Customer: CDM Smith

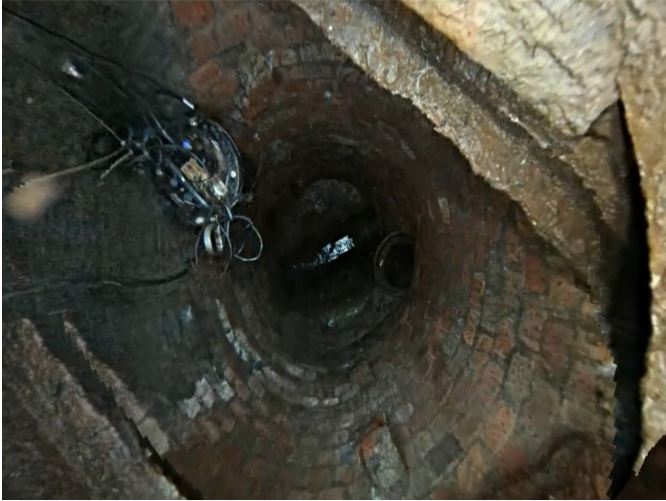
Code: **MGO**
Description: **Miscellaneous General Observation**

Distance: **0ft**
Structural Grade: **0**
O&M Grade: **0**
Clock Start/From:
Clock To:
1st Value:
2nd Value:
Value Percent:
Continuous Index:
Within Eight" of Joint: **False**
Remarks: **Start inspection**

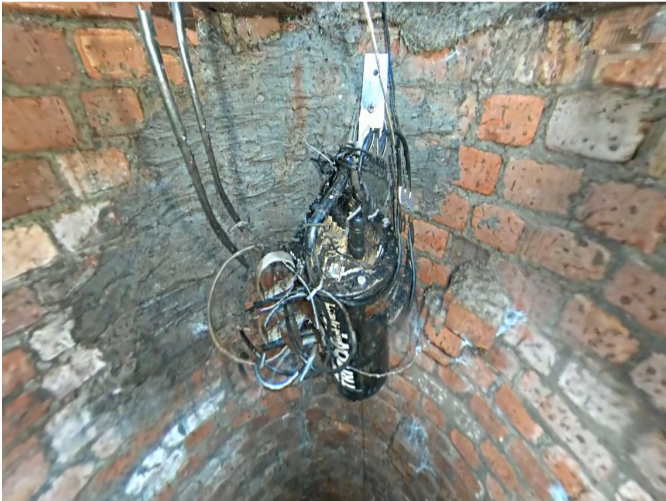
Code: **OBS**
Description: **Obstruction Built Into Structure**

Distance: **1ft**
Structural Grade: **0**
O&M Grade: **0**
Clock Start/From: **1**
Clock To:
1st Value:
2nd Value:
Value Percent: **20**
Continuous Index:
Within Eight" of Joint: **False**
Remarks:

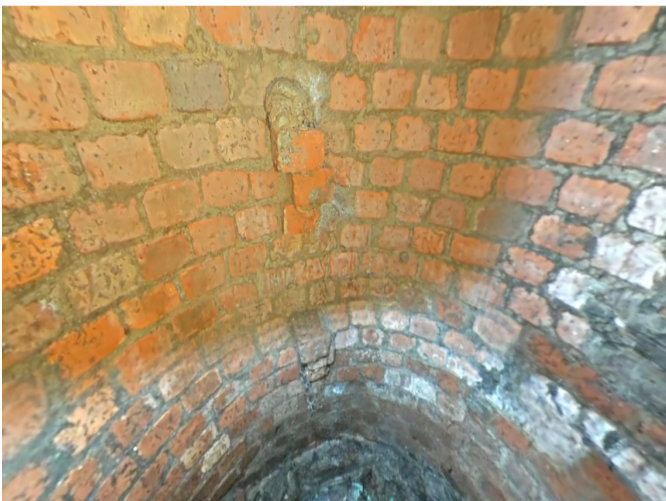
Code: **DB**
Description: **Displaced Brick**

Distance: **1ft**
Structural Grade: **3**
O&M Grade: **0**
Clock Start/From: **3**
Clock To:
1st Value:
2nd Value:
Value Percent:
Continuous Index:
Within Eight" of Joint: **False**
Remarks:

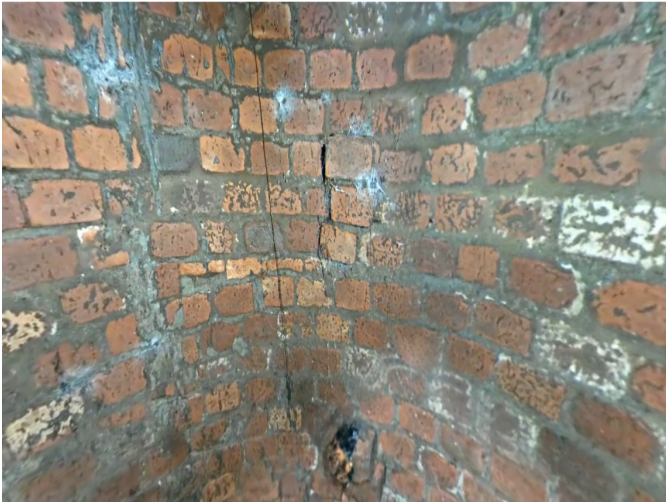
Code: **DB**
Description: **Displaced Brick**

Distance: **4ft**
Structural Grade: **3**
O&M Grade: **0**
Clock Start/From: **2**
Clock To:
1st Value:
2nd Value:
Value Percent:
Continuous Index:
Within Eight" of Joint: **False**
Remarks:

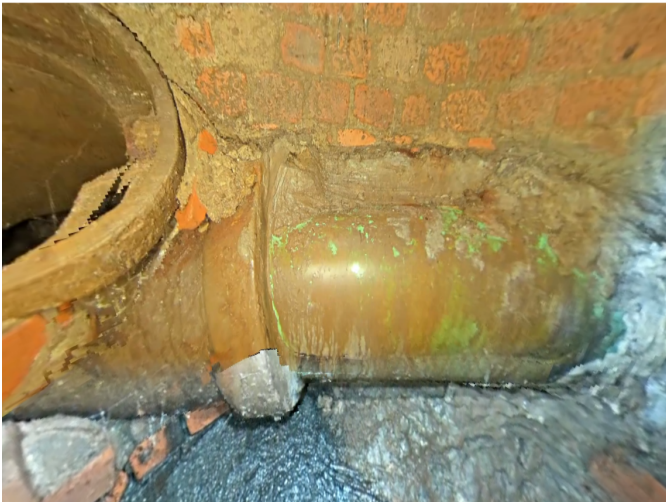
Code: **OBS**
Description: **Obstruction Built Into Structure**

Distance: **5ft**
Structural Grade: **0**
O&M Grade: **0**
Clock Start/From: **9**
Clock To:
1st Value:
2nd Value:
Value Percent: **40**
Continuous Index:
Within Eight" of Joint: **False**
Remarks: **Pipe through wall**

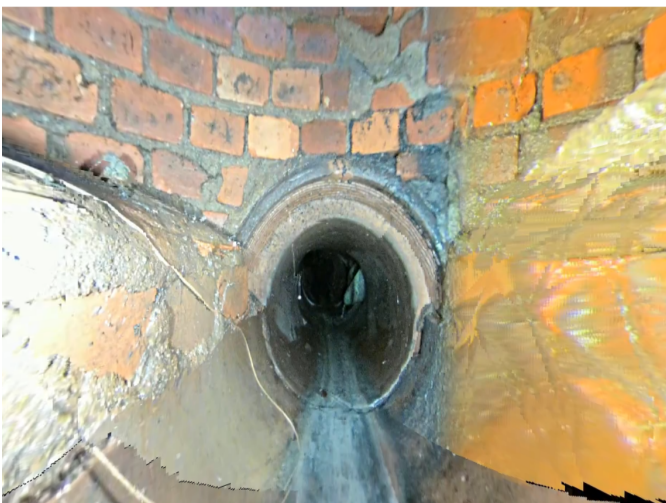
Code: **MGO**
Description: **Miscellaneous General Observation**

Distance: **7ft**
Structural Grade: **0**
O&M Grade: **0**
Clock Start/From:
Clock To:
1st Value:
2nd Value:
Value Percent:
Continuous Index:
Within Eight" of Joint: **False**
Remarks: **End inspection**
