R-010A

BELLEVUE ST
New Bedford

Inspection Status: Remote Inspection
Inspection Level: Level 2

Project: | New Bedford 3D Regulator Inspections

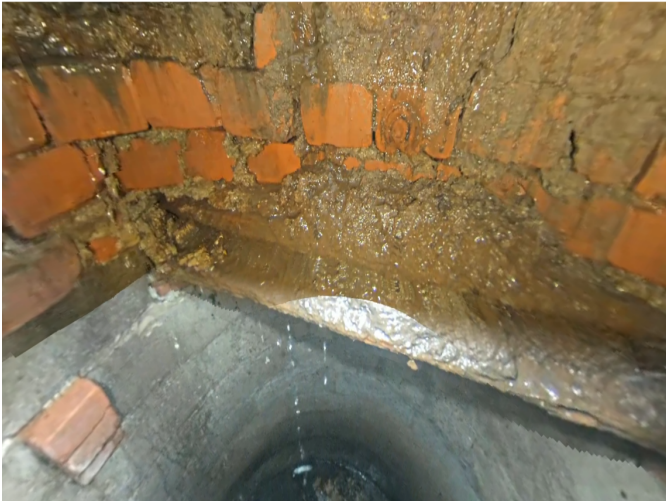
Code: **ID**
Description: **Infiltration Dripper**

Distance: **1ft**
Structural Grade: **0**
O&M Grade: **3**
Clock Start/From: **12**
Clock To: **6**
1st Value:
2nd Value:
Value Percent:
Continuous Index:
Within Eight" of Joint: **False**
Remarks:
