R-012A

RICKETSON ST
New Bedford

Inspection Status: Remote Inspection
Inspection Level: Level 2

Project: | New Bedford 3D Regulator Inspections

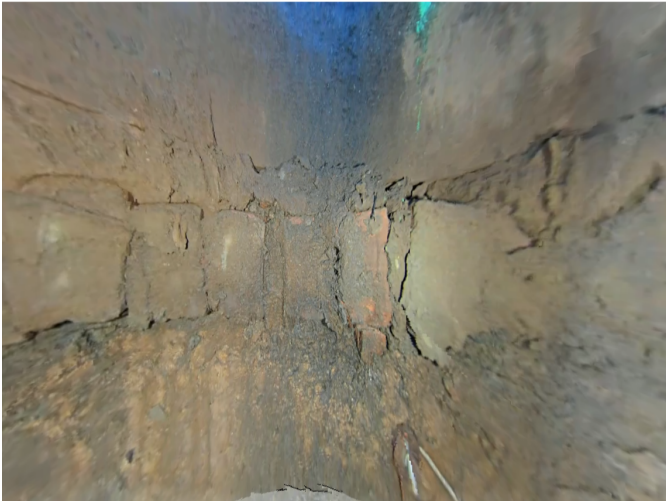
Code: **SRI**
Description: **Surface Damage Roughness Increased**

Distance: **0ft**
Structural Grade: **1**
O&M Grade: **0**
Clock Start/From: **12**
Clock To: **12**
1st Value:
2nd Value:
Value Percent:
Continuous Index:
Within Eight" of Joint: **True**
Remarks:

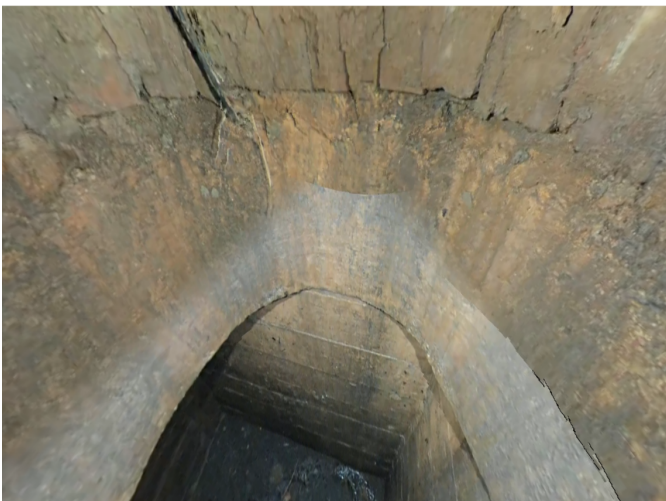
Code: **IS**
Description: **Infiltration Stain**

Distance: **0ft**
Structural Grade: **0**
O&M Grade: **1**
Clock Start/From: **12**
Clock To: **12**
1st Value:
2nd Value:
Value Percent:
Continuous Index: **S01**
Within Eight" of Joint: **False**
Remarks:

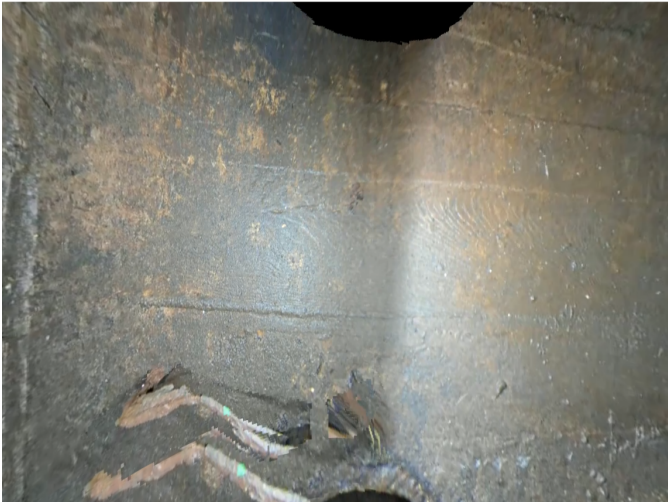
Code: **IS**
Description: **Infiltration Stain**

Distance: **5ft**
Structural Grade: **0**
O&M Grade: **1**
Clock Start/From: **12**
Clock To: **12**
1st Value:
2nd Value:
Value Percent:
Continuous Index: **F01**
Within Eight" of Joint: **False**
Remarks:
