# R-013A

AQUIDNECK ST  
New Bedford

Inspection Status: Remote Inspection  
Inspection Level: Level 2

**Project:** | New Bedford 3D Regulator Inspections

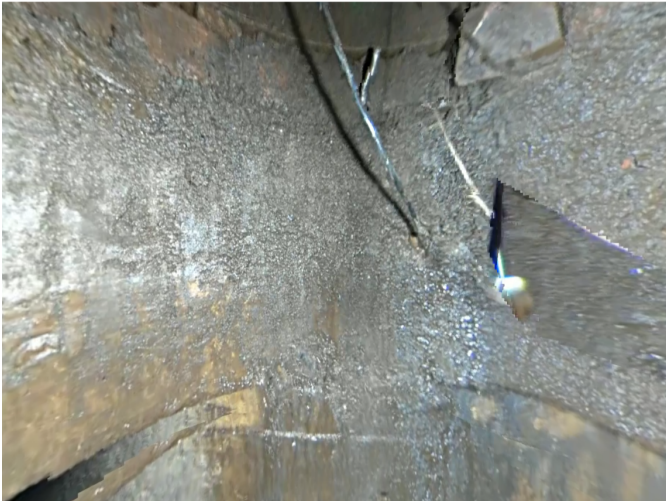
Code: **SRI**  
Description: **Surface Damage Roughness Increased**

Distance: **1ft**  
Structural Grade: **1**  
O&M Grade: **0**  
Clock Start/From: **12**  
Clock To: **12**  
1st Value:  
2nd Value:  
Value Percent:  
Continuous Index:  
Within Eight" of Joint: **False**  
Remarks:

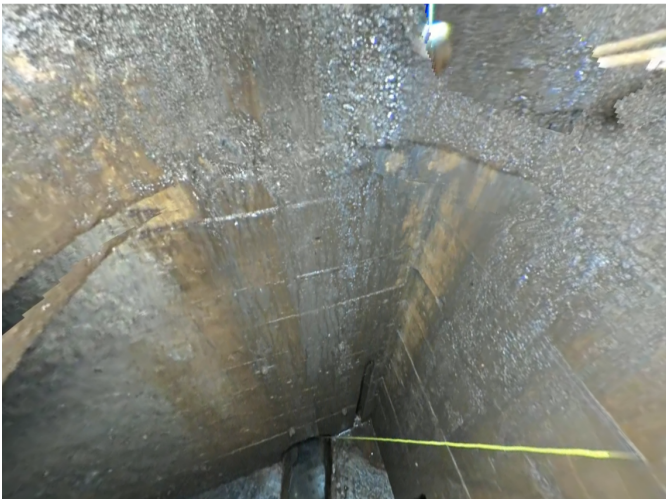
Code: **IW**  
Description: **Infiltration Weeper**

Distance: **1ft**  
Structural Grade: **0**  
O&M Grade: **2**  
Clock Start/From: **12**  
Clock To: **12**  
1st Value:  
2nd Value:  
Value Percent:  
Continuous Index: **S01**  
Within Eight" of Joint: **False**  
Remarks:

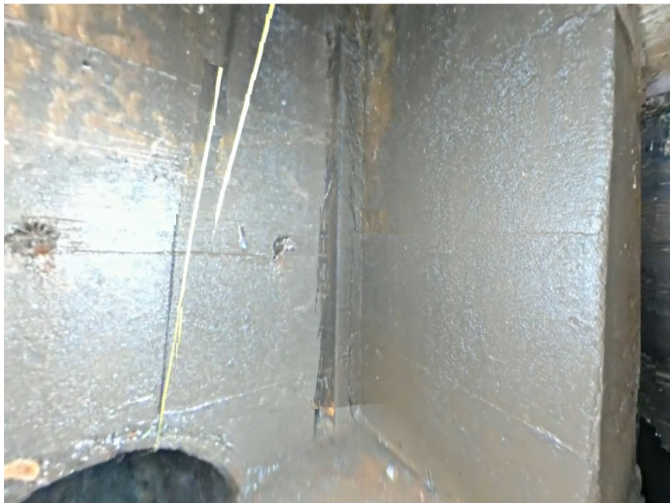
Code: **IW**  
Description: **Infiltration Weeper**

Distance: **5ft**  
Structural Grade: **0**  
O&M Grade: **2**  
Clock Start/From: **12**  
Clock To: **12**  
1st Value:  
2nd Value:  
Value Percent:  
Continuous Index: **F01**  
Within Eight" of Joint: **False**  
Remarks:
