R-015A

E RODNEY FRENCH BLVD
New Bedford

Inspection Status: Remote Inspection
Inspection Level: Level 2

Project: | New Bedford 3D Regulator Inspections

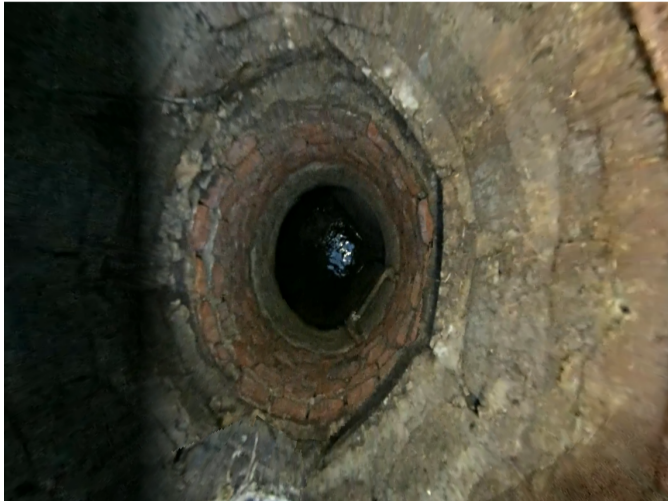
Code: **MGO**
Description: **Miscellaneous General Observation**

Distance: **0ft**
Structural Grade: **0**
O&M Grade: **0**
Clock Start/From:
Clock To:
1st Value:
2nd Value:
Value Percent:
Continuous Index:
Within Eight" of Joint: **False**
Remarks: **Start inspection**

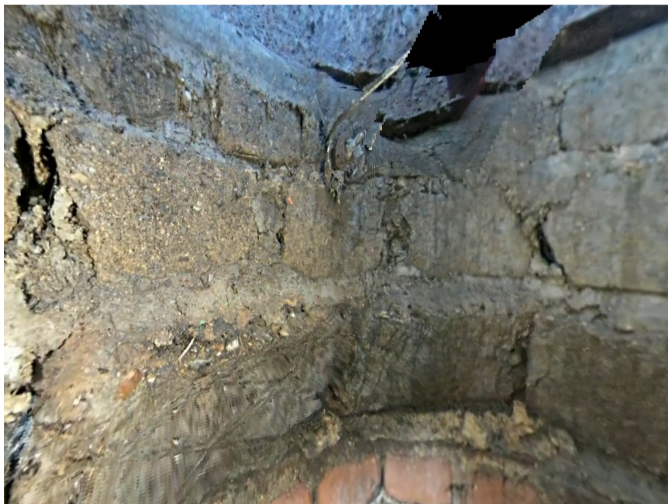
Code: **SRI**
Description: **Surface Damage Roughness Increased**

Distance: **1ft**
Structural Grade: **1**
O&M Grade: **0**
Clock Start/From: **12**
Clock To: **12**
1st Value:
2nd Value:
Value Percent:
Continuous Index:
Within Eight" of Joint: **False**
Remarks:

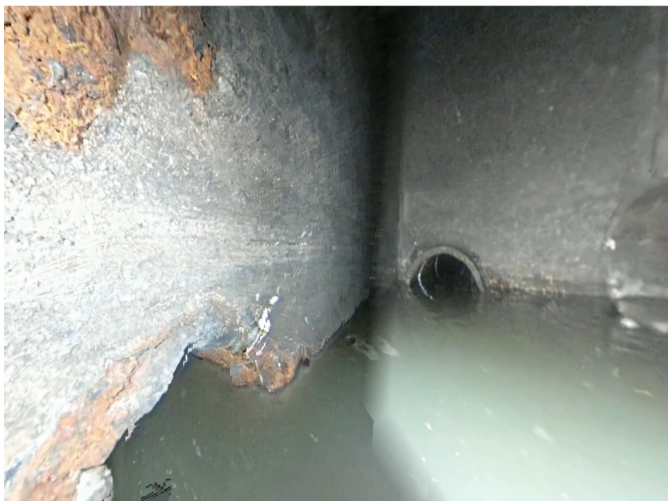
Code: **MGO**
Description: **Miscellaneous General Observation**

Distance: **8ft**
Structural Grade: **0**
O&M Grade: **0**
Clock Start/From:
Clock To:
1st Value:
2nd Value:
Value Percent:
Continuous Index:
Within Eight" of Joint: **False**
Remarks: **End inspection**
