R-016A

FREDERICK ST
New Bedford

Inspection Status: Remote Inspection
Inspection Level: Level 2

Project: | New Bedford 3D Regulator Inspections

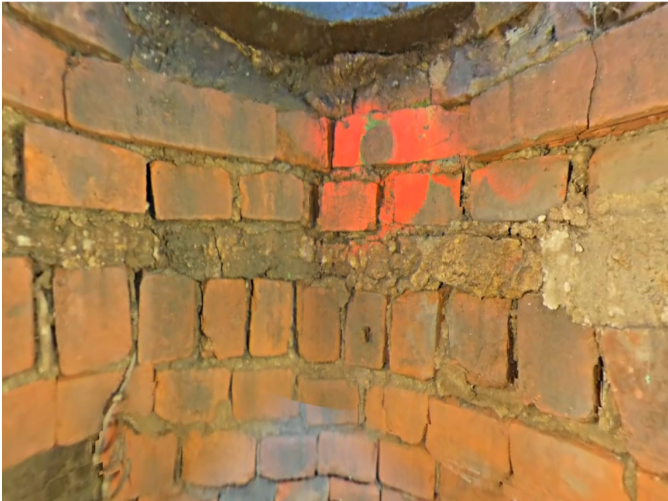
Code: **MMS**
Description: **Missing Mortar Small**

Distance: **1ft**
Structural Grade: **2**
O&M Grade: **0**
Clock Start/From: **12**
Clock To: **12**
1st Value:
2nd Value:
Value Percent:
Continuous Index:
Within Eight" of Joint: **False**
Remarks:

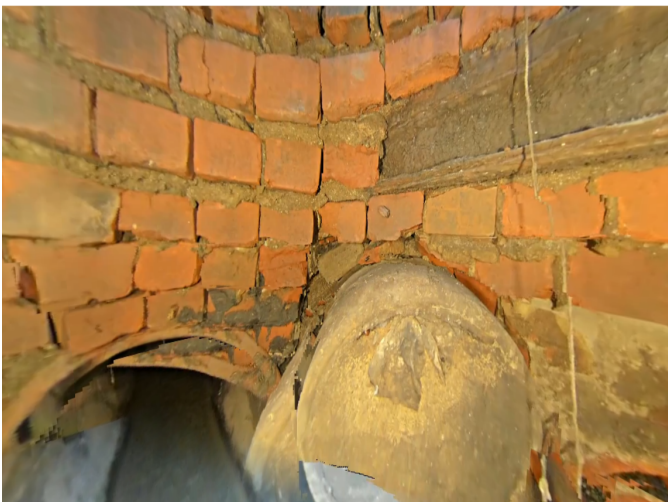
Code: **MMS**
Description: **Missing Mortar Small**

Distance: **2ft**
Structural Grade: **2**
O&M Grade: **0**
Clock Start/From: **12**
Clock To: **12**
1st Value:
2nd Value:
Value Percent:
Continuous Index:
Within Eight" of Joint: **False**
Remarks:
