R-017A

RODNEY ST
New Bedford

Project: | New Bedford 3D Regulator Inspections

Condition Report

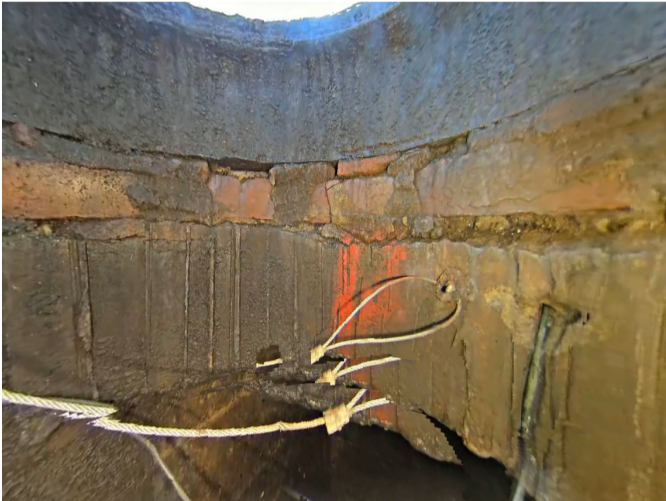
Code: **MMS**
Description: **Missing Mortar Small**

Distance: **1ft**
Structural Grade: **2**
O&M Grade: **0**
Clock Start/From: **12**
Clock To: **12**
1st Value:
2nd Value:
Value Percent:
Continuous Index:
Within Eight" of Joint: **False**
Remarks:

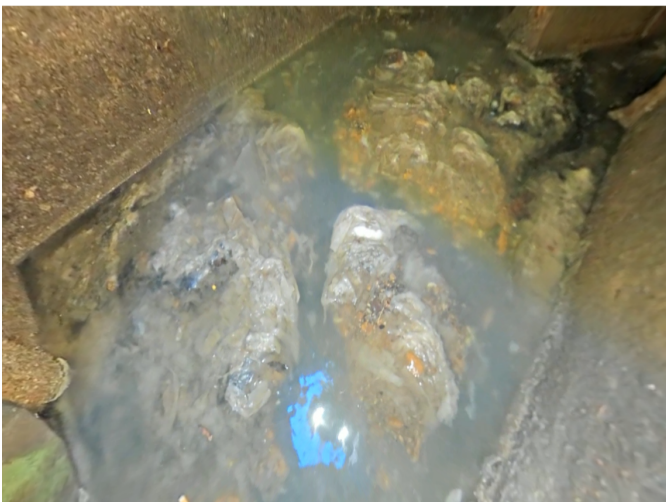
Code: **DSC**
Description: **Deposits Settled Compacted**

Distance: **3ft**
Structural Grade: **0**
O&M Grade: **4**
Clock Start/From: **12**
Clock To: **12**
1st Value:
2nd Value:
Value Percent: **50**
Continuous Index:
Within Eight" of Joint: **False**
Remarks:

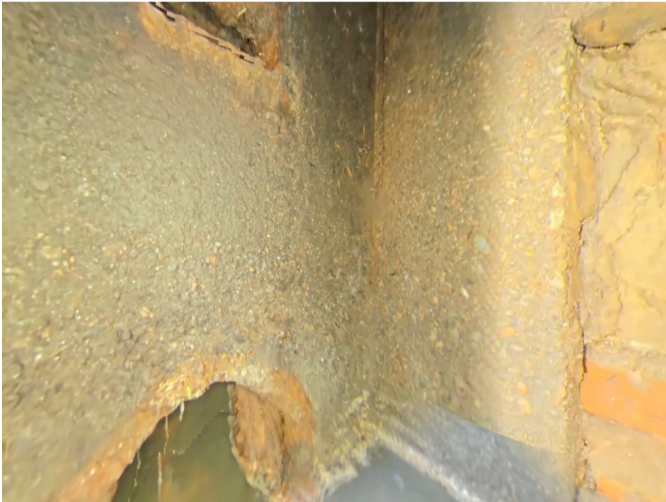
Code: **SAV**
Description: **Surface Damage
Aggregate Visible**

Distance: **4ft**
Structural Grade: **2**
O&M Grade: **0**
Clock Start/From: **12**
Clock To: **12**
1st Value:
2nd Value:
Value Percent:
Continuous Index:
Within Eight" of Joint: **False**
Remarks:
