R-017C

DAVID ST
New Bedford

Inspection Status: Remote Inspection
Inspection Level: Level 2

Project: | New Bedford 3D Regulator Inspections
Owner: New Bedford, MA
Customer: CDM Smith

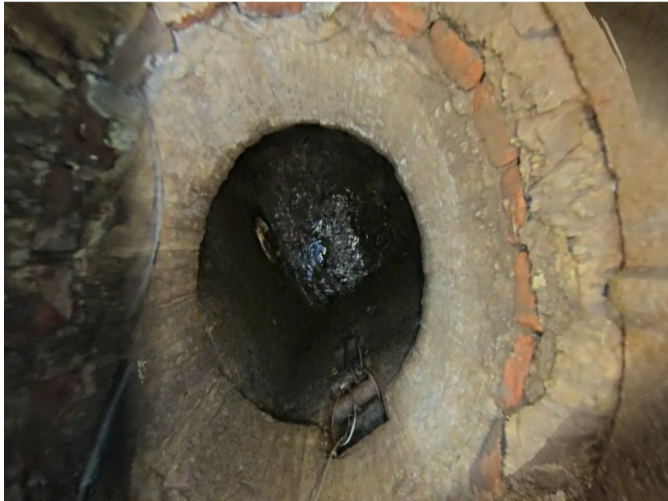
Code: **MGO**
Description: **Miscellaneous General Observation**

Distance: **0ft**
Structural Grade: **0**
O&M Grade: **0**
Clock Start/From:
Clock To:
1st Value:
2nd Value:
Value Percent:
Continuous Index:
Within Eight" of Joint: **False**
Remarks: **Start inspection**

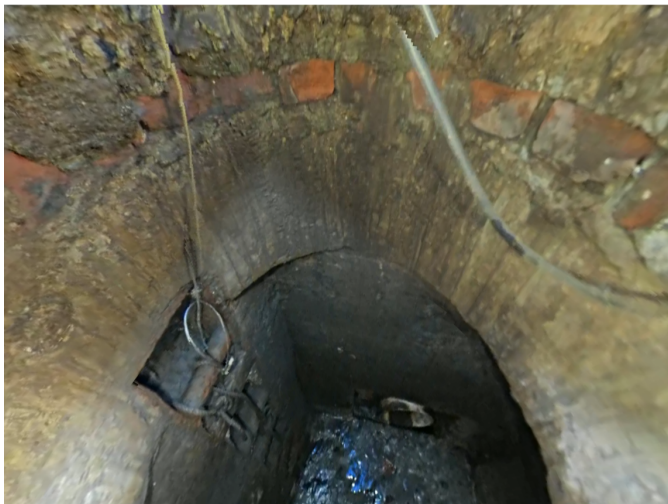
Code: **IS**
Description: **Infiltration Stain**

Distance: **0ft**
Structural Grade: **0**
O&M Grade: **1**
Clock Start/From: **12**
Clock To: **12**
1st Value:
2nd Value:
Value Percent:
Continuous Index: **S01**
Within Eight" of Joint: **False**
Remarks:

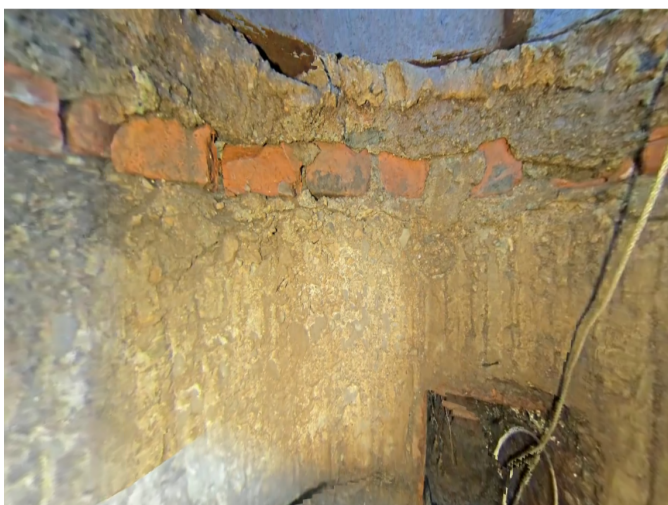
Code: **SAV**
Description: **Surface Damage Aggregate Visible**

Distance: **1ft**
Structural Grade: **2**
O&M Grade: **0**
Clock Start/From: **12**
Clock To: **12**
1st Value:
2nd Value:
Value Percent:
Continuous Index:
Within Eight" of Joint: **False**
Remarks:

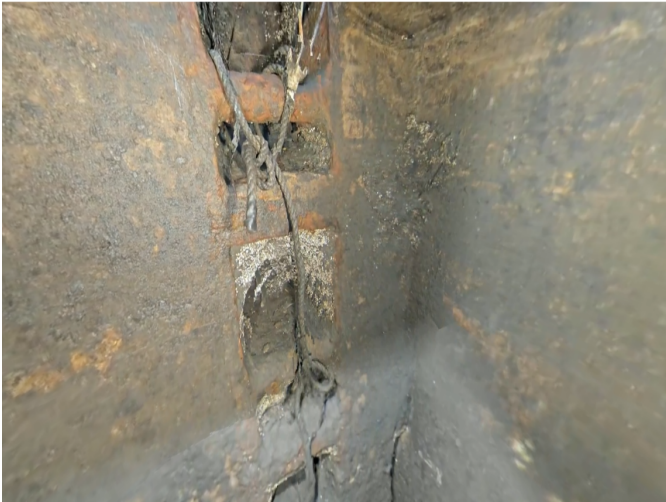
Code: **MGP**
Description: **Miscellaneous General Photo**

Distance: **2ft**
Structural Grade: **0**
O&M Grade: **0**
Clock Start/From:
Clock To:
1st Value:
2nd Value:
Value Percent:
Continuous Index:
Within Eight" of Joint: **False**
Remarks: **Rope on steps**

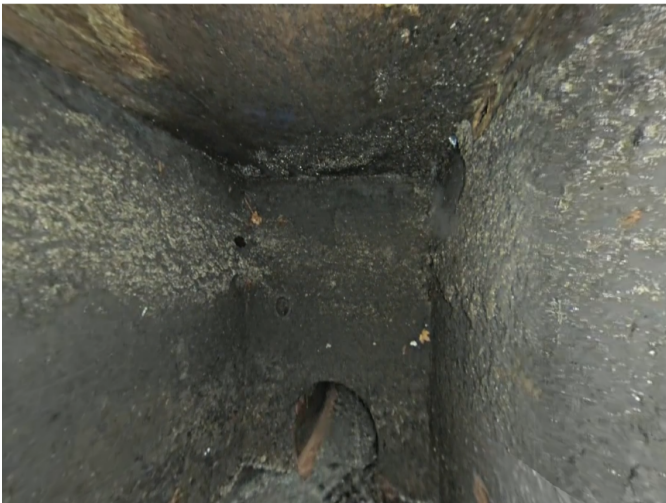
Code: **SAV**
Description: **Surface Damage Aggregate Visible**

Distance: **3ft**
Structural Grade: **2**
O&M Grade: **0**
Clock Start/From: **12**
Clock To: **12**
1st Value:
2nd Value:
Value Percent:
Continuous Index:
Within Eight" of Joint: **False**
Remarks:

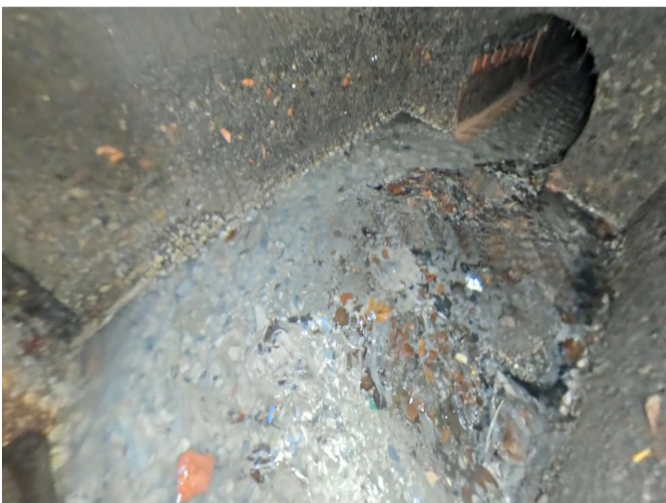
Code: **DSGV**
Description: **Deposits Settled Gravel**

Distance: **4ft**
Structural Grade: **0**
O&M Grade: **2**
Clock Start/From: **12**
Clock To: **12**
1st Value:
2nd Value:
Value Percent: **15**
Continuous Index:
Within Eight" of Joint: **False**
Remarks:

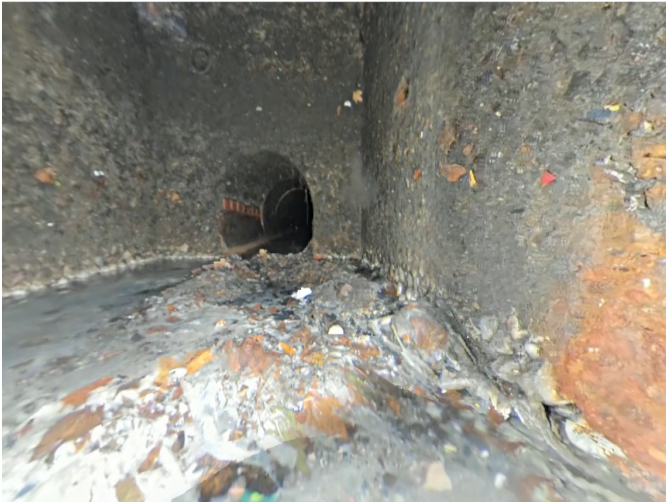
Code: **MGO**
Description: **Miscellaneous General Observation**

Distance: **6ft**
Structural Grade: **0**
O&M Grade: **0**
Clock Start/From:
Clock To:
1st Value:
2nd Value:
Value Percent:
Continuous Index:
Within Eight" of Joint: **False**
Remarks: **End inspection**

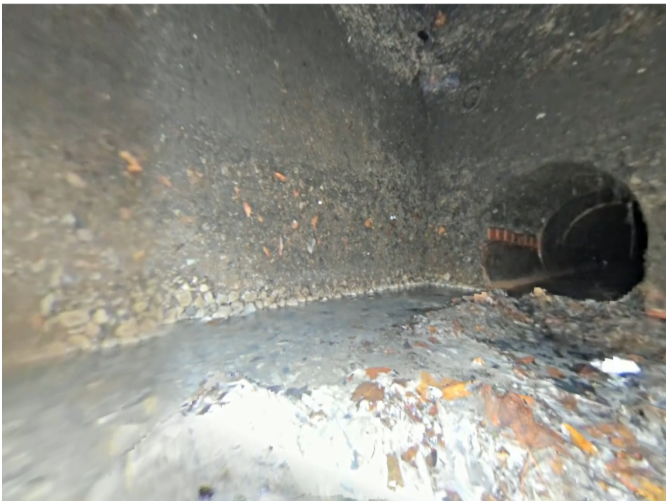
Code: **IS**
Description: **Infiltration Stain**

Distance: **6ft**
Structural Grade: **0**
O&M Grade: **1**
Clock Start/From: **12**
Clock To: **12**
1st Value:
2nd Value:
Value Percent:
Continuous Index: **F01**
Within Eight" of Joint: **False**
Remarks:

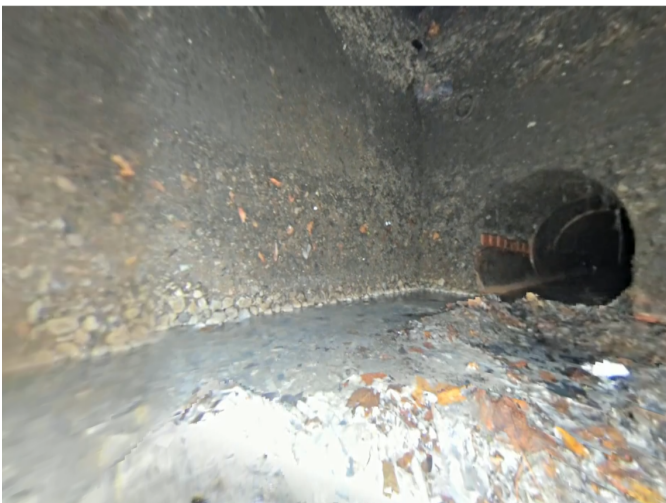
Code: **SAP**
Description: **Surface Damage Aggregate Projecting**

Distance: **6ft**
Structural Grade: **3**
O&M Grade: **0**
Clock Start/From: **12**
Clock To: **12**
1st Value:
2nd Value:
Value Percent:
Continuous Index:
Within Eight" of Joint: **False**
Remarks:
