# R-017D

RUTH ST  
New Bedford

**Project:** | New Bedford 3D Regulator Inspections

# Condition Report

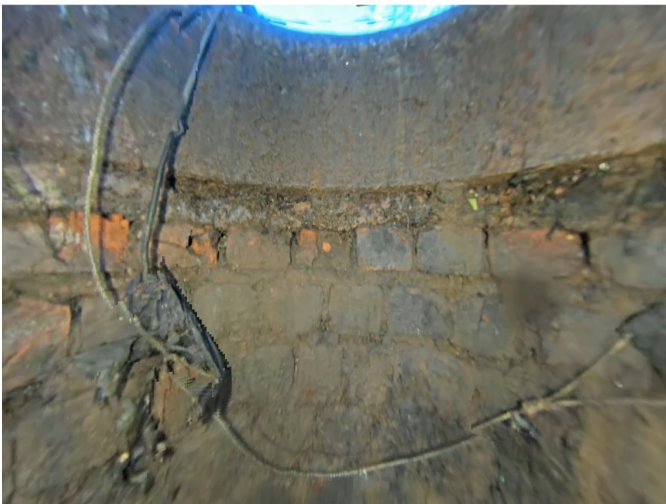
Code: **MMS**  
Description: **Missing Mortar Small**

Distance: **0ft**  
Structural Grade: **2**  
O&M Grade: **0**  
Clock Start/From: **3**  
Clock To: **7**  
1st Value:  
2nd Value:  
Value Percent:  
Continuous Index:  
Within Eight" of Joint: **False**  
Remarks:

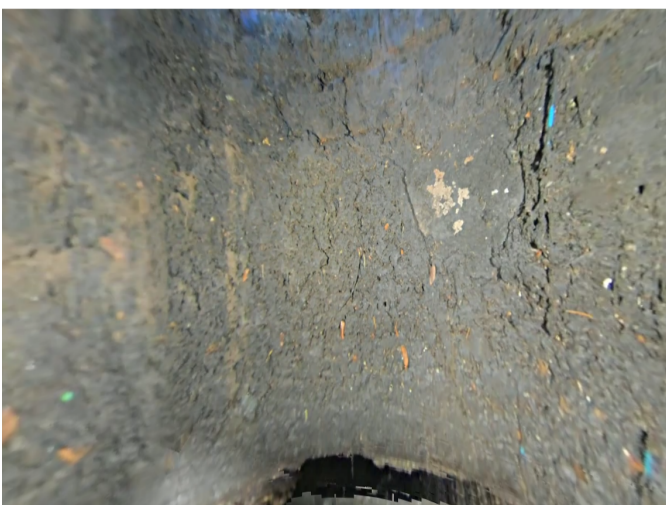
Code: **SRI**  
Description: **Surface Damage Roughness Increased**

Distance: **2ft**  
Structural Grade: **1**  
O&M Grade: **0**  
Clock Start/From: **12**  
Clock To: **12**  
1st Value:  
2nd Value:  
Value Percent:  
Continuous Index:  
Within Eight" of Joint: **False**  
Remarks:

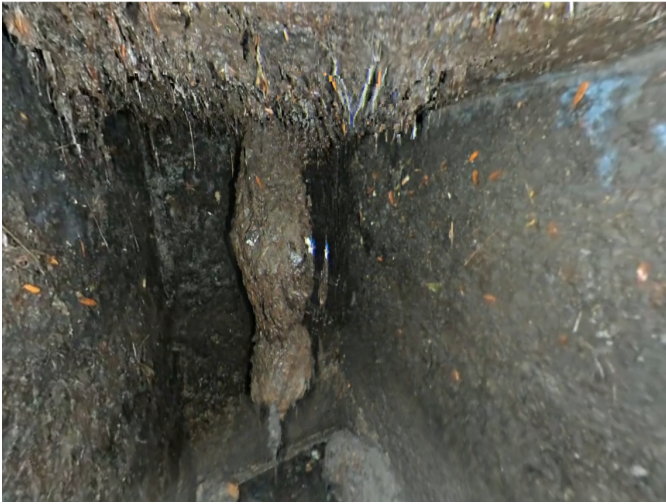
Code: **DAE**  
Description: **Deposits Attached Encrustation**

Distance: **3ft**  
Structural Grade: **0**  
O&M Grade: **0**  
Clock Start/From: **3**  
Clock To:  
1st Value:  
2nd Value:  
Value Percent: **55**  
Continuous Index:  
Within Eight" of Joint: **False**  
Remarks: **Hanging from ceiling**

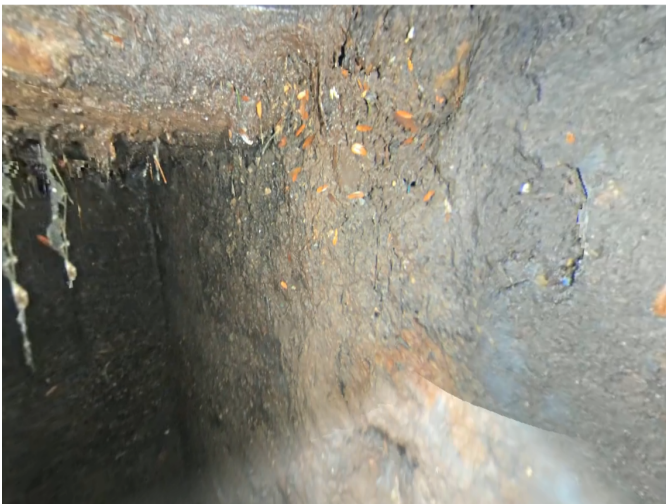
Code: **DAE**  
Description: **Deposits Attached Encrustation**

Distance: **3ft**  
Structural Grade: **0**  
O&M Grade: **0**  
Clock Start/From: **12**  
Clock To:  
1st Value:  
2nd Value:  
Value Percent: **25**  
Continuous Index: **S01**  
Within Eight" of Joint: **False**  
Remarks:

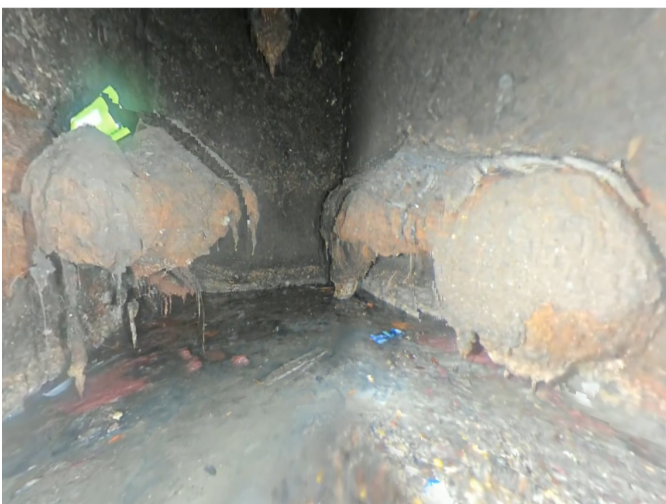
Code: **DAE**  
Description: **Deposits Attached Encrustation**

Distance: **7ft**  
Structural Grade: **0**  
O&M Grade: **2**  
Clock Start/From: **3**  
Clock To:  
1st Value:  
2nd Value:  
Value Percent: **65**  
Continuous Index:  
Within Eight" of Joint: **False**  
Remarks:

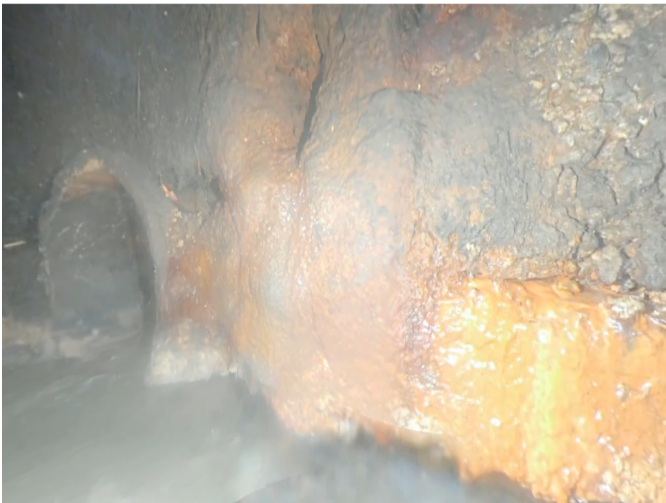
Code: **DAE**  
Description: **Deposits Attached Encrustation**

Distance: **7ft**  
Structural Grade: **0**  
O&M Grade: **0**  
Clock Start/From: **12**  
Clock To:  
1st Value:  
2nd Value:  
Value Percent: **25**  
Continuous Index: **F01**  
Within Eight" of Joint: **False**  
Remarks:

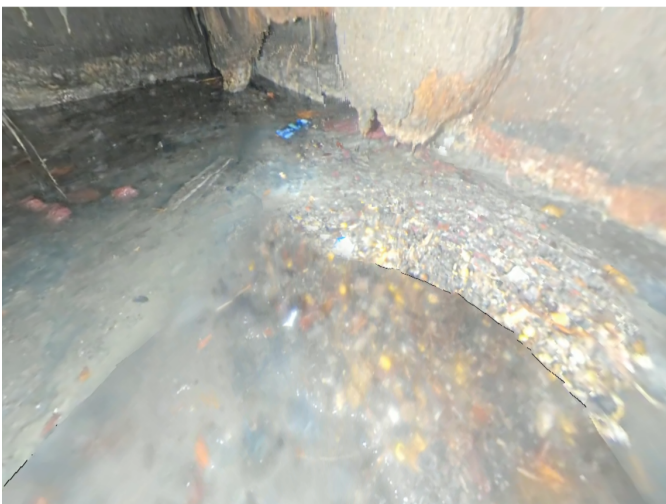
Code: **DSC**  
Description: **Deposits Settled Compacted**

Distance: **7ft**  
Structural Grade: **0**  
O&M Grade: **4**  
Clock Start/From: **3**  
Clock To:  
1st Value:  
2nd Value:  
Value Percent: **35**  
Continuous Index:  
Within Eight" of Joint: **False**  
Remarks:
