R-018A

CUYE ST
New Bedford

Project: | New Bedford 3D Regulator Inspections

Owner: New Bedford, MA

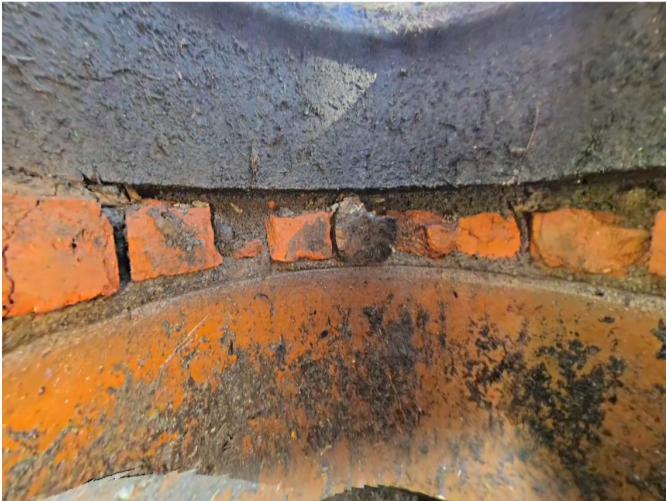
Code: **MMS**
Description: **Missing Mortar Small**

Distance: **0ft**
Structural Grade: **2**
O&M Grade: **0**
Clock Start/From: **12**
Clock To: **12**
1st Value:
2nd Value:
Value Percent:
Continuous Index:
Within Eight" of Joint: **False**
Remarks:

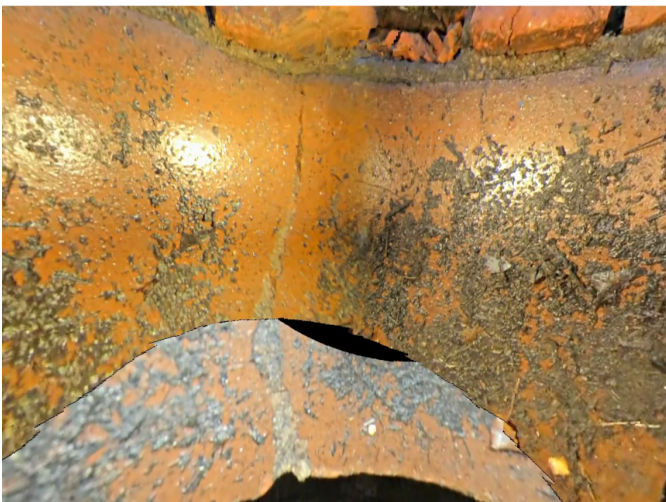
Code: **CL**
Description: **Crack Longitudinal**

Distance: **1ft**
Structural Grade: **2**
O&M Grade: **0**
Clock Start/From: **5**
Clock To:
1st Value:
2nd Value:
Value Percent:
Continuous Index:
Within Eight" of Joint: **False**
Remarks:

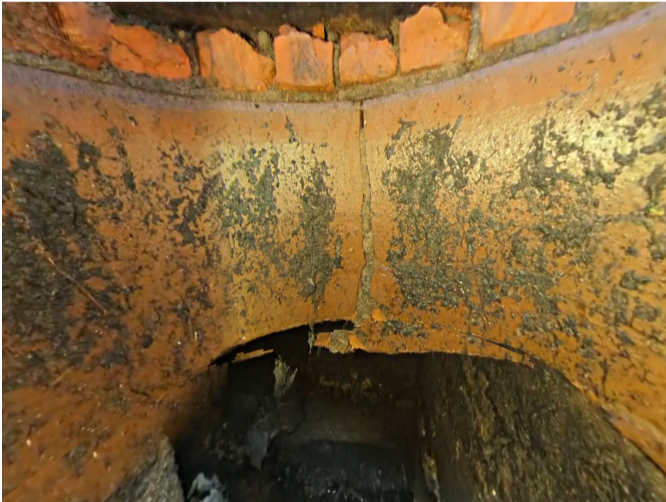
Code: **CL**
Description: **Crack Longitudinal**

Distance: **1ft**
Structural Grade: **2**
O&M Grade: **0**
Clock Start/From: **9**
Clock To:
1st Value:
2nd Value:
Value Percent:
Continuous Index:
Within Eight" of Joint: **False**
Remarks:

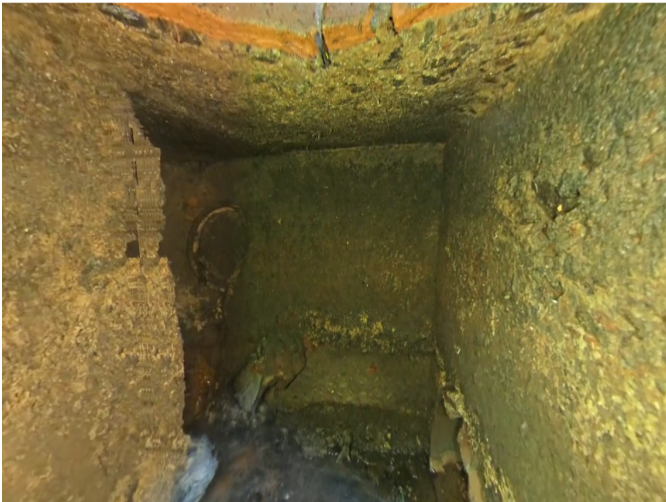
Code: **SAV**
Description: **Surface Damage
Aggregate Visible**

Distance: **2ft**
Structural Grade: **2**
O&M Grade: **0**
Clock Start/From: **12**
Clock To: **12**
1st Value:
2nd Value:
Value Percent:
Continuous Index: **S01**
Within Eight" of Joint: **False**
Remarks:

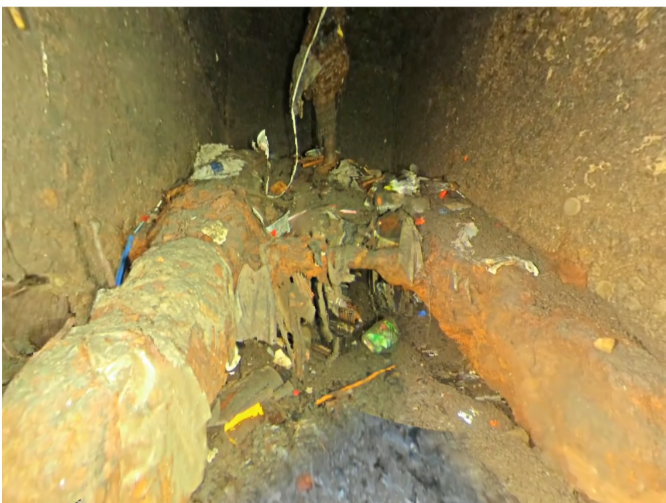
Code: **OBS**
Description: **Obstruction Built Into
Structure**

Distance: **4ft**
Structural Grade: **0**
O&M Grade: **2**
Clock Start/From: **9**
Clock To:
1st Value:
2nd Value:
Value Percent: **75**
Continuous Index:
Within Eight" of Joint: **False**
Remarks: **Pipe structure**

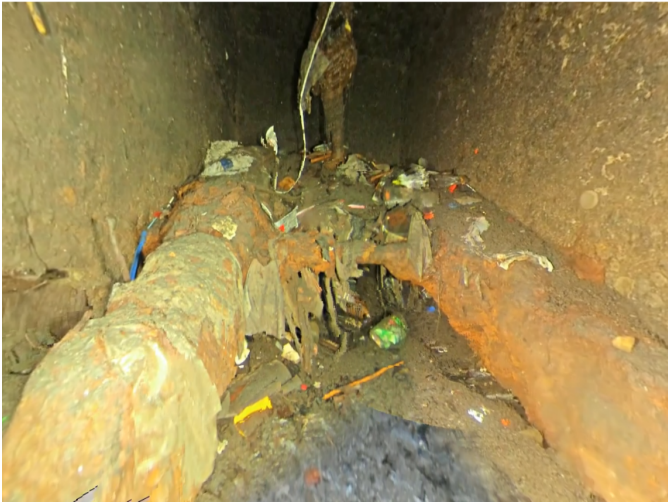
Code: **DSZ**
Description: **Deposits Settled Other**

Distance: **4ft**
Structural Grade: **0**
O&M Grade: **2**
Clock Start/From: **9**
Clock To:
1st Value:
2nd Value:
Value Percent: **30**
Continuous Index:
Within Eight" of Joint: **False**
Remarks: **Mixed debris on structure**

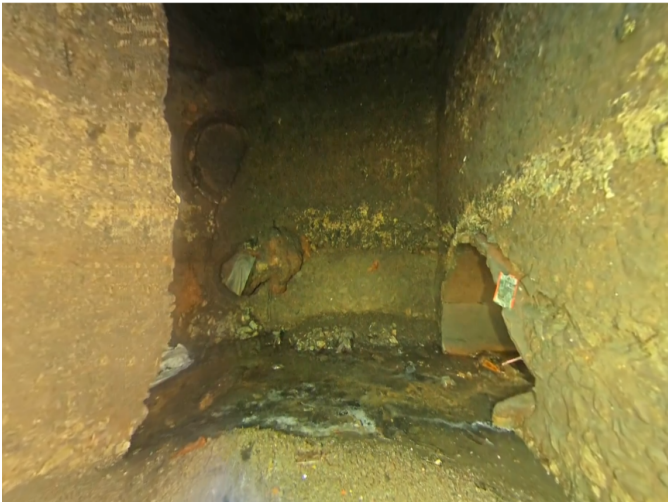
Code: **SAV**
Description: **Surface Damage Aggregate Visible**

Distance: **4ft**
Structural Grade: **2**
O&M Grade: **0**
Clock Start/From: **12**
Clock To: **12**
1st Value:
2nd Value:
Value Percent:
Continuous Index: **F01**
Within Eight" of Joint: **False**
Remarks:
