# R-018B

COVE ST  
New Bedford

**Project:** | New Bedford 3D Regulator Inspections  
**Owner:** | New Bedford, MA  
**Customer:** CCDM Smith

# Condition Report

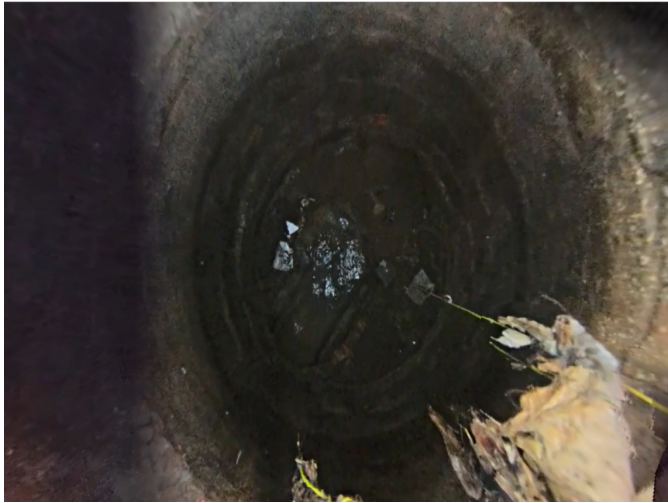
Code: **MGO**  
Description: **Miscellaneous General Observation**

Distance: **0ft**  
Structural Grade: **0**  
O&M Grade: **0**  
Clock Start/From:  
Clock To:  
1st Value:  
2nd Value:  
Value Percent:  
Continuous Index:  
Within Eight" of Joint: **False**  
Remarks: **Start inspection**

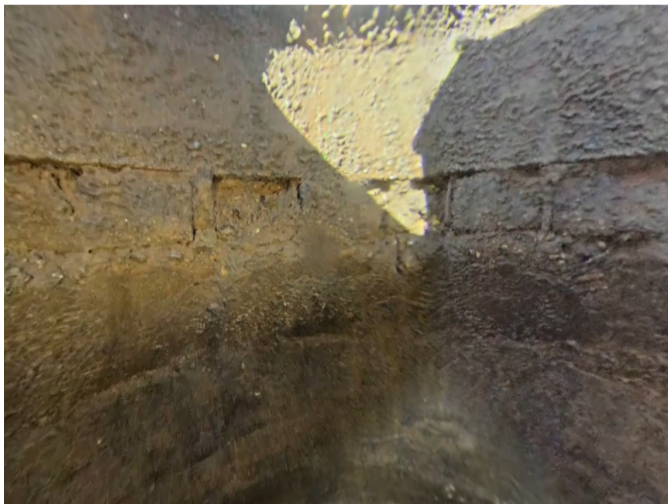
Code: **SRI**  
Description: **Surface Damage Roughness Increased**

Distance: **0ft**  
Structural Grade: **1**  
O&M Grade: **0**  
Clock Start/From: **12**  
Clock To: **12**  
1st Value:  
2nd Value:  
Value Percent:  
Continuous Index: **S01**  
Within Eight" of Joint: **False**  
Remarks:

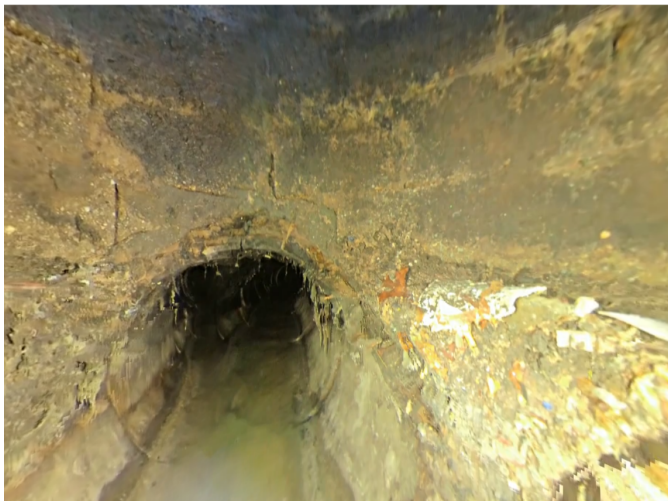
Code: **SRI**  
Description: **Surface Damage Roughness Increased**

Distance: **4ft**  
Structural Grade: **1**  
O&M Grade: **0**  
Clock Start/From: **12**  
Clock To: **12**  
1st Value:  
2nd Value:  
Value Percent:  
Continuous Index: **F01**  
Within Eight" of Joint: **False**  
Remarks:

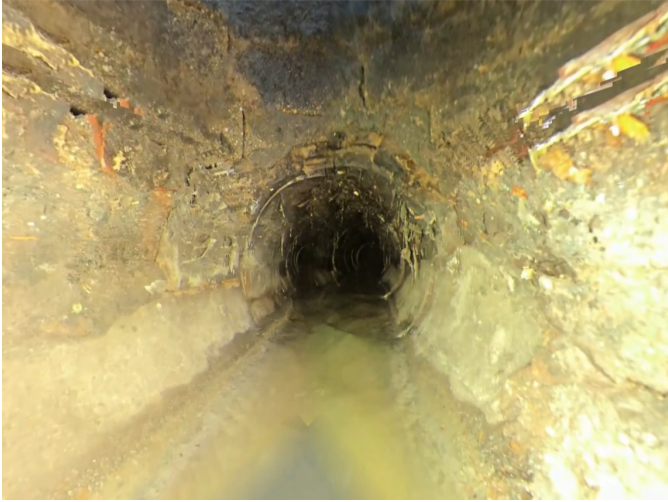
Code: **MGO**  
Description: **Miscellaneous General Observation**

Distance: **5ft**  
Structural Grade: **0**  
O&M Grade: **0**  
Clock Start/From:  
Clock To:  
1st Value:  
2nd Value:  
Value Percent:  
Continuous Index:  
Within Eight" of Joint: **False**  
Remarks: **End inspection**
