R-020A

WAMSUTTA ST
New Bedford

Inspection Status: Remote Inspection
Inspection Level: Level 2

Project: | New Bedford 3D Regulator Inspections

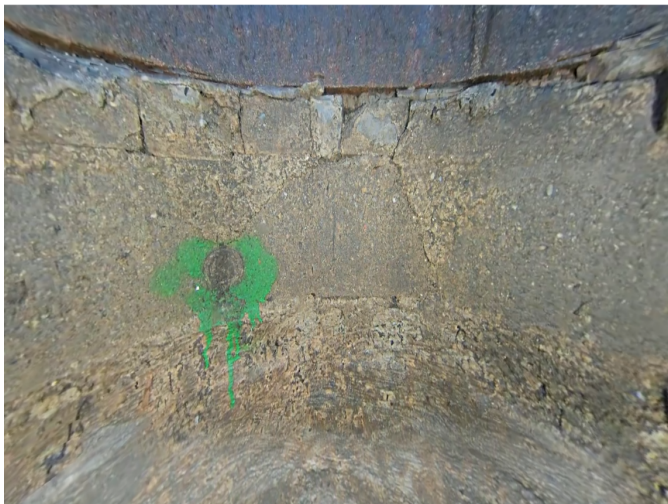
Code: **SRI**
Description: **Surface Damage Roughness Increased**

Distance: **0ft**
Structural Grade: **1**
O&M Grade: **0**
Clock Start/From: **12**
Clock To: **12**
1st Value:
2nd Value:
Value Percent:
Continuous Index: **S01**
Within Eight" of Joint: **False**
Remarks:

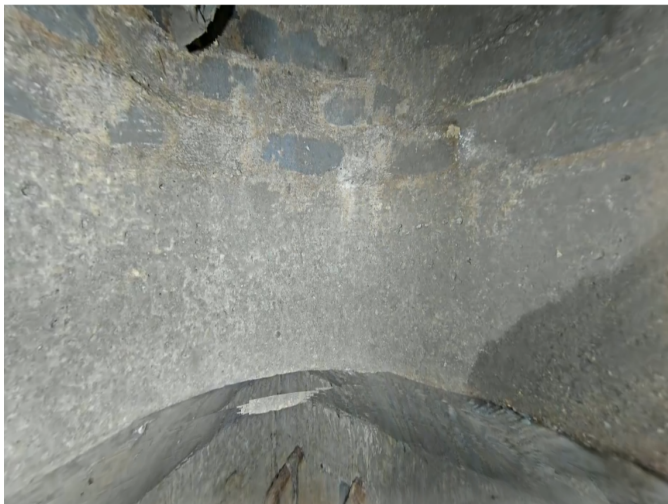
Code: **SRI**
Description: **Surface Damage Roughness Increased**

Distance: **8ft**
Structural Grade: **1**
O&M Grade: **0**
Clock Start/From: **12**
Clock To: **12**
1st Value:
2nd Value:
Value Percent:
Continuous Index: **F01**
Within Eight" of Joint: **False**
Remarks:
