R-020B

ACUSHNET ST
New Bedford

Inspection Status: Remote Inspection
Inspection Level: Level 2

Project: | New Bedford 3D Regulator Inspections

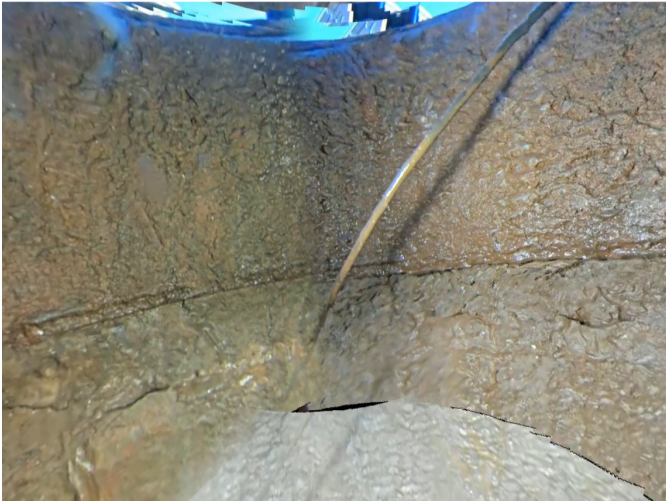
Code: **SRI**
Description: **Surface Damage Roughness Increased**

Distance: **0ft**
Structural Grade: **1**
O&M Grade: **0**
Clock Start/From: **12**
Clock To: **12**
1st Value:
2nd Value:
Value Percent:
Continuous Index:
Within Eight" of Joint: **False**
Remarks:

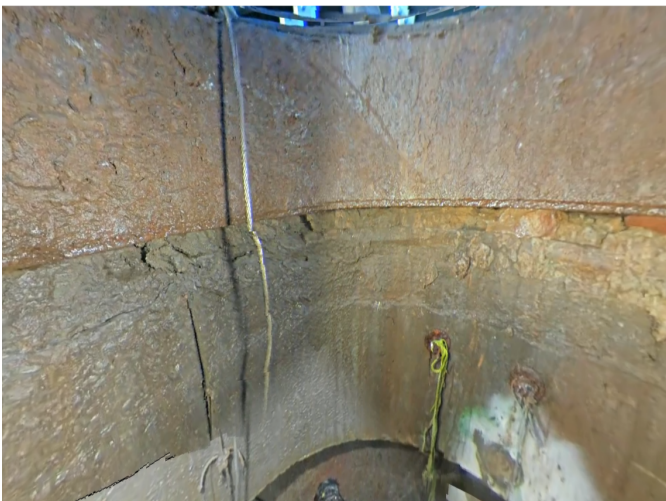
Code: **IS**
Description: **Infiltration Stain**

Distance: **0ft**
Structural Grade: **0**
O&M Grade: **1**
Clock Start/From: **12**
Clock To: **12**
1st Value:
2nd Value:
Value Percent:
Continuous Index: **S01**
Within Eight" of Joint: **False**
Remarks:

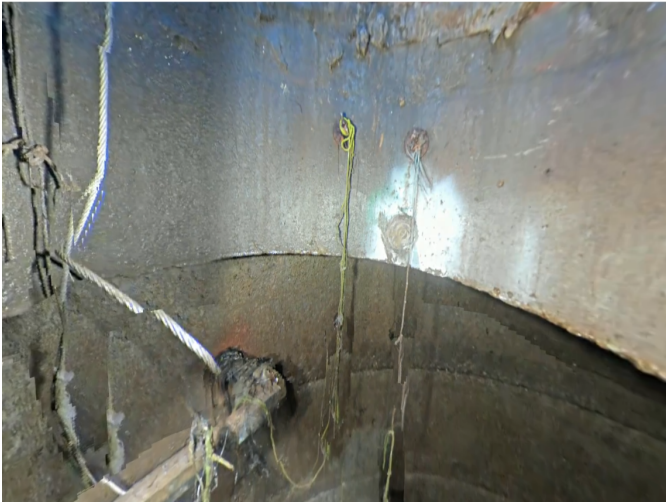
Code: **OBS**
Description: **Obstruction Built Into Structure**

Distance: **1ft**
Structural Grade: **0**
O&M Grade: **0**
Clock Start/From: **6**
Clock To:
1st Value:
2nd Value:
Value Percent: **5**
Continuous Index:
Within Eight" of Joint: **False**
Remarks: **Rope attached**

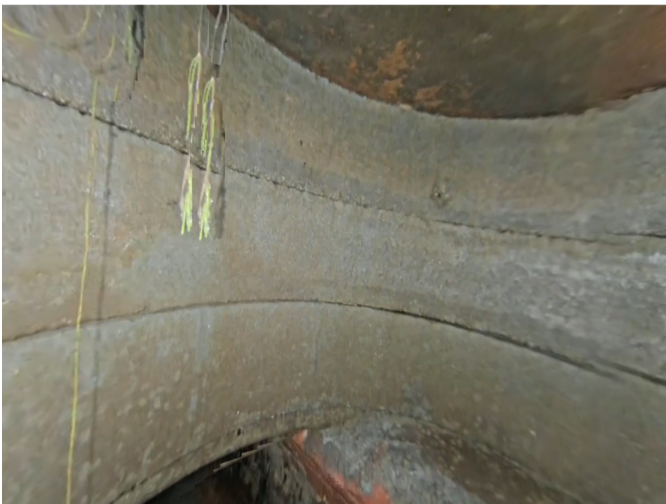
Code: **CC**
Description: **Crack Circumferential**

Distance: **3ft**
Structural Grade: **2**
O&M Grade: **0**
Clock Start/From: **12**
Clock To: **12**
1st Value:
2nd Value:
Value Percent:
Continuous Index:
Within Eight" of Joint: **False**
Remarks:

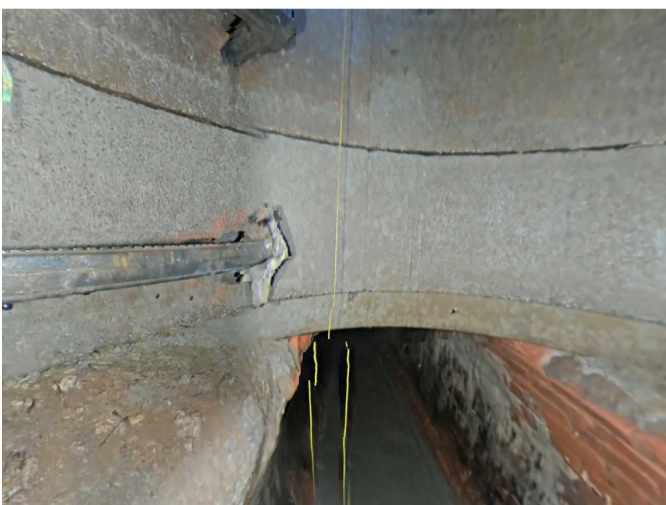
Code: **IS**
Description: **Infiltration Stain**

Distance: **4ft**
Structural Grade: **0**
O&M Grade: **1**
Clock Start/From: **12**
Clock To: **12**
1st Value:
2nd Value:
Value Percent:
Continuous Index: **F01**
Within Eight" of Joint: **False**
Remarks:

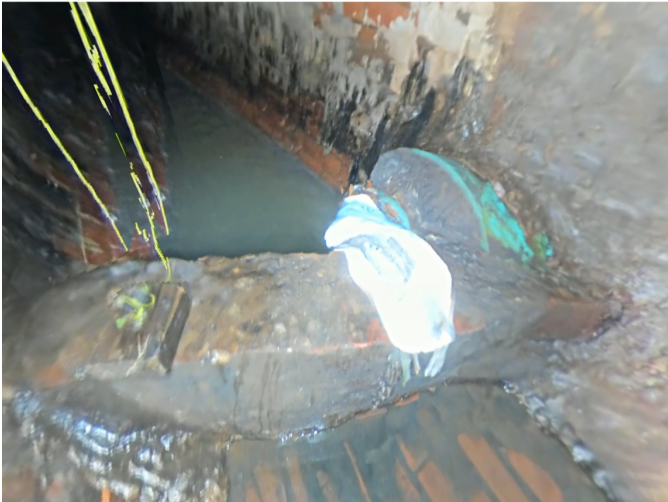
Code: **OBS**
Description: **Obstruction Built Into Structure**

Distance: **6ft**
Structural Grade: **0**
O&M Grade: **5**
Clock Start/From: **12**
Clock To:
1st Value:
2nd Value:
Value Percent: **50**
Continuous Index:
Within Eight" of Joint: **False**
Remarks: **Wall in channel**

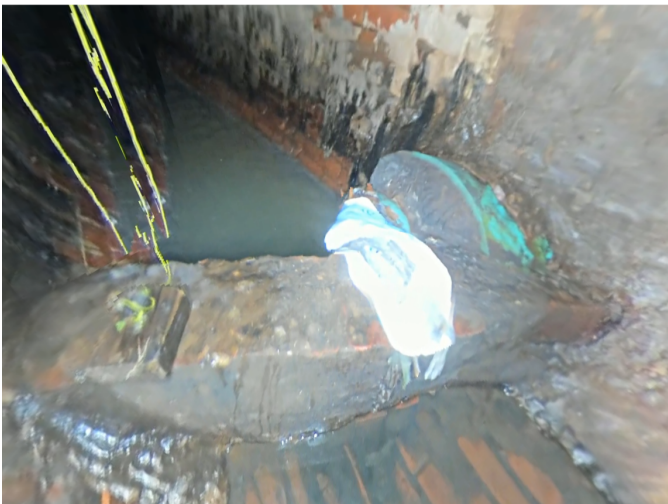
Code: **DAR**
Description: **Deposits Attached Ragging**

Distance: **6ft**
Structural Grade: **0**
O&M Grade: **3**
Clock Start/From: **12**
Clock To:
1st Value:
2nd Value:
Value Percent: **30**
Continuous Index:
Within Eight" of Joint: **False**
Remarks: **Mixed deposits on wall**
