# R-021A

WASHBURN ST  
New Bedford

**Project:** | New Bedford 3D Regulator Inspections

# Condition Report

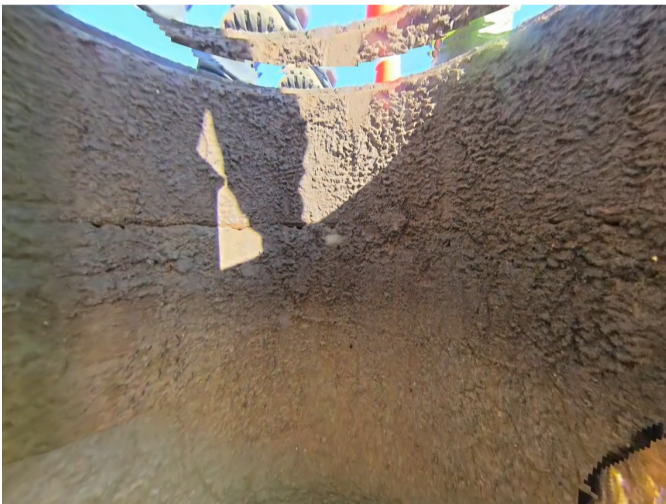
Code: **SRI**  
Description: **Surface Damage Roughness Increased**

Distance: **0ft**  
Structural Grade: **1**  
O&M Grade: **0**  
Clock Start/From: **12**  
Clock To: **12**  
1st Value:  
2nd Value:  
Value Percent:  
Continuous Index: **S01**  
Within Eight" of Joint: **False**  
Remarks:

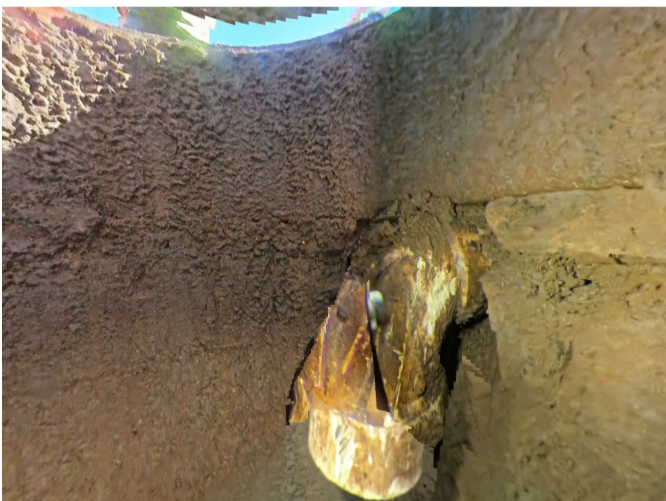
Code: **OBS**  
Description: **Obstruction Built Into Structure**

Distance: **0ft**  
Structural Grade: **0**  
O&M Grade: **0**  
Clock Start/From: **12**  
Clock To:  
1st Value:  
2nd Value:  
Value Percent: **15**  
Continuous Index:  
Within Eight" of Joint: **False**  
Remarks: **Tap break in**

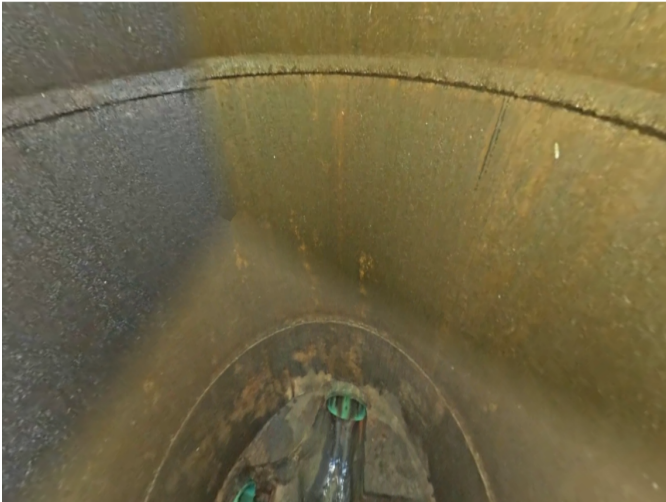
Code: **IS**  
Description: **Infiltration Stain**

Distance: **3ft**  
Structural Grade: **0**  
O&M Grade: **1**  
Clock Start/From: **12**  
Clock To: **12**  
1st Value:  
2nd Value:  
Value Percent:  
Continuous Index: **S02**  
Within Eight" of Joint: **False**  
Remarks:

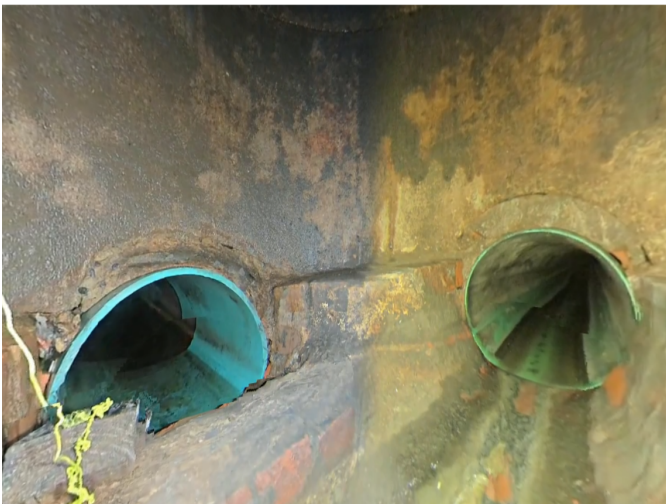
Code: **SRI**  
Description: **Surface Damage  
Roughness Increased**

Distance: **9ft**  
Structural Grade: **1**  
O&M Grade: **0**  
Clock Start/From: **12**  
Clock To: **12**  
1st Value:  
2nd Value:  
Value Percent:  
Continuous Index: **F01**  
Within Eight" of Joint: **False**  
Remarks:

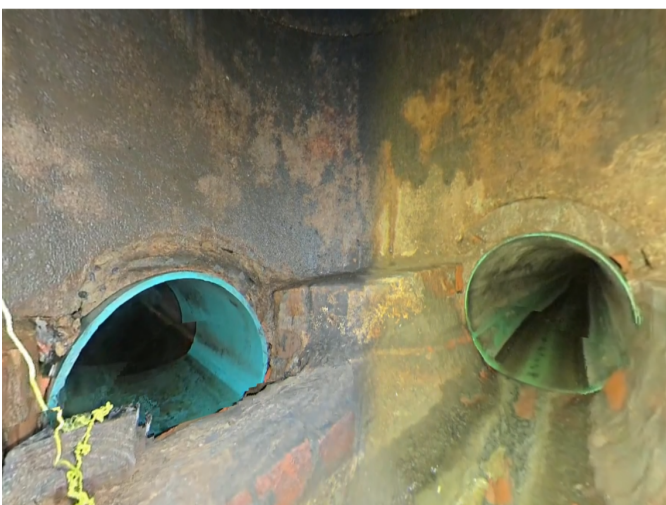
Code: **IS**  
Description: **Infiltration Stain**

Distance: **9ft**  
Structural Grade: **0**  
O&M Grade: **1**  
Clock Start/From: **12**  
Clock To: **12**  
1st Value:  
2nd Value:  
Value Percent:  
Continuous Index: **F02**  
Within Eight" of Joint: **False**  
Remarks:
