R-022A

SAWYER ST
New Bedford

Inspection Status: Remote Inspection
Inspection Level: Level 2

Project: | New Bedford 3D Regulator Inspections

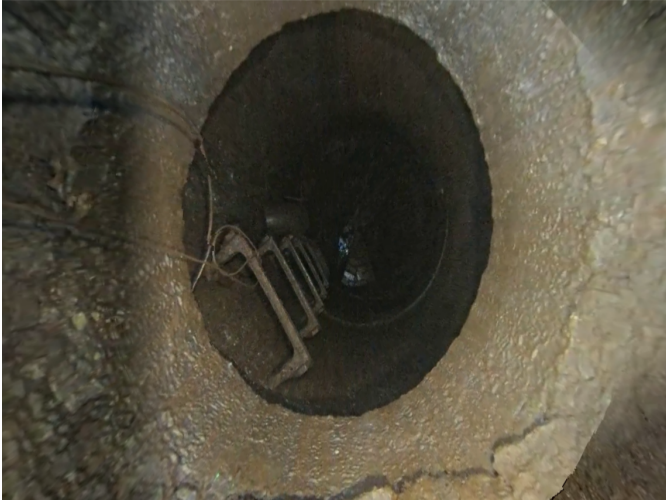
Code: **MGO**
Description: **Miscellaneous General Observation**

Distance: **0ft**
Structural Grade: **0**
O&M Grade: **0**
Clock Start/From:
Clock To:
1st Value:
2nd Value:
Value Percent:
Continuous Index:
Within Eight" of Joint: **False**
Remarks: **Start inspection**

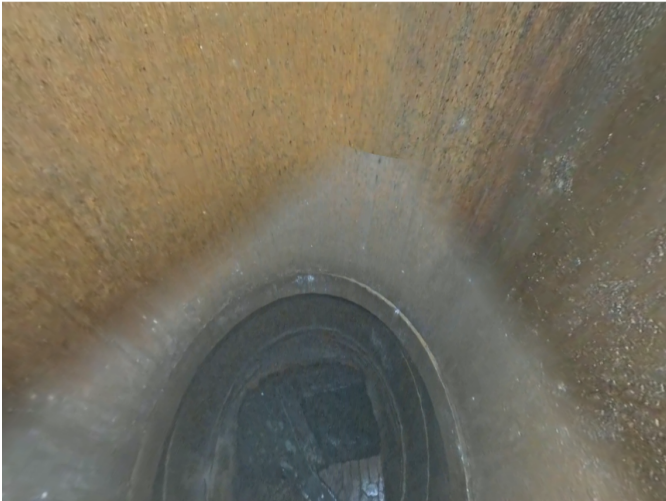
Code: **IS**
Description: **Infiltration Stain**

Distance: **2ft**
Structural Grade: **0**
O&M Grade: **1**
Clock Start/From: **12**
Clock To: **12**
1st Value:
2nd Value:
Value Percent:
Continuous Index: **S02**
Within Eight" of Joint: **False**
Remarks:

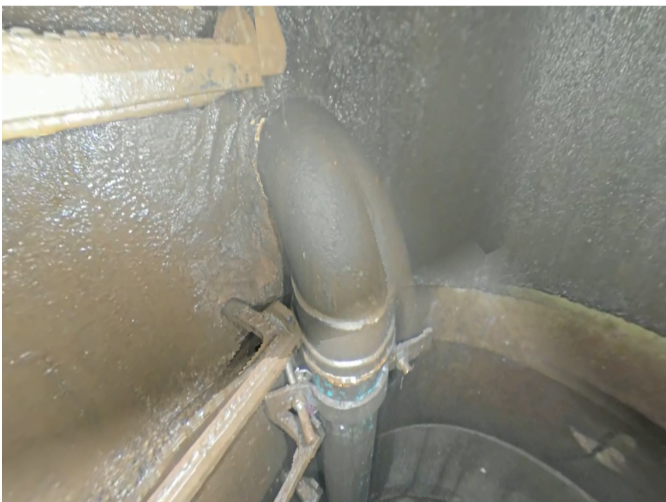
Code: **OBS**
Description: **Obstruction Built Into Structure**

Distance: **4ft**
Structural Grade: **0**
O&M Grade: **0**
Clock Start/From: **6**
Clock To:
1st Value:
2nd Value:
Value Percent: **25**
Continuous Index: **S01**
Within Eight" of Joint: **False**
Remarks: **Tap break in**

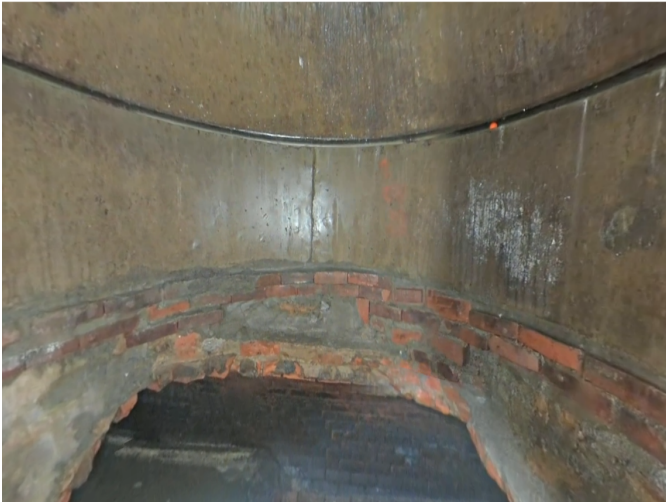
Code: **CL**
 Description: **Crack Longitudinal**

Distance: **9ft**
 Structural Grade: **2**
 O&M Grade: **0**
 Clock Start/From: **12**
 Clock To:
 1st Value:
 2nd Value:
 Value Percent:
 Continuous Index:
 Within Eight" of Joint: **False**
 Remarks:

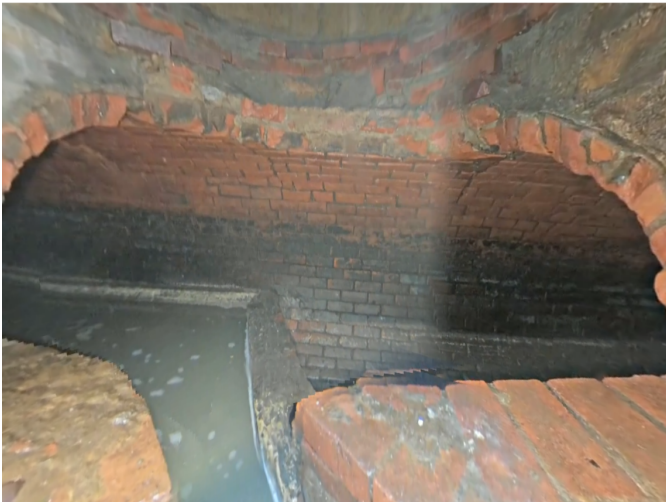
Code: **MGO**
 Description: **Miscellaneous General Observation**

Distance: **12ft**
 Structural Grade: **0**
 O&M Grade: **0**
 Clock Start/From:
 Clock To:
 1st Value:
 2nd Value:
 Value Percent:
 Continuous Index:
 Within Eight" of Joint: **False**
 Remarks: **End inspection**

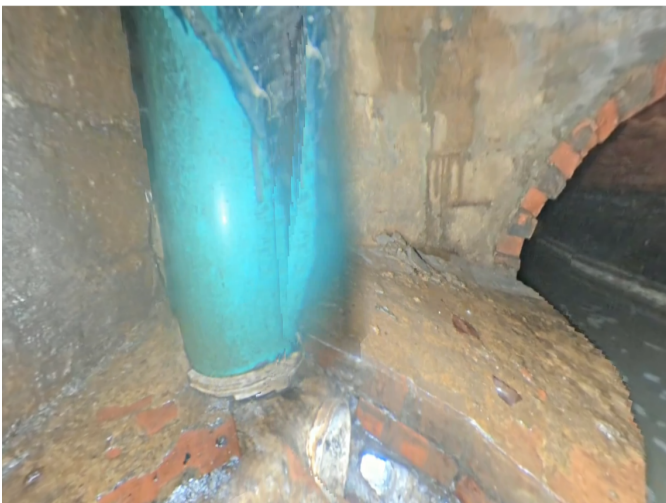
Code: **OBS**
 Description: **Obstruction Built Into Structure**

Distance: **12ft**
 Structural Grade: **0**
 O&M Grade: **0**
 Clock Start/From: **6**
 Clock To:
 1st Value:
 2nd Value:
 Value Percent: **25**
 Continuous Index: **F01**
 Within Eight" of Joint: **False**
 Remarks:

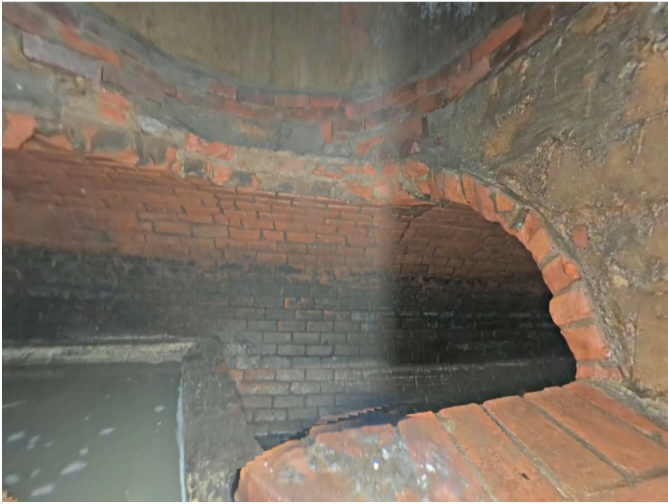
Code: **IS**
Description: **Infiltration Stain**

Distance: **12ft**
Structural Grade: **0**
O&M Grade: **1**
Clock Start/From: **12**
Clock To: **12**
1st Value:
2nd Value:
Value Percent:
Continuous Index: **F02**
Within Eight" of Joint: **False**
Remarks:
