R-022C

BELLEVILLE AVE
New Bedford

Inspection Status: Remote Inspection
Inspection Level: Level 2

Project: | New Bedford 3D Regulator Inspections

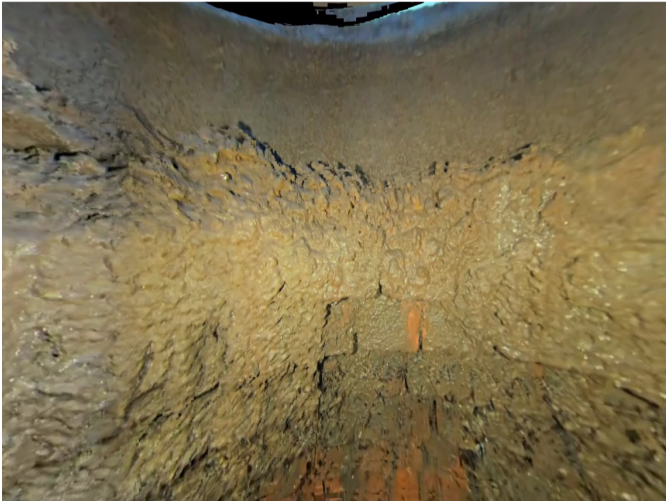
Code: **SRI**
Description: **Surface Damage Roughness Increased**

Distance: **0ft**
Structural Grade: **1**
O&M Grade: **0**
Clock Start/From: **12**
Clock To: **12**
1st Value:
2nd Value:
Value Percent:
Continuous Index:
Within Eight" of Joint: **True**
Remarks:

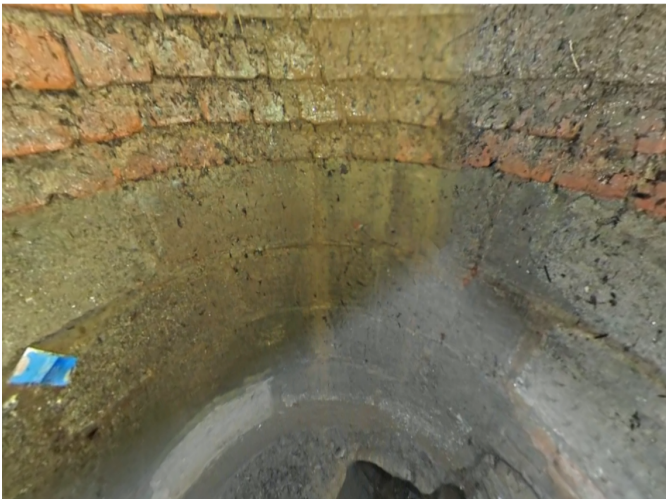
Code: **IS**
Description: **Infiltration Stain**

Distance: **2ft**
Structural Grade: **0**
O&M Grade: **1**
Clock Start/From: **12**
Clock To: **12**
1st Value:
2nd Value:
Value Percent:
Continuous Index: **S01**
Within Eight" of Joint: **False**
Remarks:

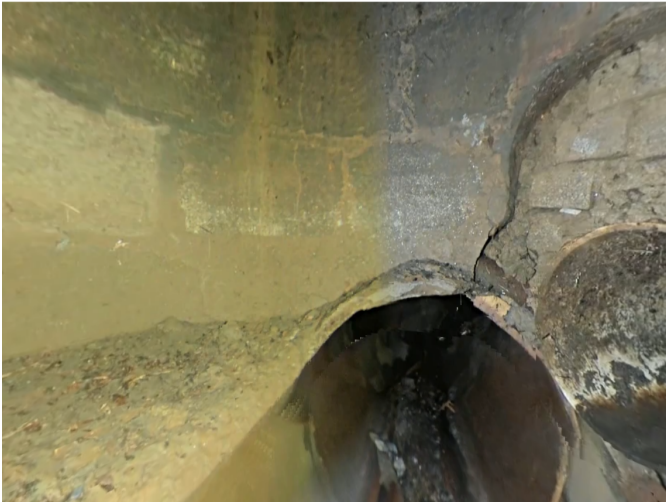
Code: **IS**
Description: **Infiltration Stain**

Distance: **5ft**
Structural Grade: **0**
O&M Grade: **1**
Clock Start/From: **12**
Clock To: **12**
1st Value:
2nd Value:
Value Percent:
Continuous Index: **F01**
Within Eight" of Joint: **False**
Remarks:
