R-022D

PURCHASE ST
New Bedford

Project: | New Bedford 3D Regulator Inspections

Condition Report

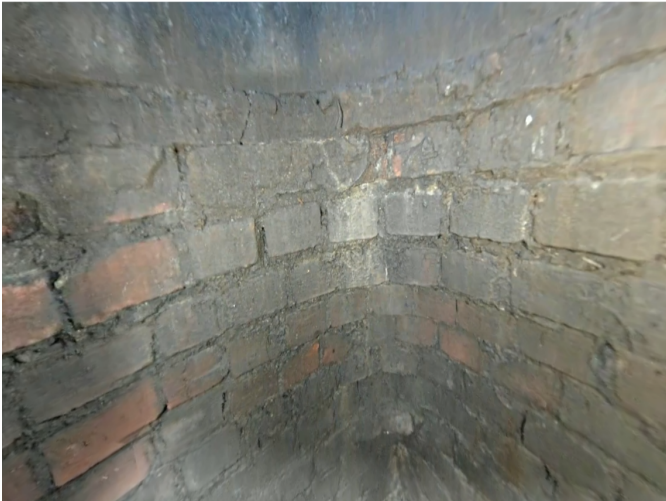
Code: **SRI**
Description: **Surface Damage Roughness Increased**

Distance: **1ft**
Structural Grade: **1**
O&M Grade: **0**
Clock Start/From: **12**
Clock To: **12**
1st Value:
2nd Value:
Value Percent:
Continuous Index: **S01**
Within Eight" of Joint: **False**
Remarks:

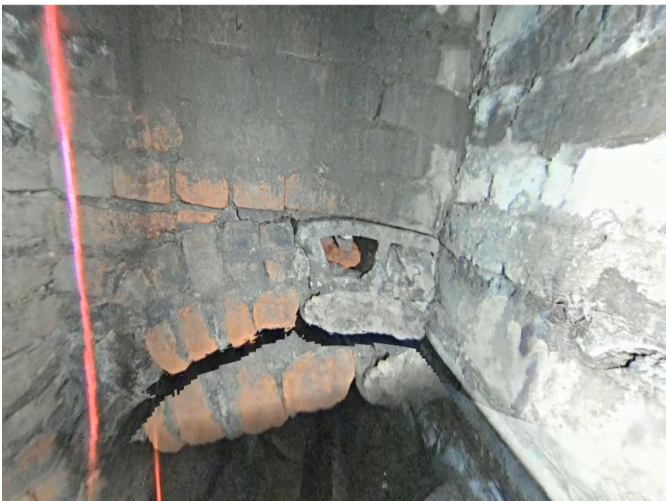
Code: **MB**
Description: **Missing Brick**

Distance: **4ft**
Structural Grade: **4**
O&M Grade: **0**
Clock Start/From: **12**
Clock To:
1st Value:
2nd Value:
Value Percent:
Continuous Index:
Within Eight" of Joint: **False**
Remarks:

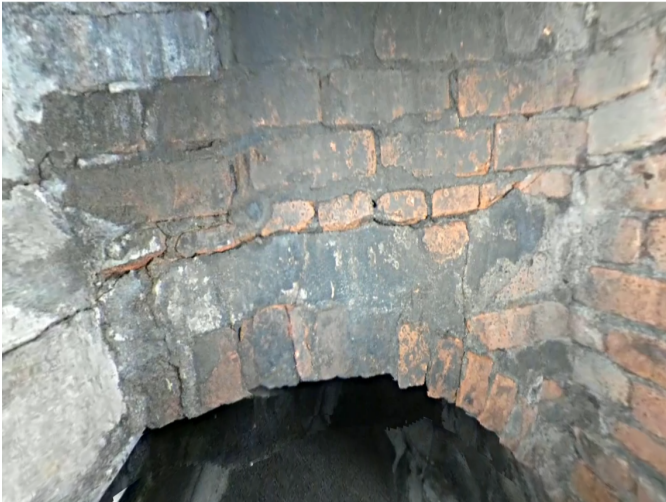
Code: **MMS**
Description: **Missing Mortar Small**

Distance: **4ft**
Structural Grade: **2**
O&M Grade: **0**
Clock Start/From: **6**
Clock To:
1st Value:
2nd Value:
Value Percent:
Continuous Index:
Within Eight" of Joint: **False**
Remarks:

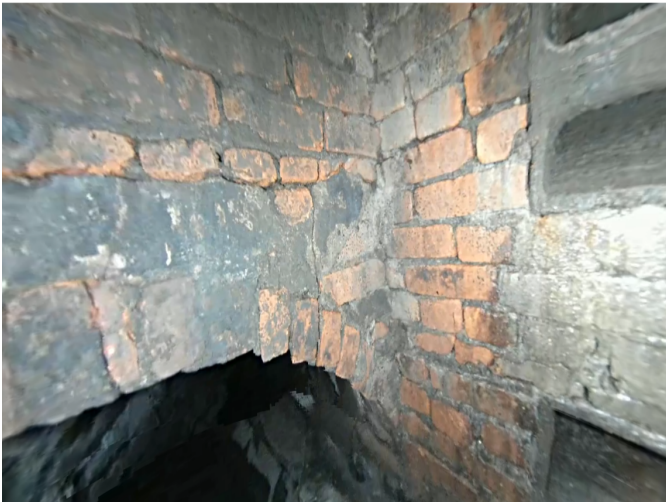
Code: **SRI**
Description: **Surface Damage
Roughness Increased**

Distance: **4ft**
Structural Grade: **1**
O&M Grade: **0**
Clock Start/From: **12**
Clock To: **12**
1st Value:
2nd Value:
Value Percent:
Continuous Index: **F01**
Within Eight" of Joint: **False**
Remarks:
