R-022E

COUNTY ST
New Bedford

Inspection Status: Remote Inspection
Inspection Level: Level 2

Project: | New Bedford 3D Regulator Inspections

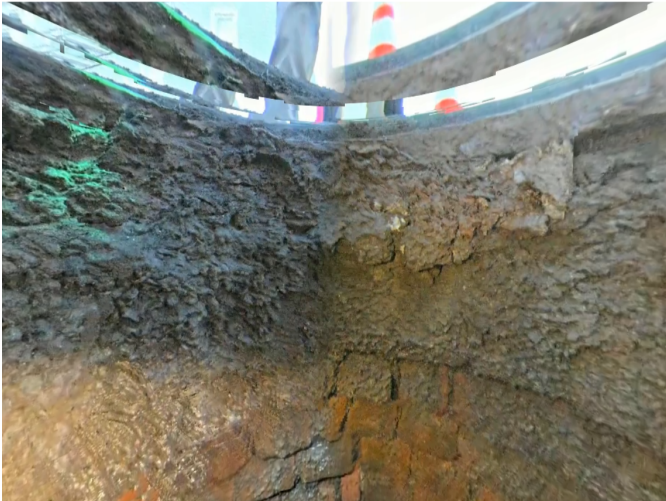
Code: **SRI**
Description: **Surface Damage Roughness Increased**

Distance: **0ft**
Structural Grade: **1**
O&M Grade: **0**
Clock Start/From: **12**
Clock To: **12**
1st Value:
2nd Value:
Value Percent:
Continuous Index: **S01**
Within Eight" of Joint: **False**
Remarks:

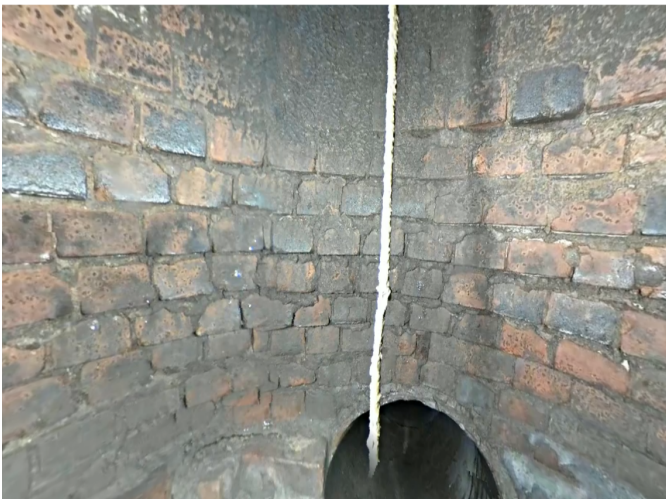
Code: **SRI**
Description: **Surface Damage Roughness Increased**

Distance: **4ft**
Structural Grade: **1**
O&M Grade: **0**
Clock Start/From: **12**
Clock To: **12**
1st Value:
2nd Value:
Value Percent:
Continuous Index: **F01**
Within Eight" of Joint: **False**
Remarks:
