# R-022F

PURCHASE ST  
New Bedford

**Project:** | New Bedford 3D Regulator Inspections

# Condition Report

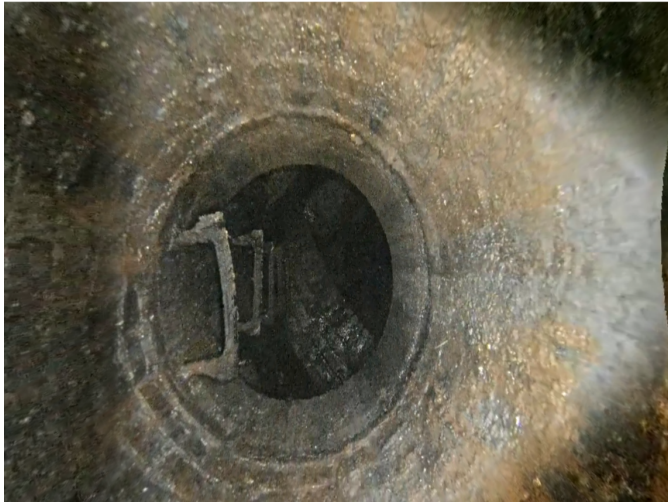
Code: **MGO**  
Description: **Miscellaneous General Observation**

Distance: **0ft**  
Structural Grade: **0**  
O&M Grade: **0**  
Clock Start/From:  
Clock To:  
1st Value:  
2nd Value:  
Value Percent:  
Continuous Index:  
Within Eight" of Joint: **False**  
Remarks: **Start inspection**

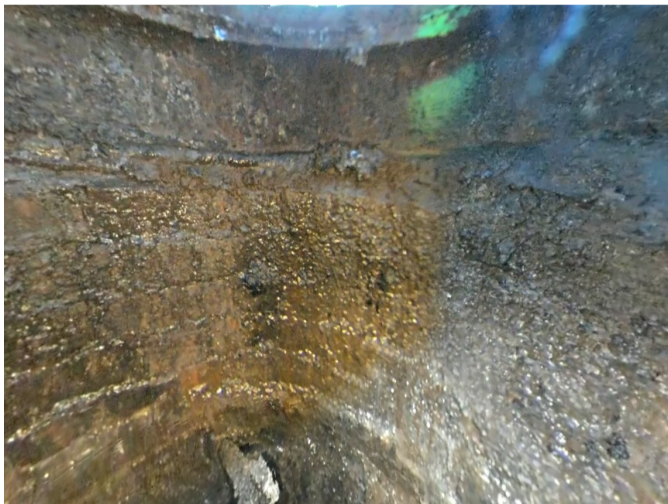
Code: **SRI**  
Description: **Surface Damage Roughness Increased**

Distance: **0ft**  
Structural Grade: **1**  
O&M Grade: **0**  
Clock Start/From: **12**  
Clock To: **12**  
1st Value:  
2nd Value:  
Value Percent:  
Continuous Index: **S01**  
Within Eight" of Joint: **False**  
Remarks:

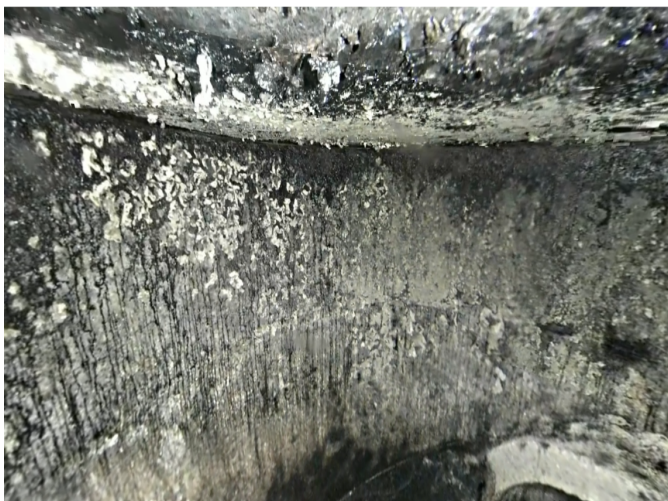
Code: **IS**  
Description: **Infiltration Stain**

Distance: **3ft**  
Structural Grade: **0**  
O&M Grade: **1**  
Clock Start/From: **12**  
Clock To: **12**  
1st Value:  
2nd Value:  
Value Percent:  
Continuous Index: **S02**  
Within Eight" of Joint: **False**  
Remarks:

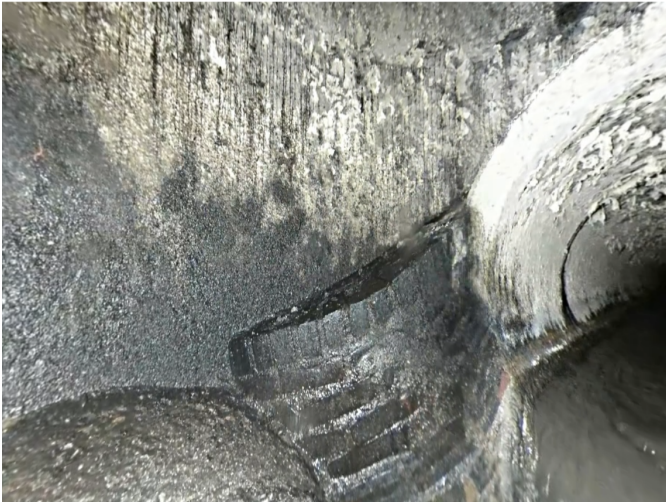
Code: **IS**  
Description: **Infiltration Stain**

Distance: **7ft**  
Structural Grade: **0**  
O&M Grade: **1**  
Clock Start/From: **12**  
Clock To: **12**  
1st Value:  
2nd Value:  
Value Percent:  
Continuous Index: **F02**  
Within Eight" of Joint: **False**  
Remarks:

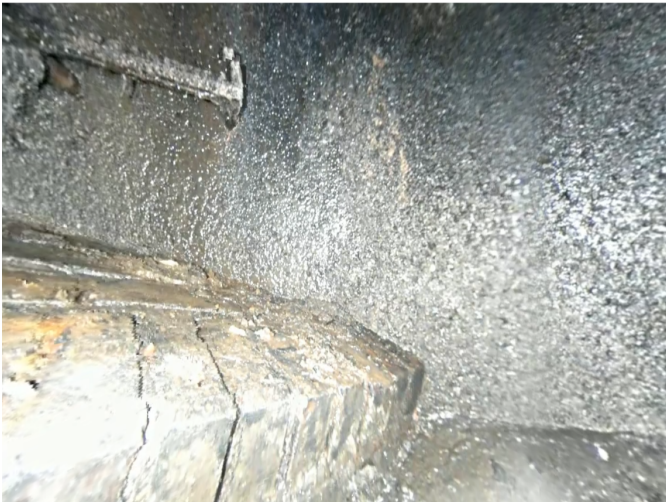
Code: **SRI**  
Description: **Surface Damage  
Roughness Increased**

Distance: **7ft**  
Structural Grade: **1**  
O&M Grade: **0**  
Clock Start/From: **12**  
Clock To: **12**  
1st Value:  
2nd Value:  
Value Percent:  
Continuous Index: **F01**  
Within Eight" of Joint: **False**  
Remarks:

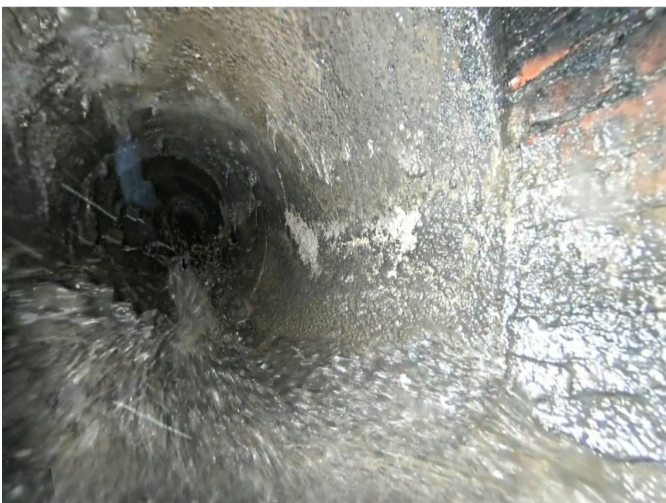
Code: **MGO**  
Description: **Miscellaneous General  
Observation**

Distance: **10ft**  
Structural Grade: **0**  
O&M Grade: **0**  
Clock Start/From:  
Clock To:  
1st Value:  
2nd Value:  
Value Percent:  
Continuous Index:  
Within Eight" of Joint: **False**  
Remarks: **End inspection**
