R-022G

HOLLY ST
New Bedford

Inspection Status: Remote Inspection
Inspection Level: Level 2

Project: | New Bedford 3D Regulator Inspections

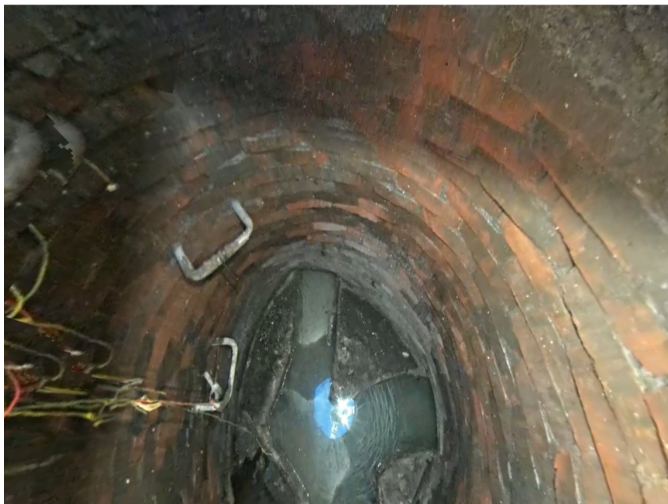
Code: **IS**
Description: **Infiltration Stain**

Distance: **0ft**
Structural Grade: **0**
O&M Grade: **1**
Clock Start/From: **12**
Clock To: **12**
1st Value:
2nd Value:
Value Percent:
Continuous Index: **S01**
Within Eight" of Joint: **False**
Remarks:

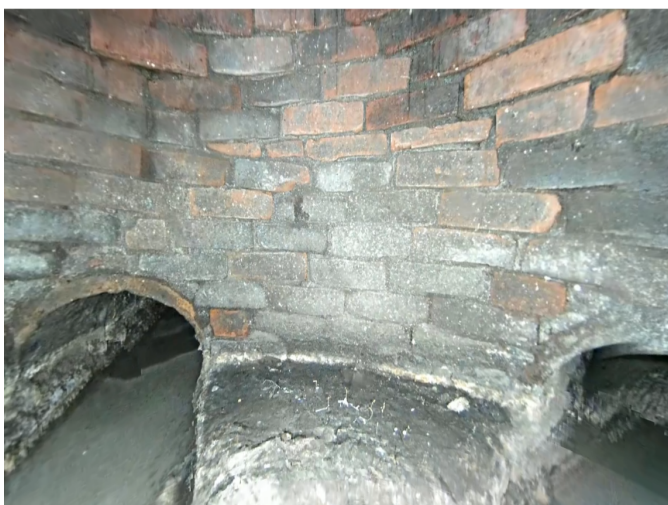
Code: **IS**
Description: **Infiltration Stain**

Distance: **5ft**
Structural Grade: **0**
O&M Grade: **1**
Clock Start/From: **12**
Clock To: **12**
1st Value:
2nd Value:
Value Percent:
Continuous Index: **F01**
Within Eight" of Joint: **False**
Remarks:
