R-023A

COFFIN AVE
New Bedford

Project: | New Bedford 3D Regulator Inspections

Condition Report

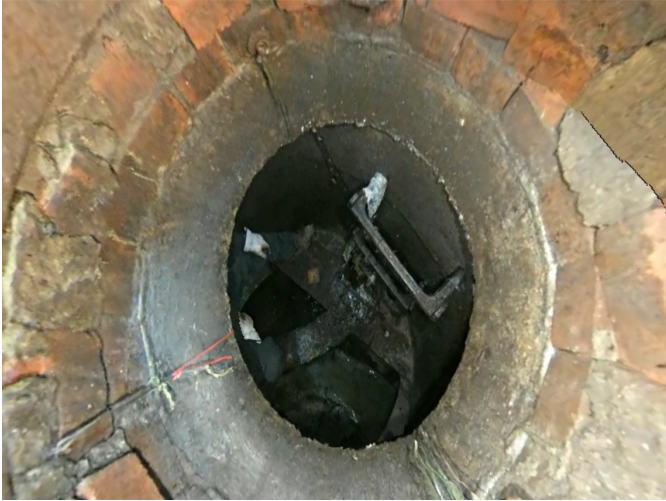
Code: **MGO**
Description: **Miscellaneous General Observation**

Distance: **0ft**
Structural Grade: **0**
O&M Grade: **0**
Clock Start/From:
Clock To:
1st Value:
2nd Value:
Value Percent:
Continuous Index:
Within Eight" of Joint: **False**
Remarks: **Start inspection**

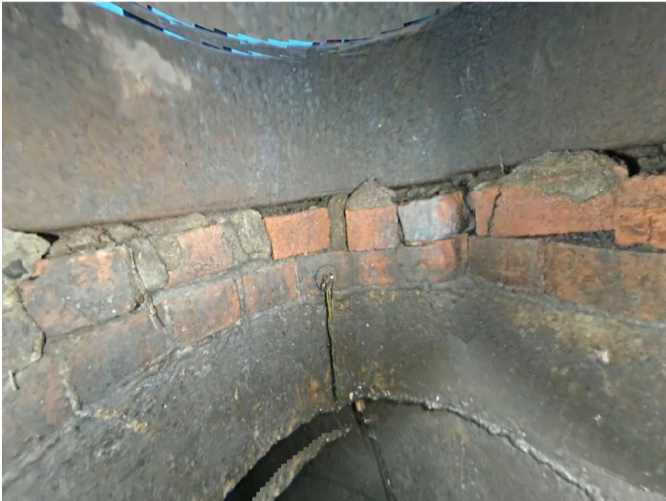
Code: **MMS**
Description: **Missing Mortar Small**

Distance: **0ft**
Structural Grade: **2**
O&M Grade: **0**
Clock Start/From: **10**
Clock To: **2**
1st Value:
2nd Value:
Value Percent:
Continuous Index:
Within Eight" of Joint: **False**
Remarks:

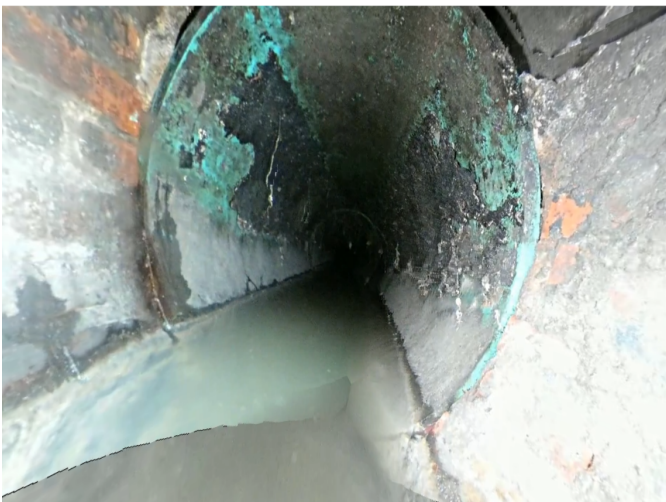
Code: **MGO**
Description: **Miscellaneous General Observation**

Distance: **7ft**
Structural Grade: **0**
O&M Grade: **0**
Clock Start/From:
Clock To:
1st Value:
2nd Value:
Value Percent:
Continuous Index:
Within Eight" of Joint: **False**
Remarks: **End inspection**
