R-024A

BELLEVILLE AVE
New Bedford

Project: | New Bedford 3D Regulator Inspections
Owner: New Bedford, MA
Customer: CDM Smith

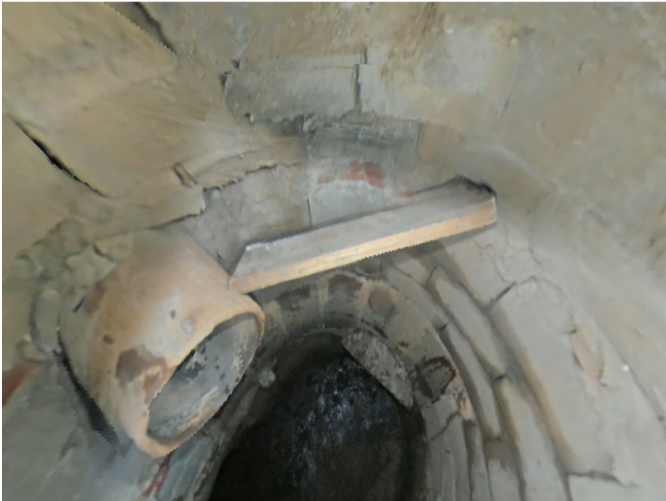
Code: **OBN**
Description: **Obstruction Construction Debris**

Distance: **1ft**
Structural Grade: **0**
O&M Grade: **0**
Clock Start/From: **12**
Clock To:
1st Value:
2nd Value:
Value Percent: **15**
Continuous Index:
Within Eight" of Joint: **False**
Remarks: **Board**

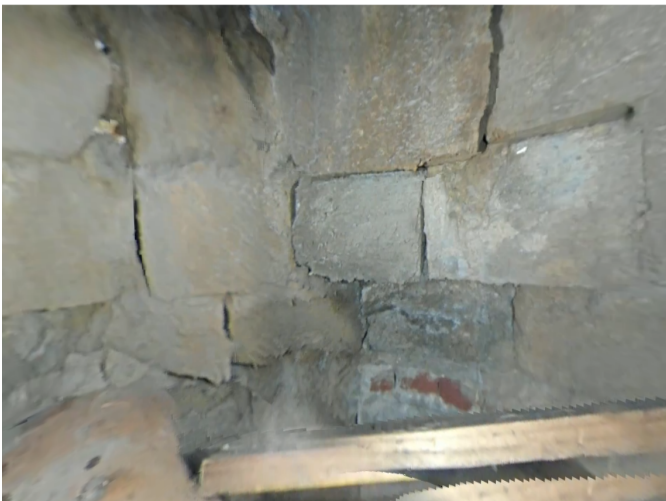
Code: **MMS**
Description: **Missing Mortar Small**

Distance: **1ft**
Structural Grade: **2**
O&M Grade: **0**
Clock Start/From: **12**
Clock To: **12**
1st Value:
2nd Value:
Value Percent:
Continuous Index:
Within Eight" of Joint: **False**
Remarks:

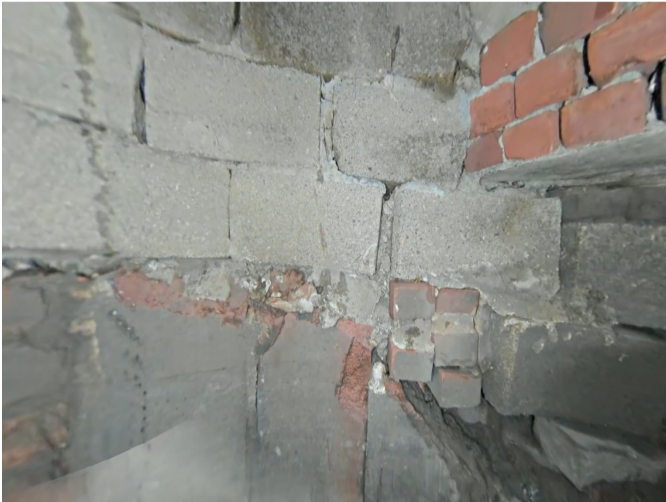
Code: **MMS**
Description: **Missing Mortar Small**

Distance: **6ft**
Structural Grade: **2**
O&M Grade: **0**
Clock Start/From: **12**
Clock To: **12**
1st Value:
2nd Value:
Value Percent:
Continuous Index:
Within Eight" of Joint: **False**
Remarks:
