R-026A

RIVER RD
New Bedford

Inspection Status: Remote Inspection
Inspection Level: Level 2

Project: | New Bedford 3D Regulator Inspections

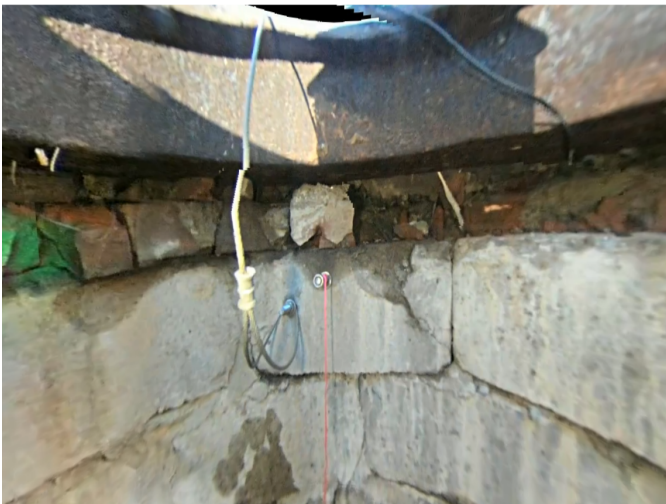
Code: **MB**
Description: **Missing Brick**

Distance: **0ft**
Structural Grade: **4**
O&M Grade: **0**
Clock Start/From: **3**
Clock To: **1**
1st Value:
2nd Value:
Value Percent:
Continuous Index:
Within Eight" of Joint: **False**
Remarks:

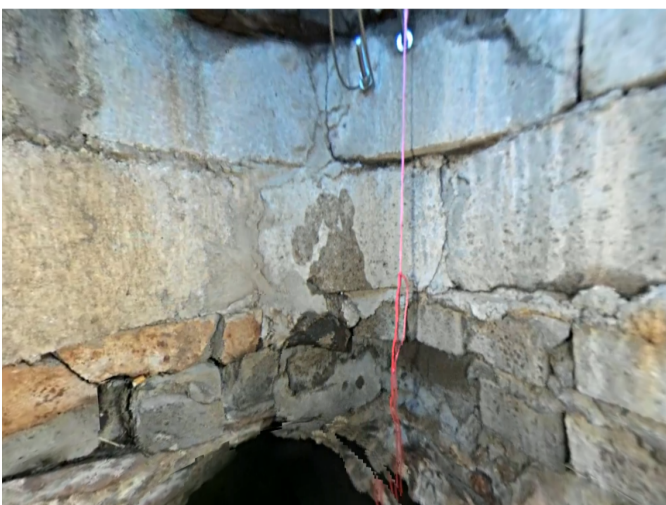
Code: **MMS**
Description: **Missing Mortar Small**

Distance: **1ft**
Structural Grade: **2**
O&M Grade: **0**
Clock Start/From: **12**
Clock To: **12**
1st Value:
2nd Value:
Value Percent:
Continuous Index:
Within Eight" of Joint: **False**
Remarks:

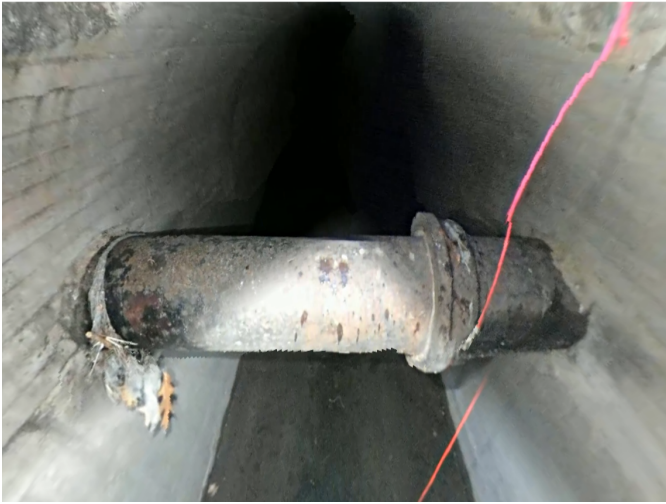
Code: **OBS**
Description: **Obstruction Built Into Structure**

Distance: **3ft**
Structural Grade: **0**
O&M Grade: **0**
Clock Start/From: **6**
Clock To:
1st Value:
2nd Value:
Value Percent: **30**
Continuous Index:
Within Eight" of Joint: **False**
Remarks: **Pipe through wall**
