R-027A

RIVER RD
New Bedford

Inspection Status: Remote Inspection
Inspection Level: Level 2

Project: | New Bedford 3D Regulator Inspections

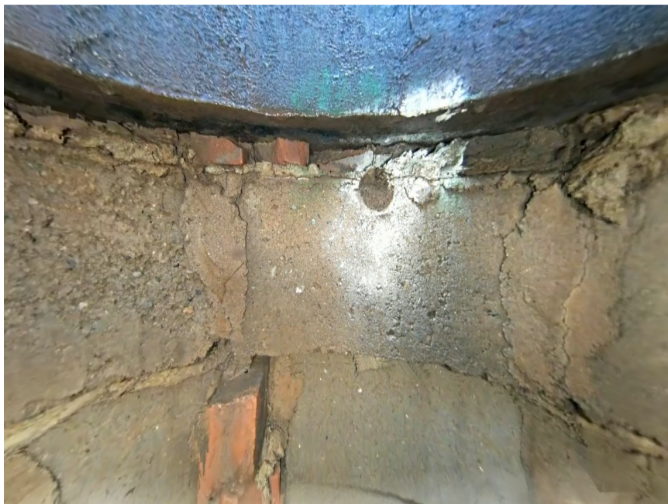
Code: **CM**
Description: **Crack Multiple**

Distance: **1ft**
Structural Grade: **3**
O&M Grade: **0**
Clock Start/From: **12**
Clock To: **12**
1st Value:
2nd Value:
Value Percent:
Continuous Index:
Within Eight" of Joint: **False**
Remarks:

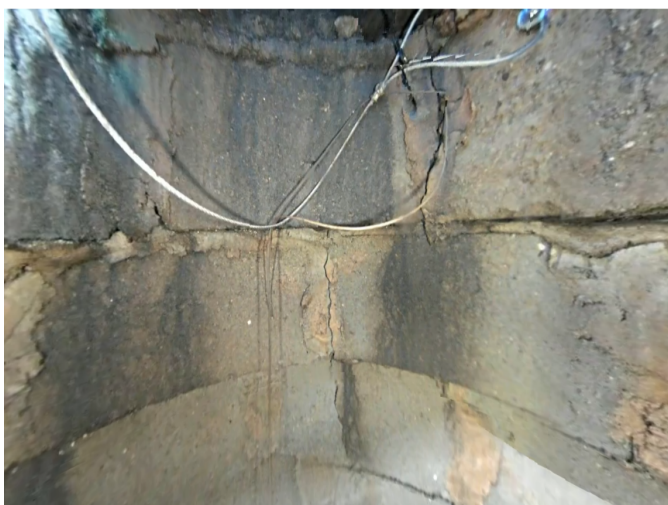
Code: **CL**
Description: **Crack Longitudinal**

Distance: **1ft**
Structural Grade: **2**
O&M Grade: **0**
Clock Start/From: **3**
Clock To:
1st Value:
2nd Value:
Value Percent:
Continuous Index: **S01**
Within Eight" of Joint: **False**
Remarks:

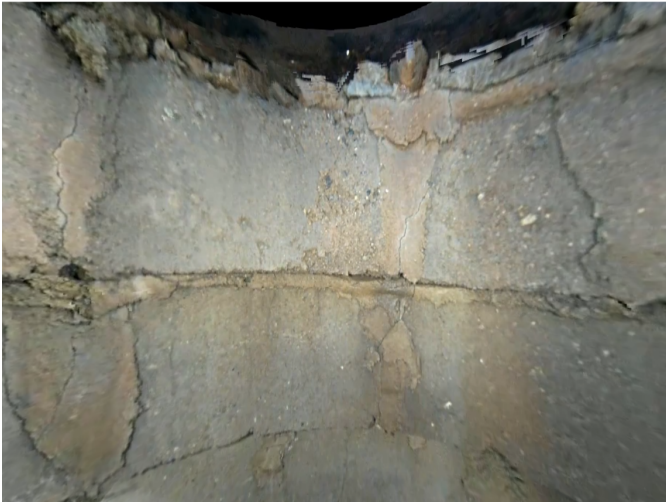
Code: **CL**
Description: **Crack Longitudinal**

Distance: **1ft**
Structural Grade: **2**
O&M Grade: **0**
Clock Start/From: **10**
Clock To:
1st Value:
2nd Value:
Value Percent:
Continuous Index: **S02**
Within Eight" of Joint: **False**
Remarks:

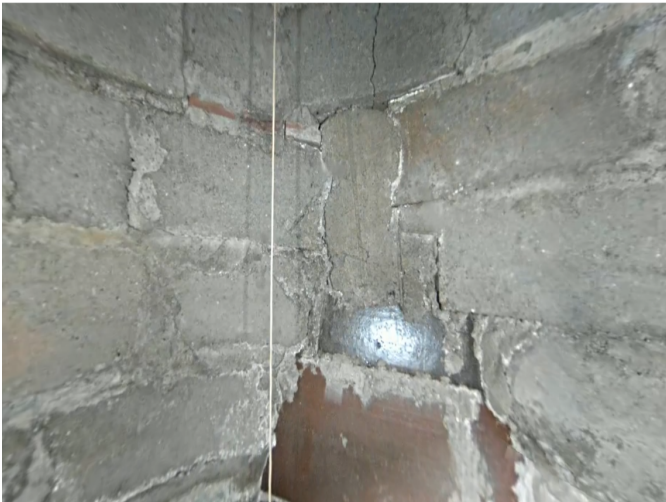
Code: **CL**
Description: **Crack Longitudinal**

Distance: **5ft**
Structural Grade: **2**
O&M Grade: **0**
Clock Start/From: **3**
Clock To:
1st Value:
2nd Value:
Value Percent:
Continuous Index: **F01**
Within Eight" of Joint: **False**
Remarks:

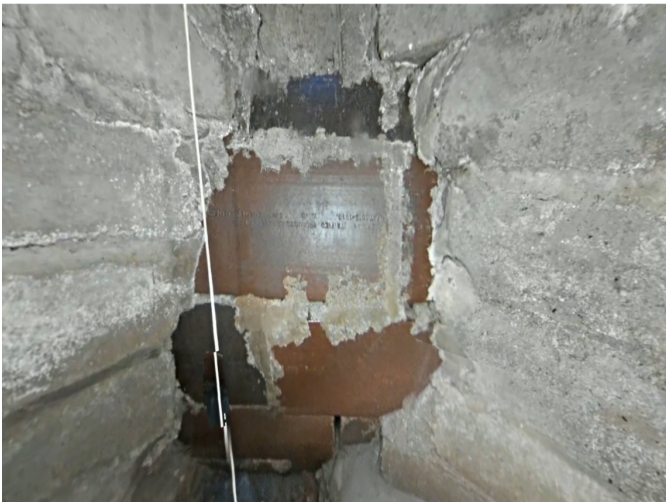
Code: **RPP**
Description: **Point Repair Patch**

Distance: **6ft**
Structural Grade: **0**
O&M Grade: **0**
Clock Start/From: **3**
Clock To:
1st Value:
2nd Value:
Value Percent:
Continuous Index:
Within Eight" of Joint: **False**
Remarks: **Blocks patching wall**

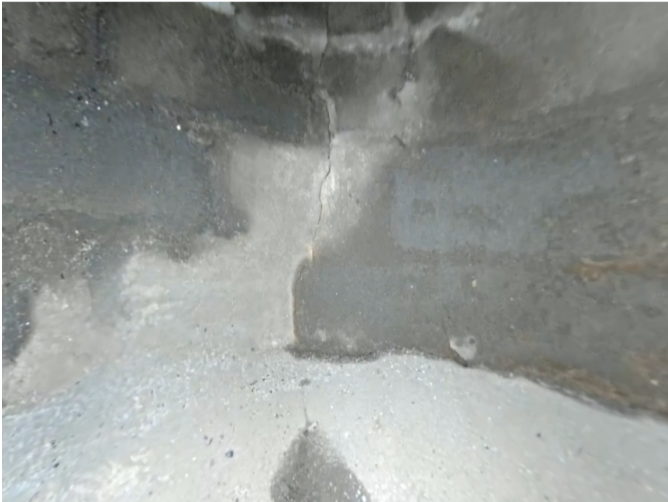
Code: **CL**
Description: **Crack Longitudinal**

Distance: **7ft**
Structural Grade: **2**
O&M Grade: **0**
Clock Start/From: **10**
Clock To:
1st Value:
2nd Value:
Value Percent:
Continuous Index: **F02**
Within Eight" of Joint: **False**
Remarks:
