R-027B

OHIO ST
New Bedford

Inspection Status: Remote Inspection
Inspection Level: Level 2

Project: | New Bedford 3D Regulator Inspections

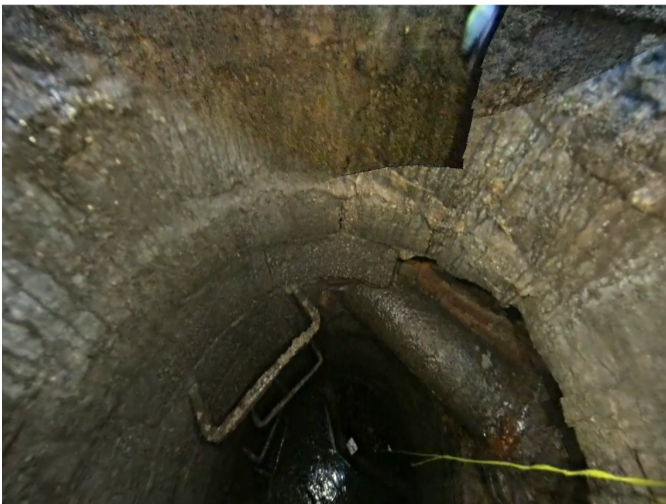
Code: **IS**
Description: **Infiltration Stain**

Distance: **0ft**
Structural Grade: **0**
O&M Grade: **1**
Clock Start/From: **12**
Clock To: **12**
1st Value:
2nd Value:
Value Percent:
Continuous Index: **S01**
Within Eight" of Joint: **False**
Remarks:

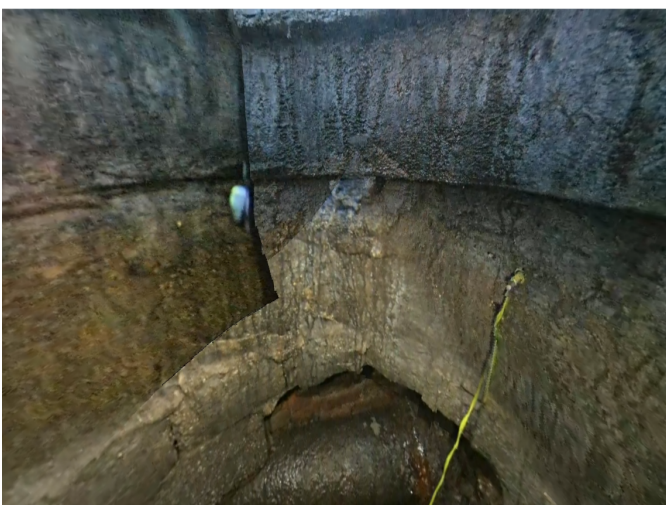
Code: **SRI**
Description: **Surface Damage Roughness Increased**

Distance: **0ft**
Structural Grade: **1**
O&M Grade: **0**
Clock Start/From: **12**
Clock To: **12**
1st Value:
2nd Value:
Value Percent:
Continuous Index: **S02**
Within Eight" of Joint: **False**
Remarks:

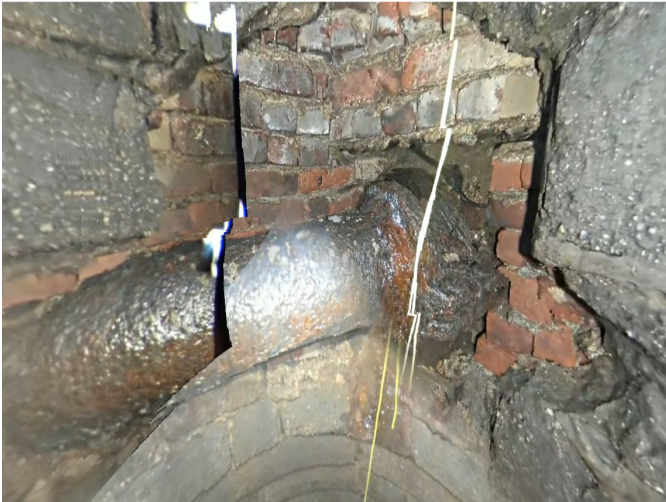
Code: **OBS**
 Description: **Obstruction Built Into Structure**

Distance: **2ft**
 Structural Grade: **0**
 O&M Grade: **0**
 Clock Start/From: **9**
 Clock To:
 1st Value:
 2nd Value:
 Value Percent: **25**
 Continuous Index:
 Within Eight" of Joint: **False**
 Remarks: **Pipe through wall**

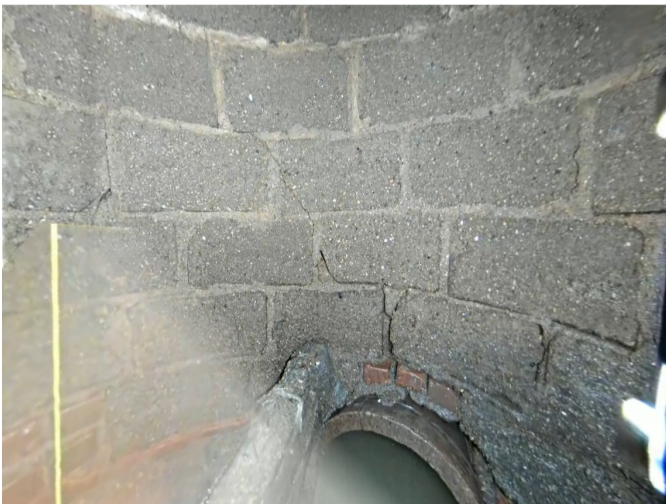
Code: **CM**
 Description: **Crack Multiple**

Distance: **8ft**
 Structural Grade: **3**
 O&M Grade: **0**
 Clock Start/From: **12**
 Clock To: **12**
 1st Value:
 2nd Value:
 Value Percent:
 Continuous Index:
 Within Eight" of Joint: **False**
 Remarks:

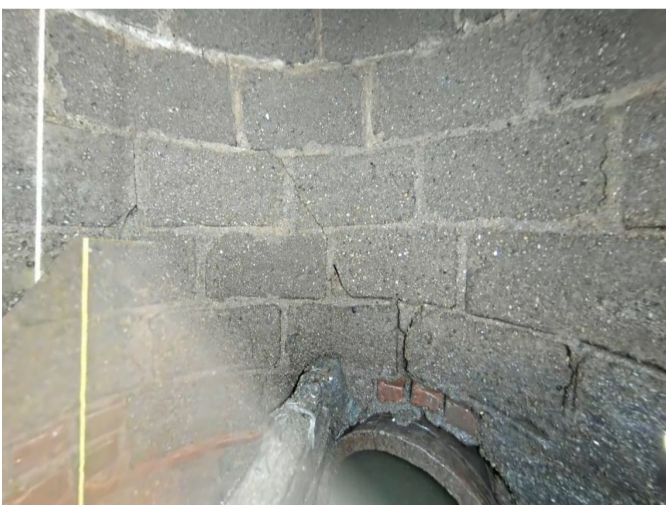
Code: **SRI**
 Description: **Surface Damage
Roughness Increased**

Distance: **8ft**
 Structural Grade: **1**
 O&M Grade: **0**
 Clock Start/From: **12**
 Clock To: **12**
 1st Value:
 2nd Value:
 Value Percent:
 Continuous Index: **F02**
 Within Eight" of Joint: **False**
 Remarks:

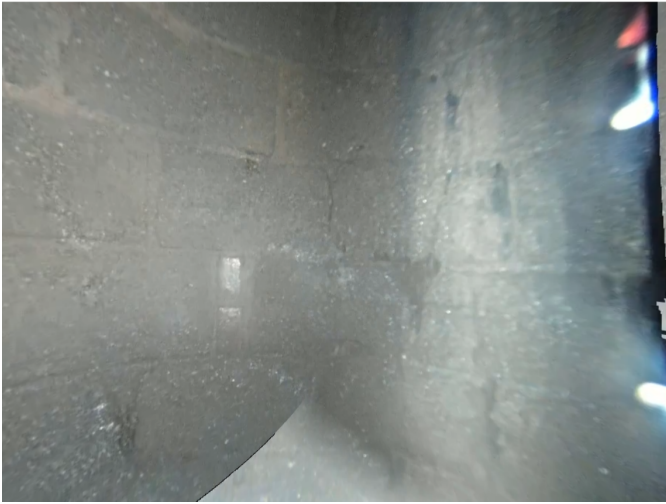
Code: **IS**
Description: **Infiltration Stain**

Distance: **8ft**
Structural Grade: **0**
O&M Grade: **1**
Clock Start/From: **12**
Clock To: **12**
1st Value:
2nd Value:
Value Percent:
Continuous Index: **F01**
Within Eight" of Joint: **False**
Remarks:
