# R-027D

MAZZEPA ST  
New Bedford

Inspection Status: Remote Inspection  
Inspection Level: Level 2

**Project:** | New Bedford 3D Regulator Inspections

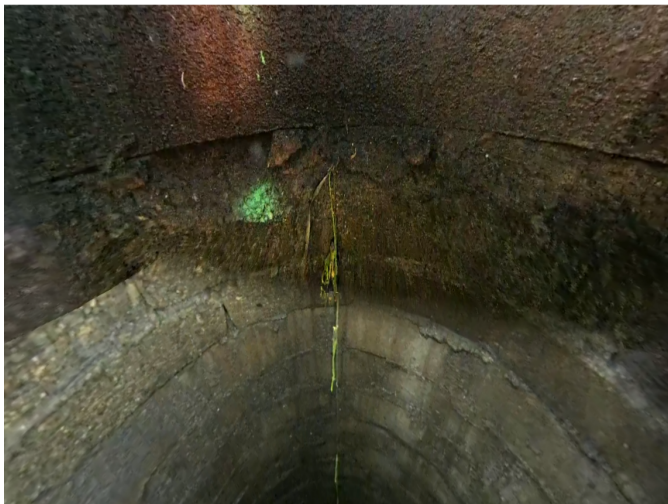
Code: **SRI**  
Description: **Surface Damage Roughness Increased**

Distance: **0ft**  
Structural Grade: **1**  
O&M Grade: **0**  
Clock Start/From: **12**  
Clock To: **12**  
1st Value:  
2nd Value:  
Value Percent:  
Continuous Index: **S01**  
Within Eight" of Joint: **False**  
Remarks:

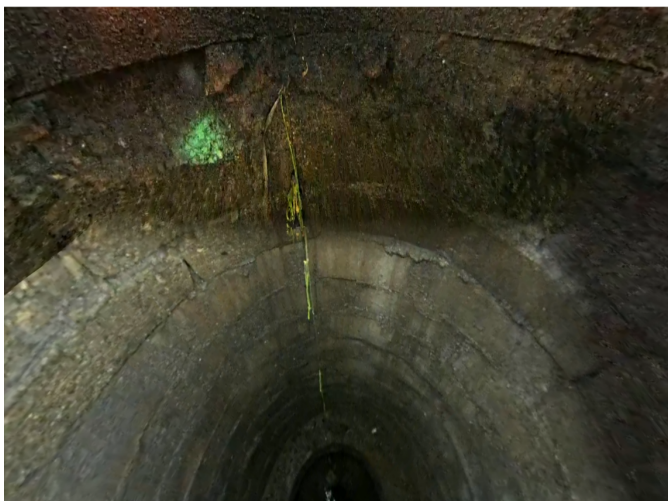
Code: **IS**  
Description: **Infiltration Stain**

Distance: **0ft**  
Structural Grade: **0**  
O&M Grade: **1**  
Clock Start/From: **12**  
Clock To: **12**  
1st Value:  
2nd Value:  
Value Percent:  
Continuous Index: **S02**  
Within Eight" of Joint: **False**  
Remarks:

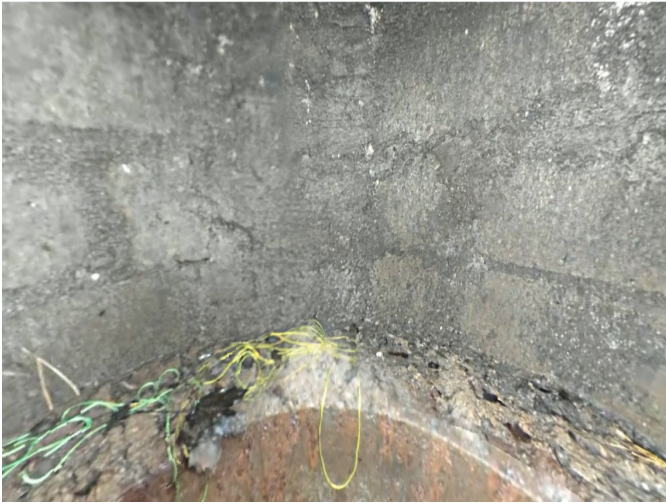
Code: **SRI**  
Description: **Surface Damage  
Roughness Increased**

Distance: **5ft**  
Structural Grade: **1**  
O&M Grade: **0**  
Clock Start/From: **12**  
Clock To: **12**  
1st Value:  
2nd Value:  
Value Percent:  
Continuous Index: **F01**  
Within Eight" of Joint: **False**  
Remarks:

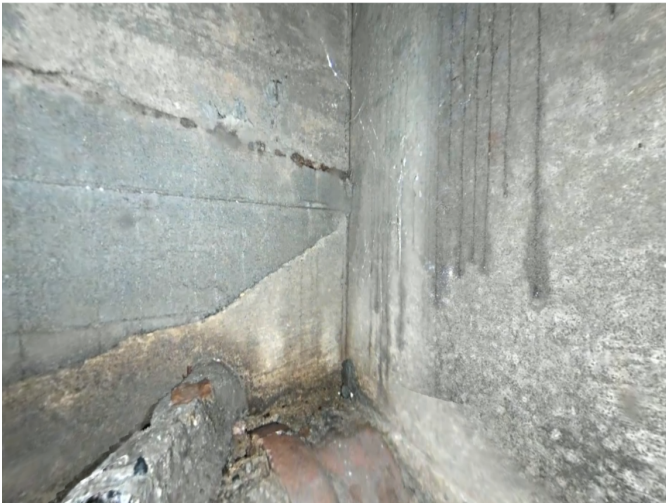
Code: **IS**  
Description: **Infiltration Stain**

Distance: **9ft**  
Structural Grade: **0**  
O&M Grade: **1**  
Clock Start/From: **12**  
Clock To: **12**  
1st Value:  
2nd Value:  
Value Percent:  
Continuous Index: **F02**  
Within Eight" of Joint: **False**  
Remarks:

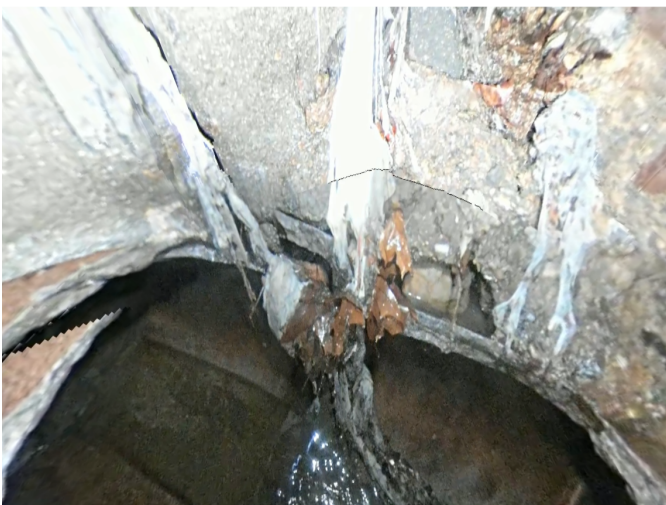
Code: **DAR**  
Description: **Deposits Attached  
Ragging**

Distance: **10ft**  
Structural Grade: **0**  
O&M Grade: **2**  
Clock Start/From: **12**  
Clock To:  
1st Value:  
2nd Value:  
Value Percent: **20**  
Continuous Index:  
Within Eight" of Joint: **False**  
Remarks:
