R-027E

BELLEVILLE AVE
New Bedford

Inspection Status: Remote Inspection
Inspection Level: Level 2

Project: | New Bedford 3D Regulator Inspections

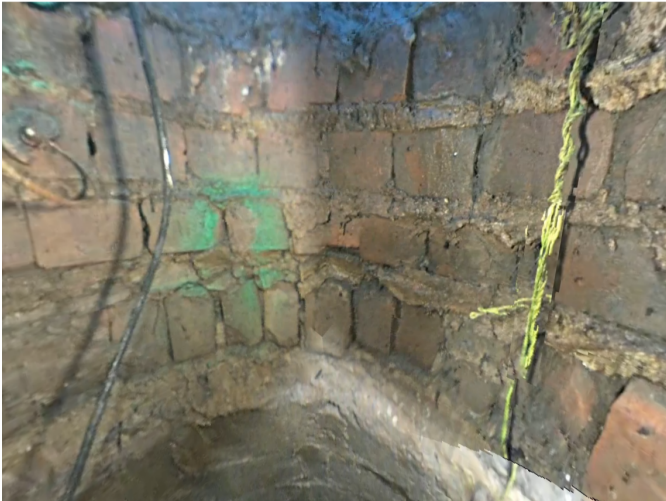
Code: **MMS**
Description: **Missing Mortar Small**

Distance: **1ft**
Structural Grade: **2**
O&M Grade: **0**
Clock Start/From: **6**
Clock To: **3**
1st Value:
2nd Value:
Value Percent:
Continuous Index:
Within Eight" of Joint: **False**
Remarks:

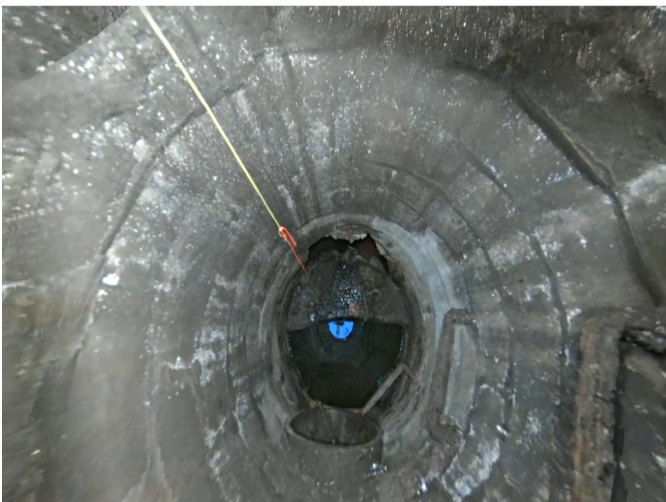
Code: **IS**
Description: **Infiltration Stain**

Distance: **2ft**
Structural Grade: **0**
O&M Grade: **1**
Clock Start/From: **12**
Clock To: **12**
1st Value:
2nd Value:
Value Percent:
Continuous Index: **S01**
Within Eight" of Joint: **False**
Remarks:

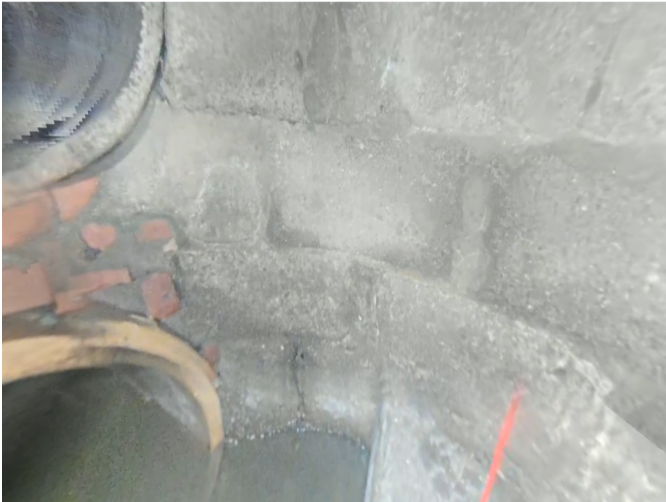
Code: **IS**
Description: **Infiltration Stain**

Distance: **7ft**
Structural Grade: **0**
O&M Grade: **1**
Clock Start/From: **12**
Clock To: **12**
1st Value:
2nd Value:
Value Percent:
Continuous Index: **F01**
Within Eight" of Joint: **False**
Remarks:
