R-027F

BELLEVILLE AVE
New Bedford

Inspection Status: Remote Inspection
Inspection Level: Level 2

Project: | New Bedford 3D Regulator Inspections

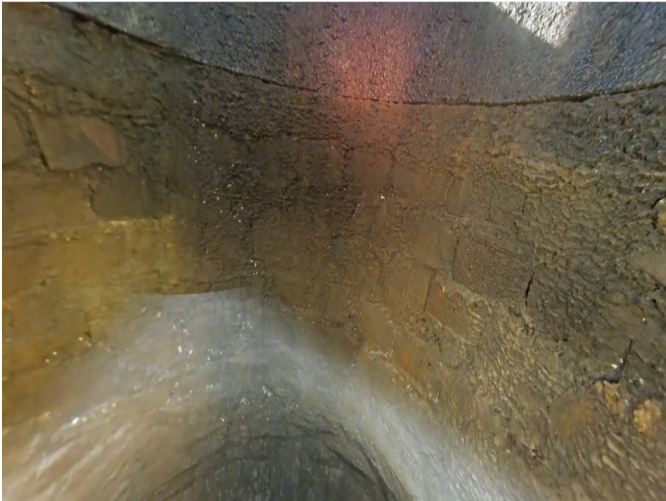
Code: **SRI**
Description: **Surface Damage Roughness Increased**

Distance: **0ft**
Structural Grade: **1**
O&M Grade: **0**
Clock Start/From: **12**
Clock To: **12**
1st Value:
2nd Value:
Value Percent:
Continuous Index: **S01**
Within Eight" of Joint: **False**
Remarks:

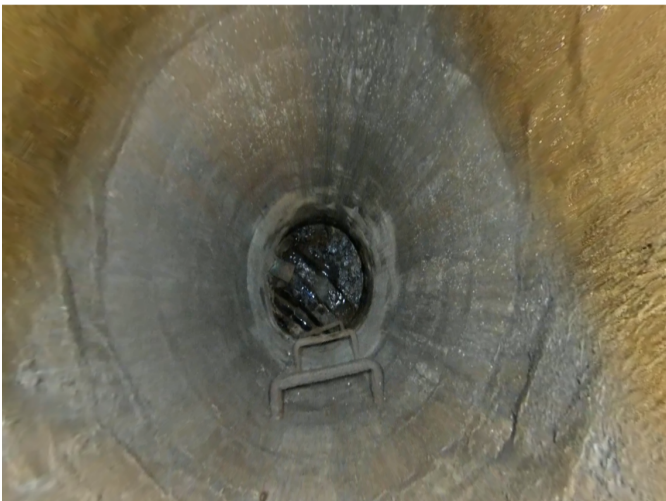
Code: **IS**
Description: **Infiltration Stain**

Distance: **1ft**
Structural Grade: **0**
O&M Grade: **1**
Clock Start/From: **12**
Clock To: **12**
1st Value:
2nd Value:
Value Percent:
Continuous Index: **S02**
Within Eight" of Joint: **False**
Remarks:

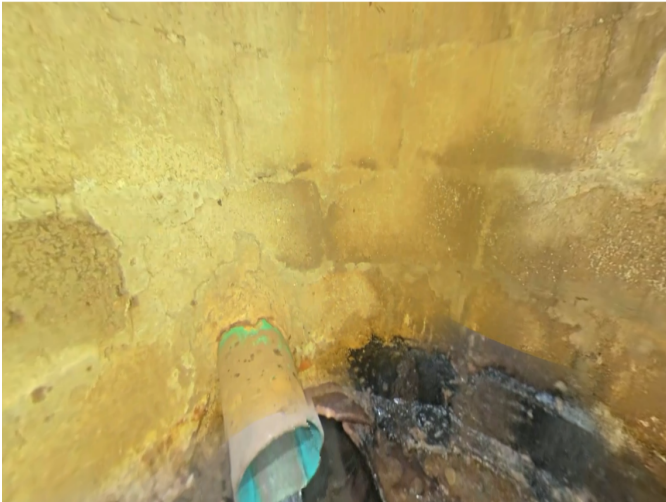
Code: **SRI**
Description: **Surface Damage
Roughness Increased**

Distance: **8ft**
Structural Grade: **1**
O&M Grade: **0**
Clock Start/From: **12**
Clock To: **12**
1st Value:
2nd Value:
Value Percent:
Continuous Index: **F01**
Within Eight" of Joint: **False**
Remarks:

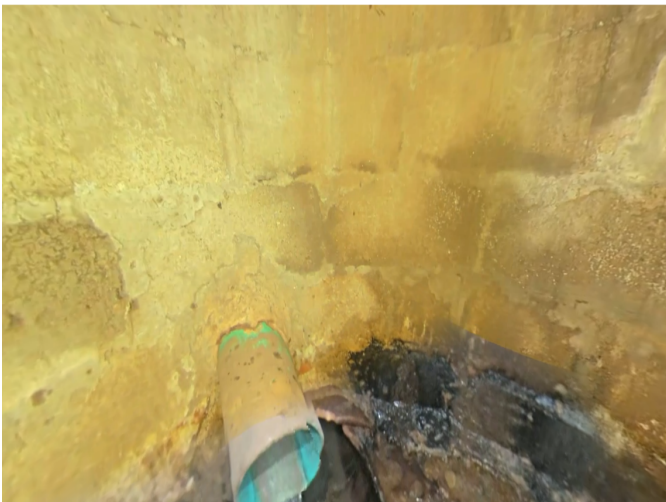
Code: **IS**
Description: **Infiltration Stain**

Distance: **8ft**
Structural Grade: **0**
O&M Grade: **1**
Clock Start/From: **12**
Clock To: **12**
1st Value:
2nd Value:
Value Percent:
Continuous Index: **F02**
Within Eight" of Joint: **False**
Remarks:
