R-027G

BELLEVILLE AVE
New Bedford

Inspection Status: Remote Inspection
Inspection Level: Level 2

Project: | New Bedford 3D Regulator Inspections

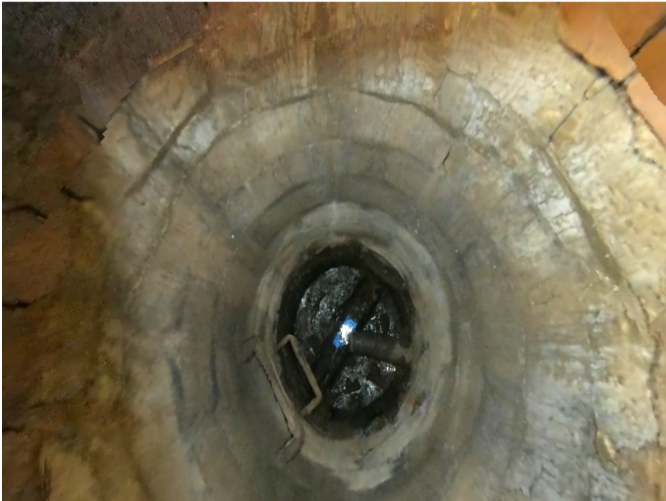
Code: **IS**
Description: **Infiltration Stain**

Distance: **0ft**
Structural Grade: **0**
O&M Grade: **1**
Clock Start/From: **12**
Clock To: **12**
1st Value:
2nd Value:
Value Percent:
Continuous Index: **S01**
Within Eight" of Joint: **False**
Remarks:

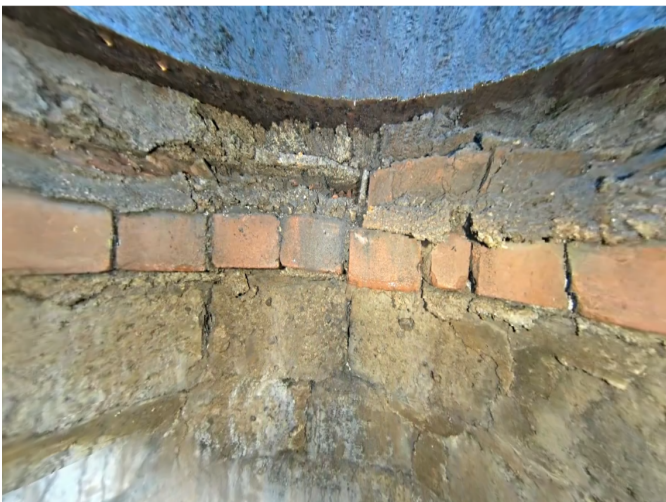
Code: **MMS**
Description: **Missing Mortar Small**

Distance: **1ft**
Structural Grade: **2**
O&M Grade: **0**
Clock Start/From: **12**
Clock To: **12**
1st Value:
2nd Value:
Value Percent:
Continuous Index:
Within Eight" of Joint: **False**
Remarks:

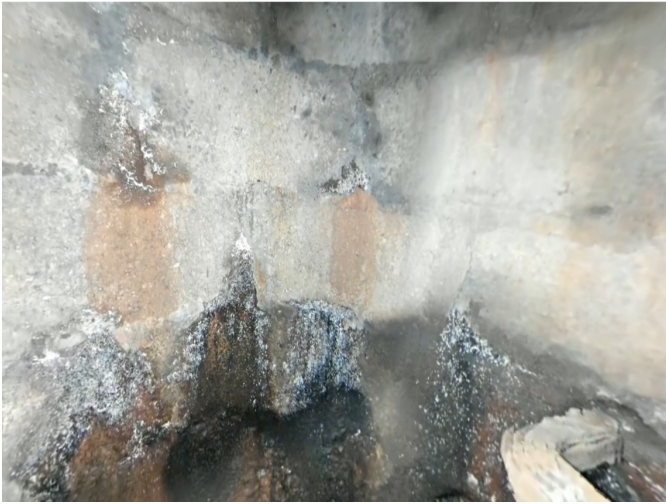
Code: **IS**
Description: **Infiltration Stain**

Distance: **5ft**
Structural Grade: **0**
O&M Grade: **1**
Clock Start/From: **12**
Clock To: **12**
1st Value:
2nd Value:
Value Percent:
Continuous Index: **F01**
Within Eight" of Joint: **False**
Remarks:

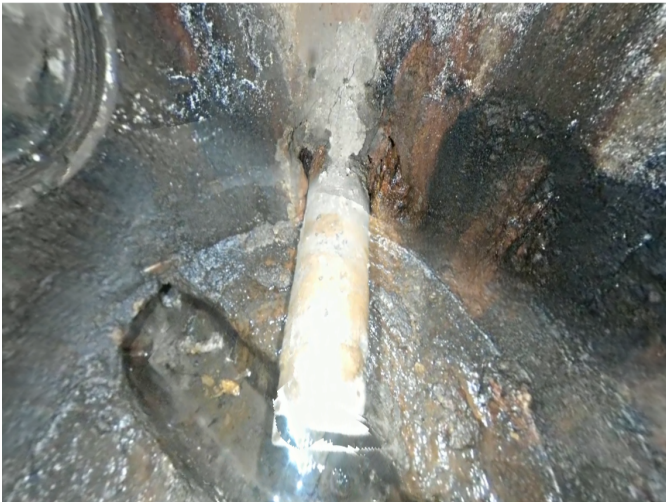
Code: **OBS**
Description: **Obstruction Built Into Structure**

Distance: **6ft**
Structural Grade: **0**
O&M Grade: **0**
Clock Start/From: **2**
Clock To:
1st Value:
2nd Value:
Value Percent: **15**
Continuous Index:
Within Eight" of Joint: **False**
Remarks: **Pipe through wall**
